AGENDA

NOTICE OF AN ORDINARY MEETING OF

COUNCIL

to be held on **Thursday, 29 August 2024** commencing at **1 pm** in the Council Chambers,
36 Weld Street, Hokitika and via Zoom

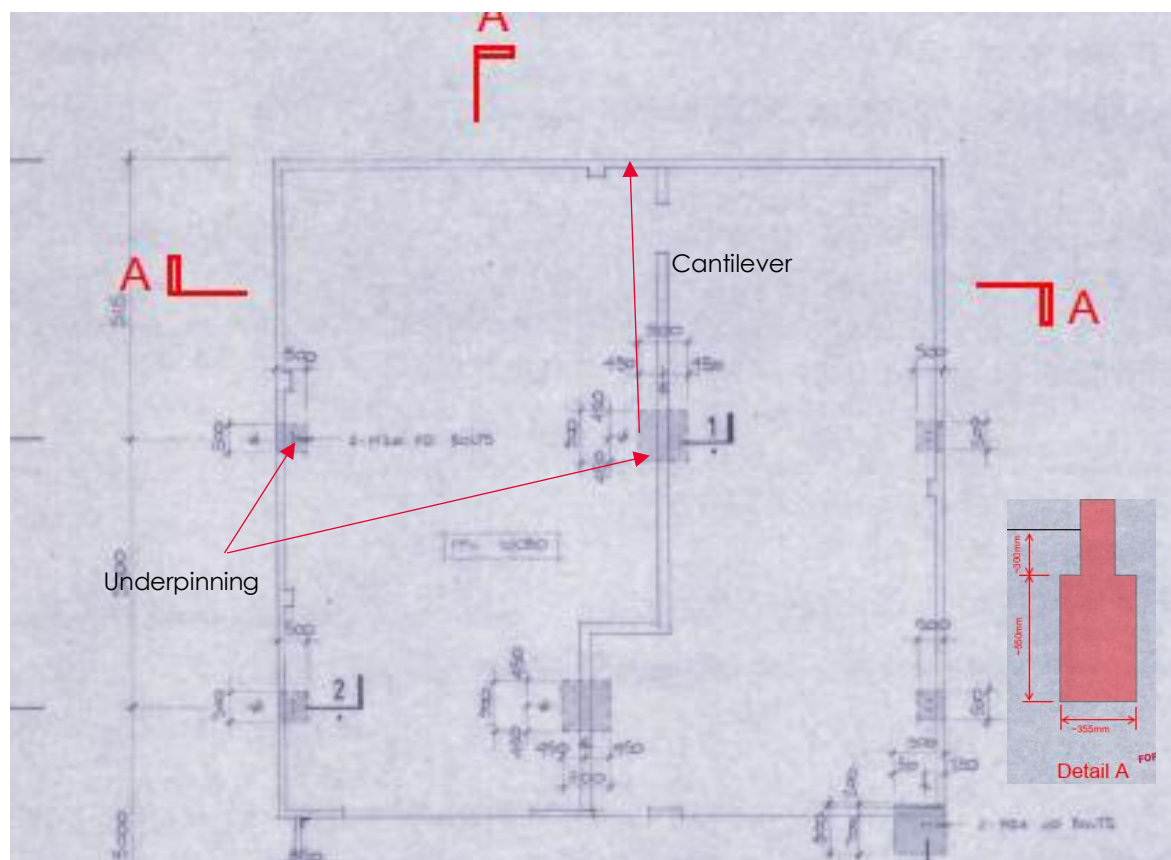
Figure 6. The older section of the building with existing shallow strip footings.

The older part of the building has a perimeter footing which we understand has been underpinned in several locations as shown in figure 6.

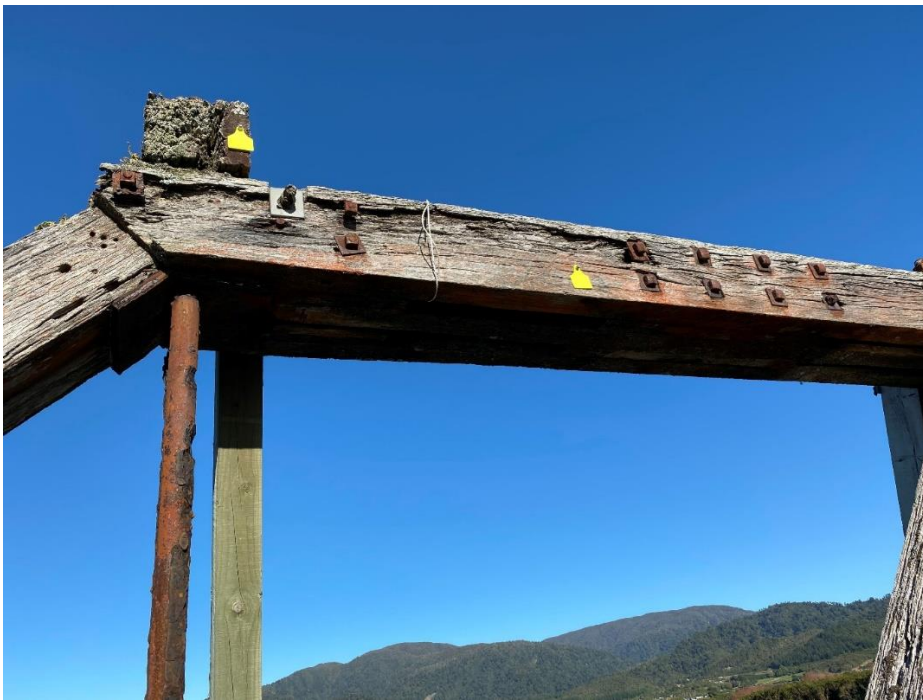
Top Cord Surface loss
Saddle block split in timber and timber decay.

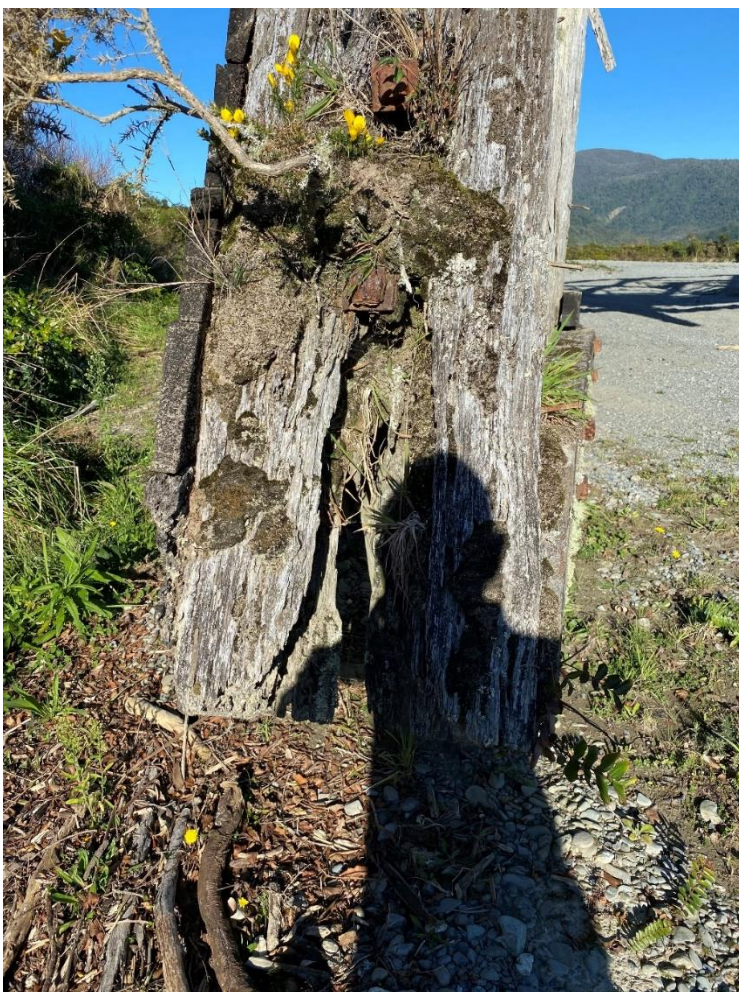
Raking pile timber split and timber decay.

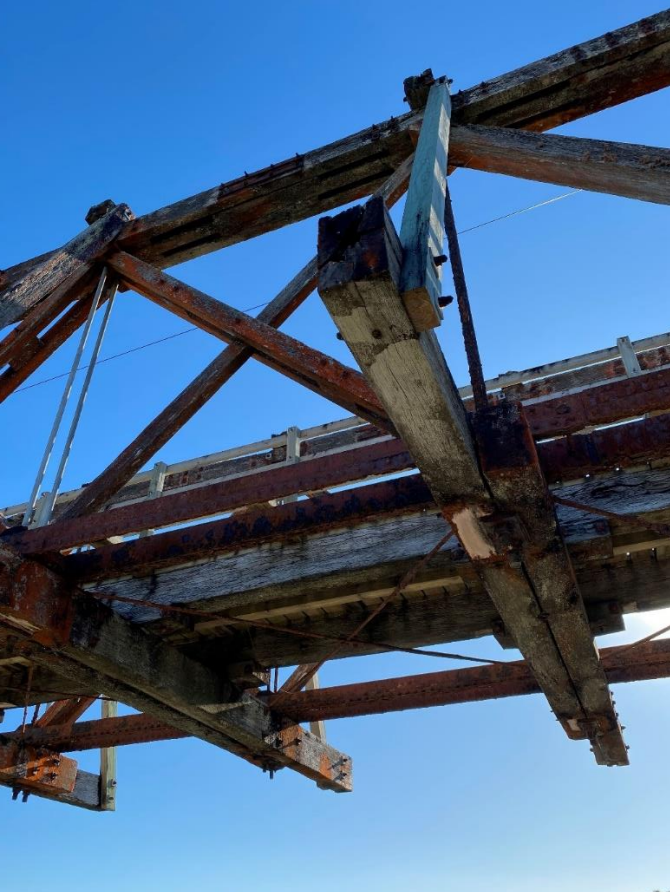
Transom end timber decay.

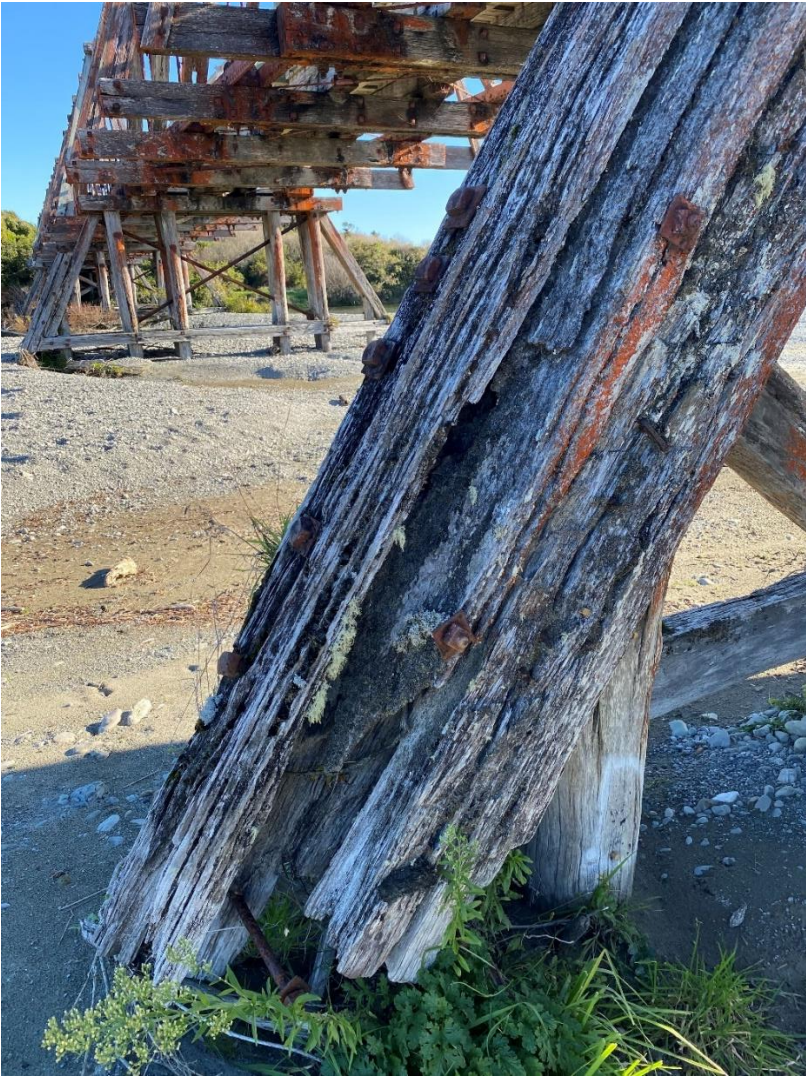
Raking pile timber decay.

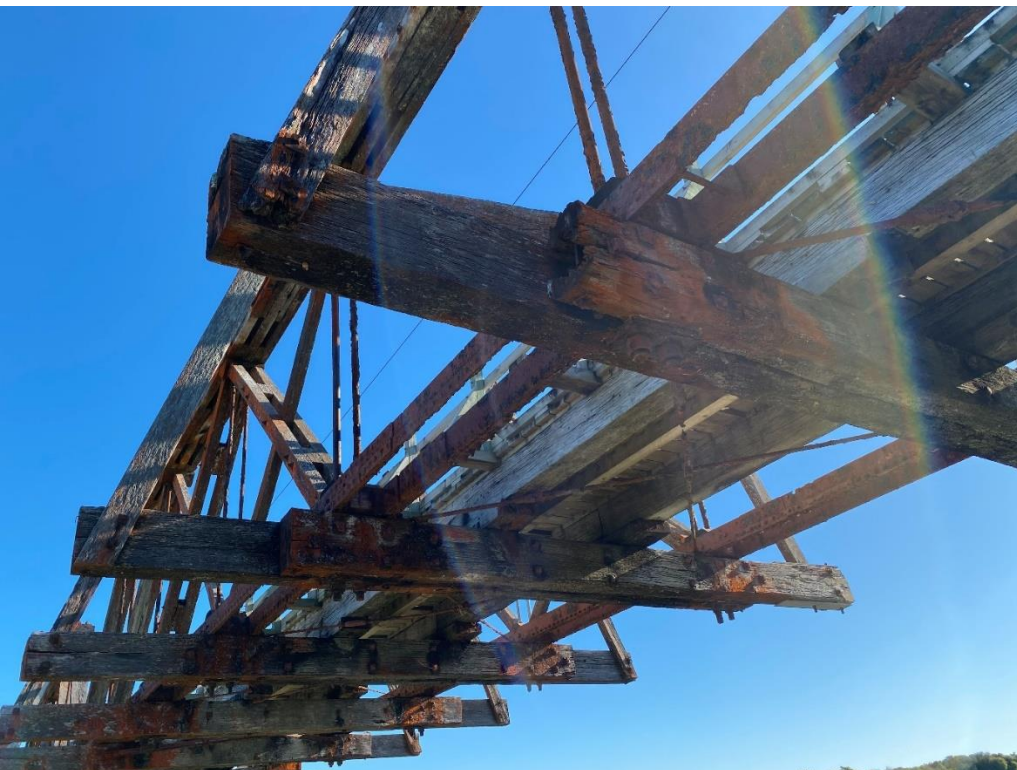
Transom Timber decay and timber split

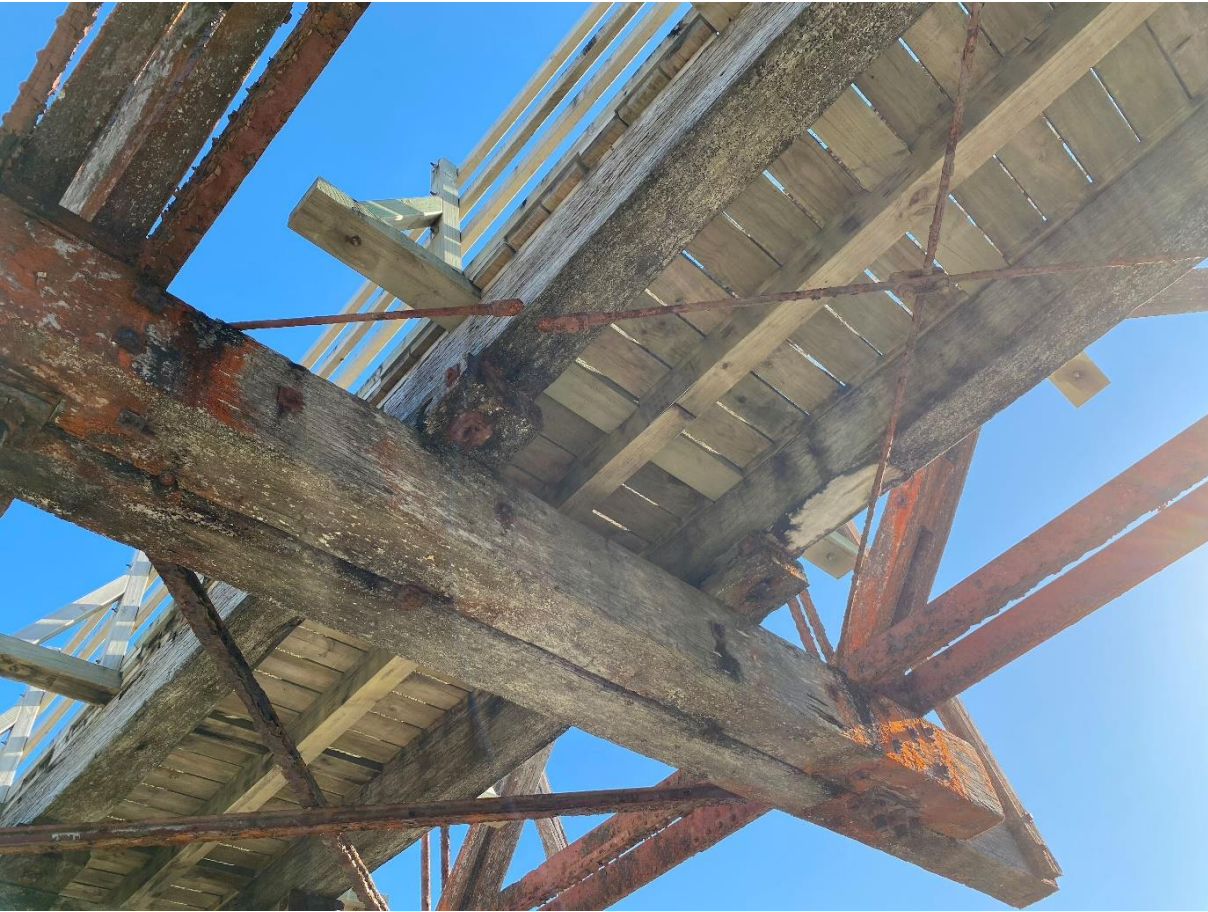
Cross bracing corroded away.

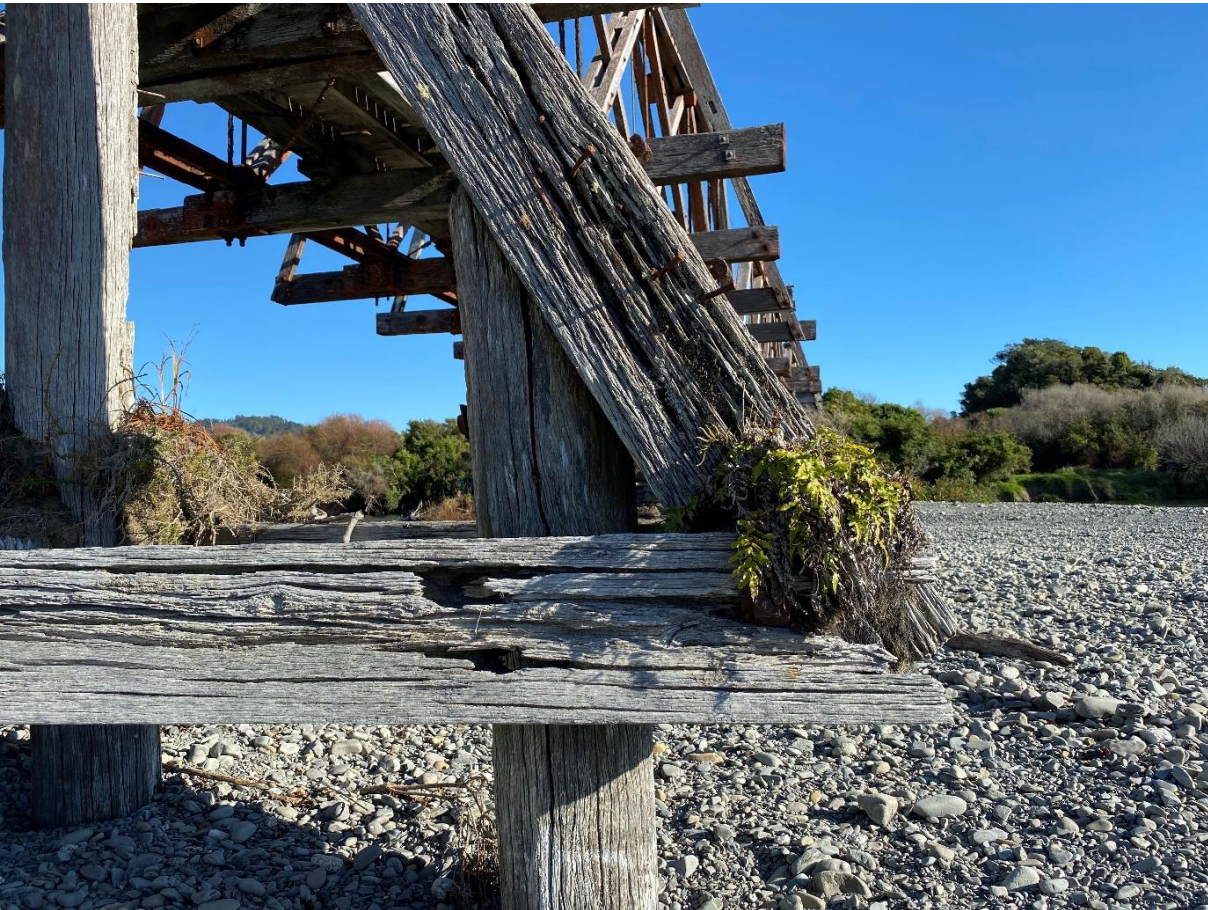
Timber loss and decay.

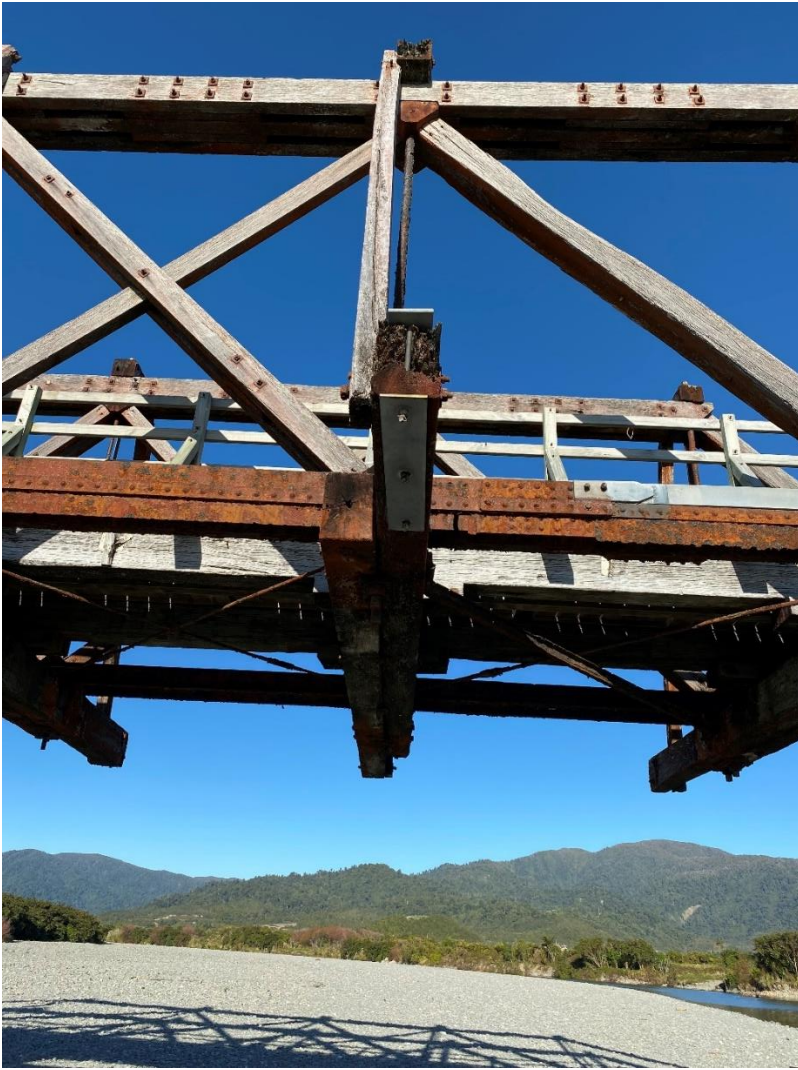
Previous repair to transom end.
More timber decay present

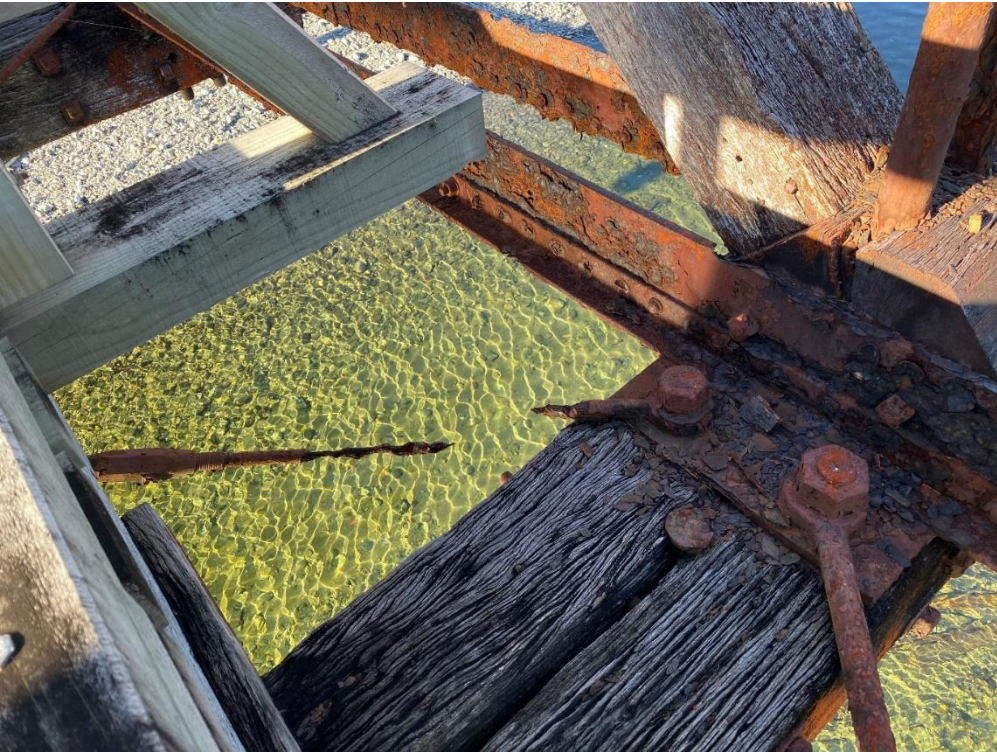
Steel cross bracing corroded. Needs replacing

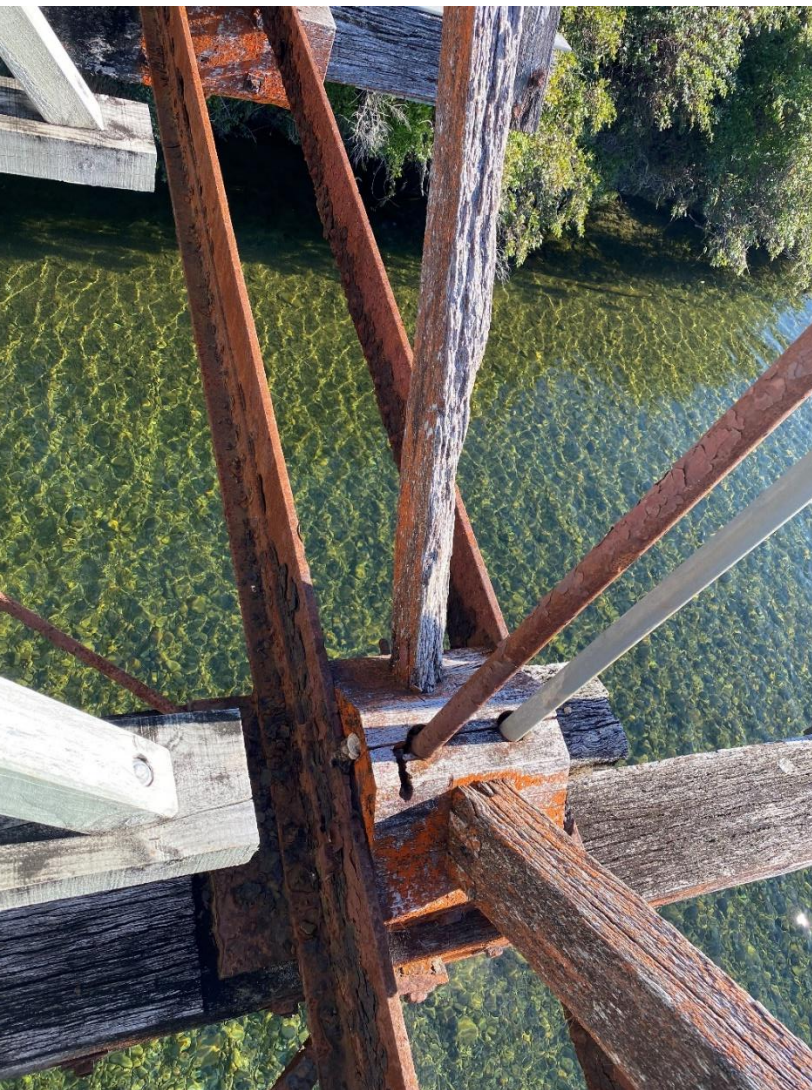
Loss of section on timber strut.

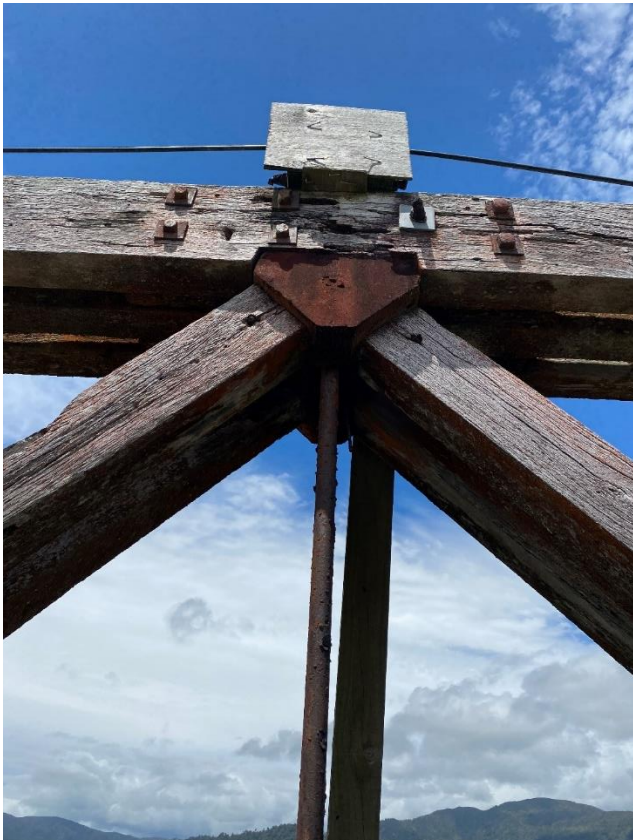
Saddle block needs replacing.

Saddle block split

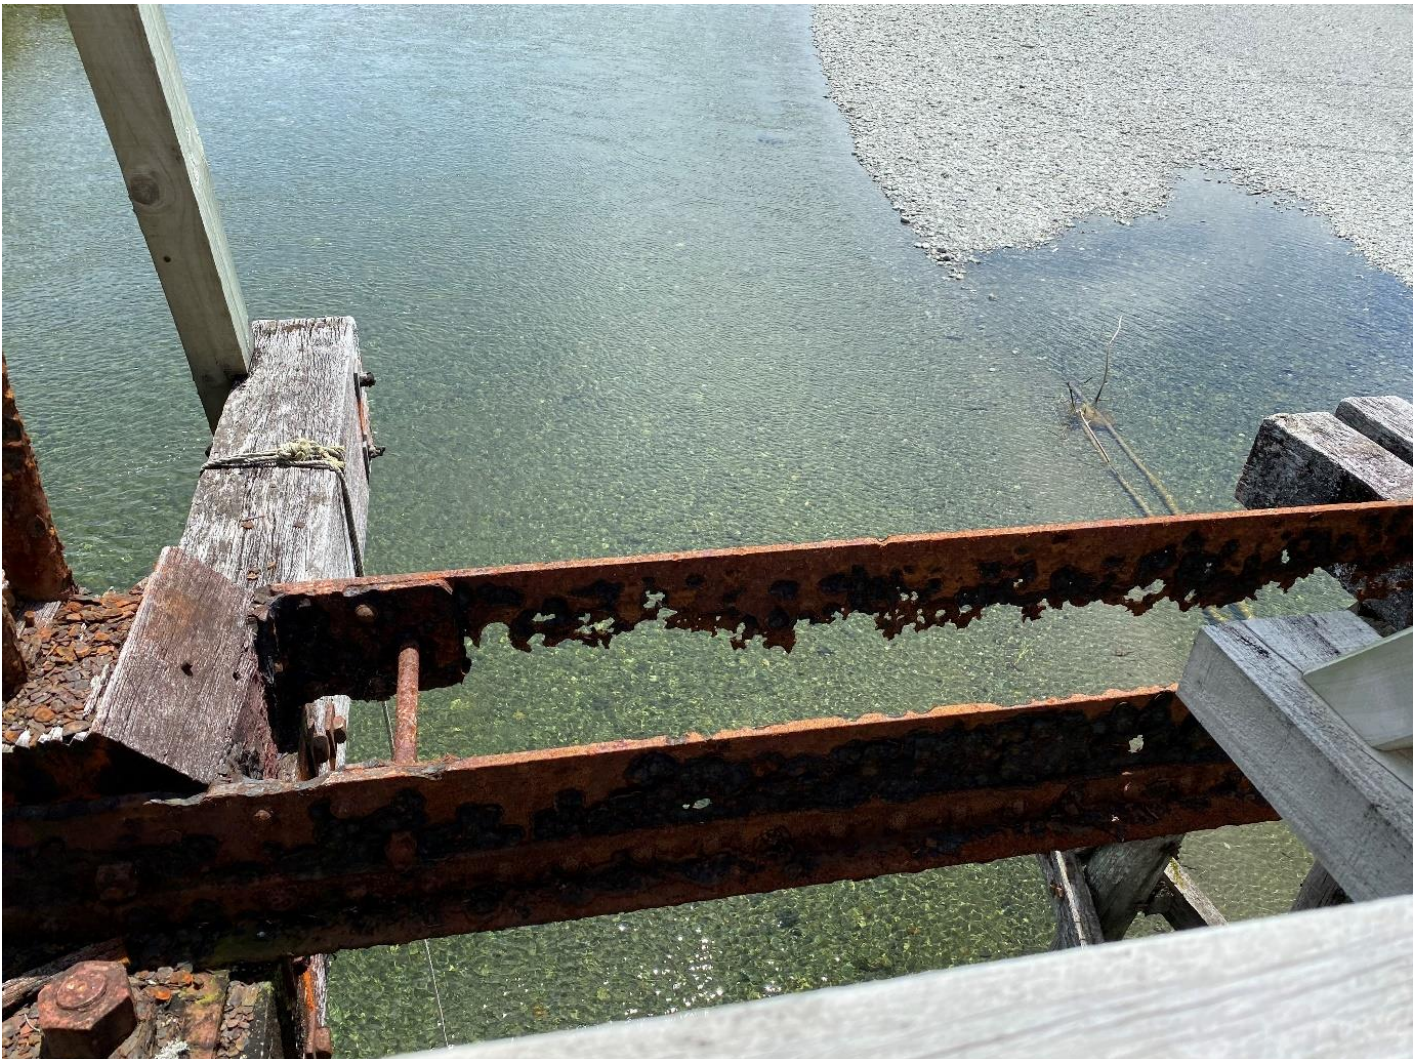
Bottom cord corroded, needs replacing

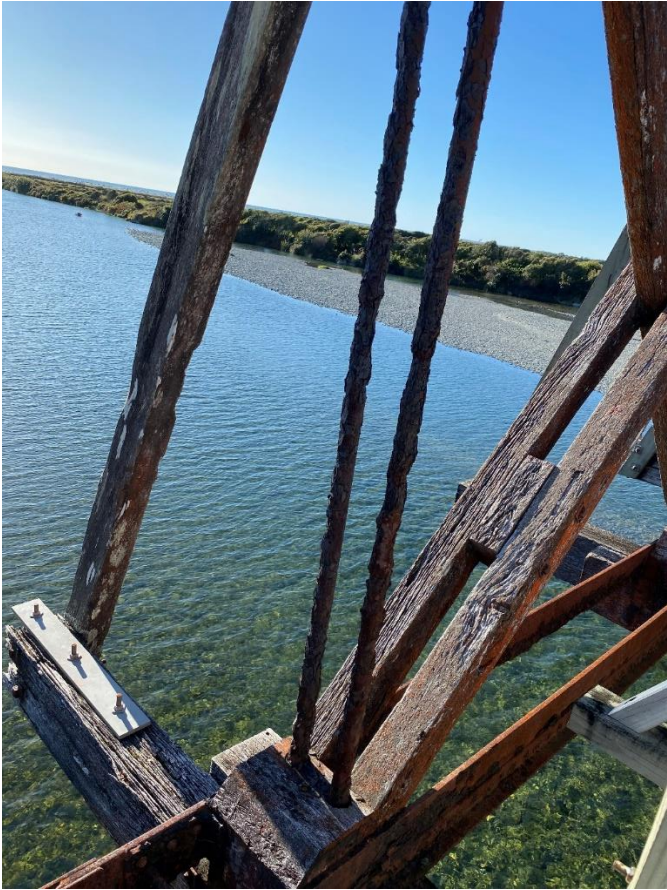
Tension rods corroded.
Previous repair to transom. Needs more repairs.
Decay to timber strut.

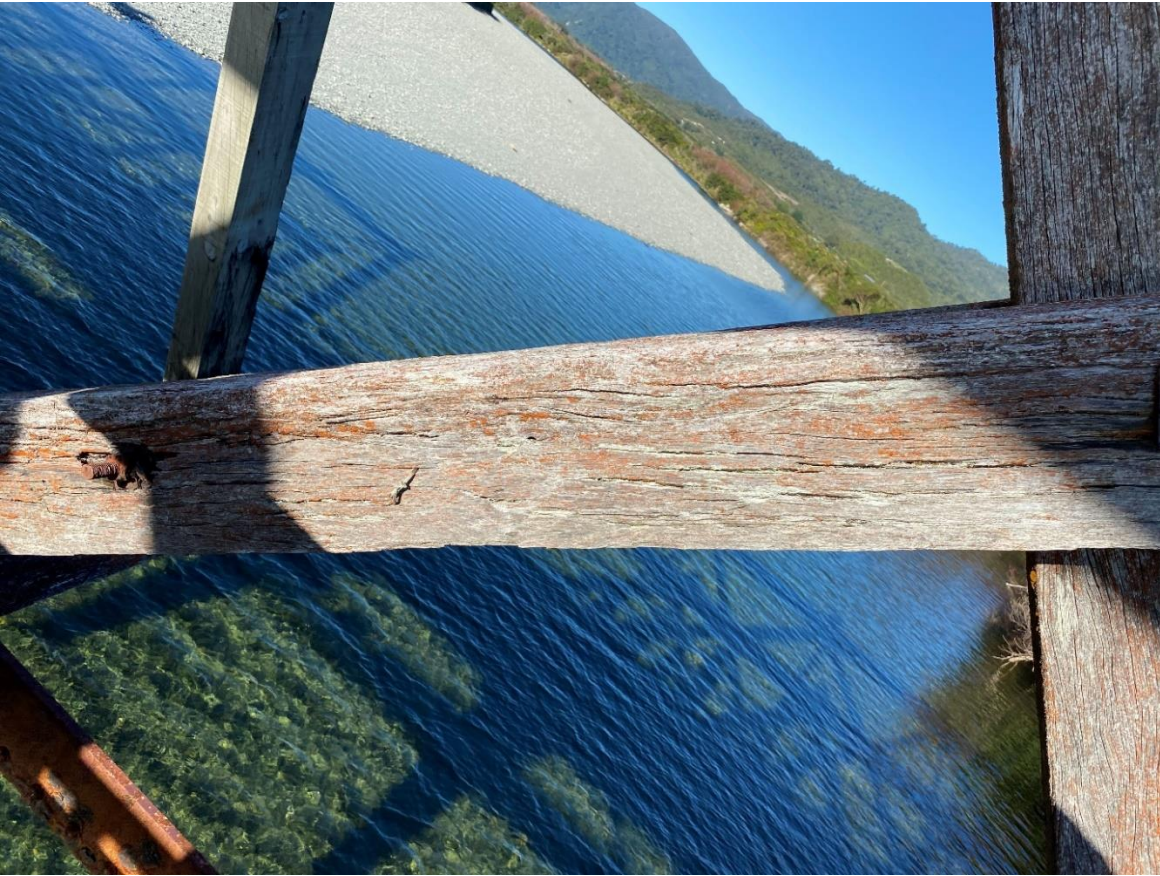
Centre strut timber decay.

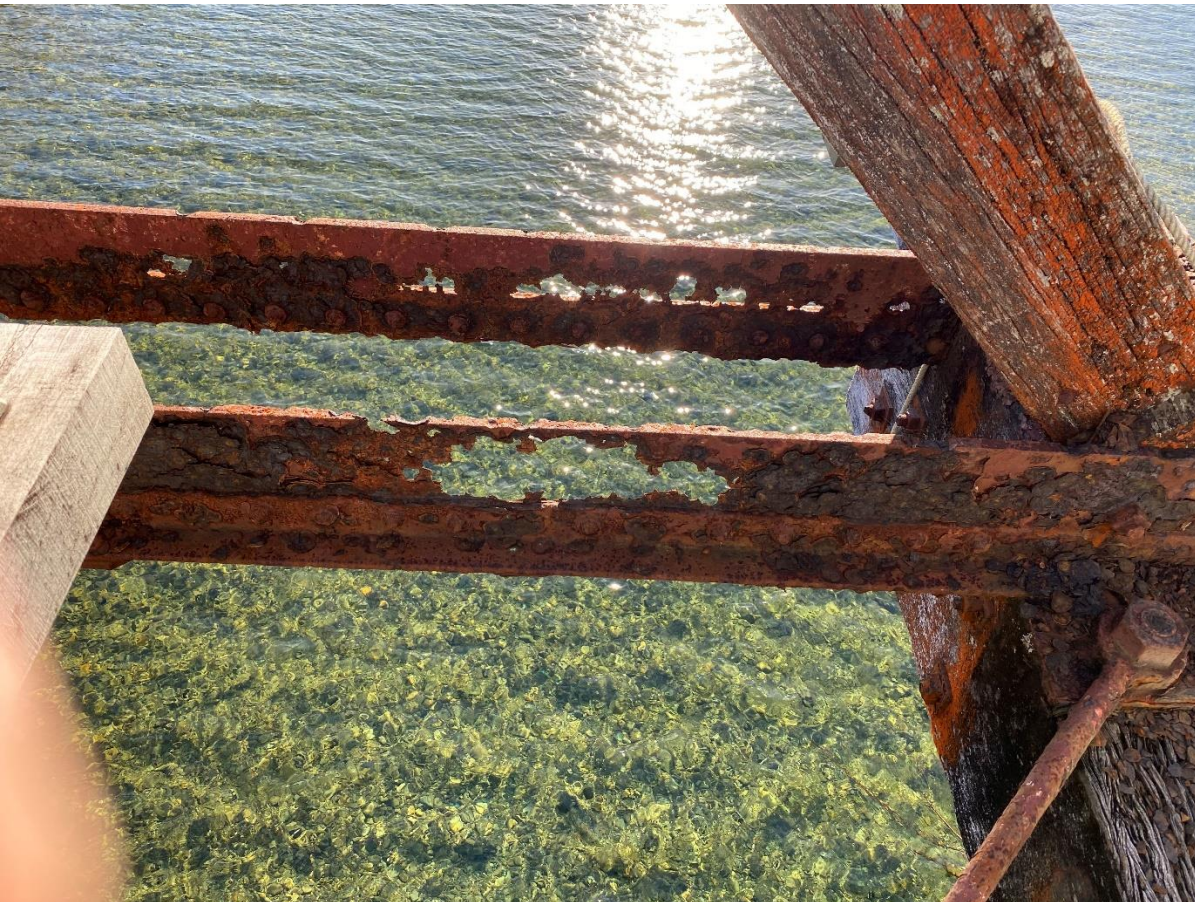
Bottom cord corroded. Needs replacing

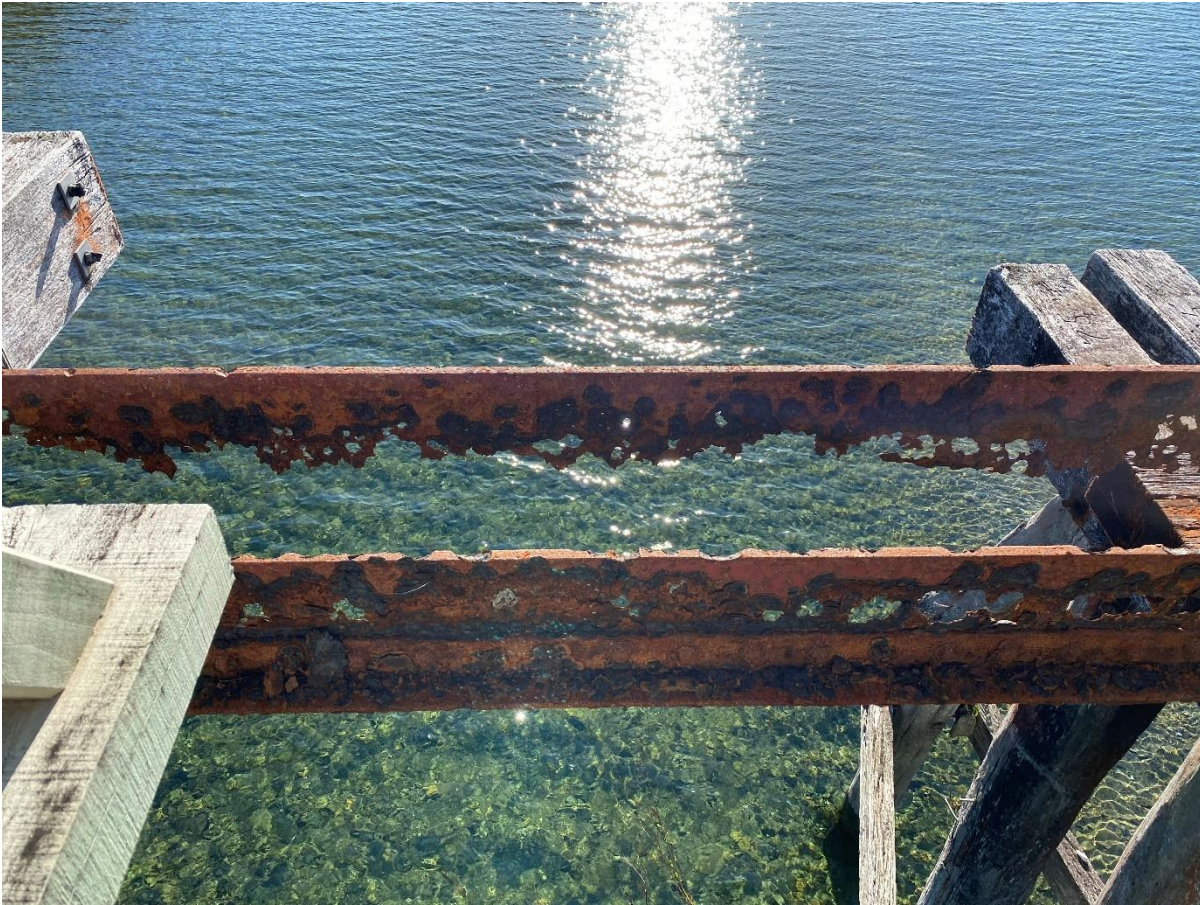
Bottom cord corroded. Needs replacing.

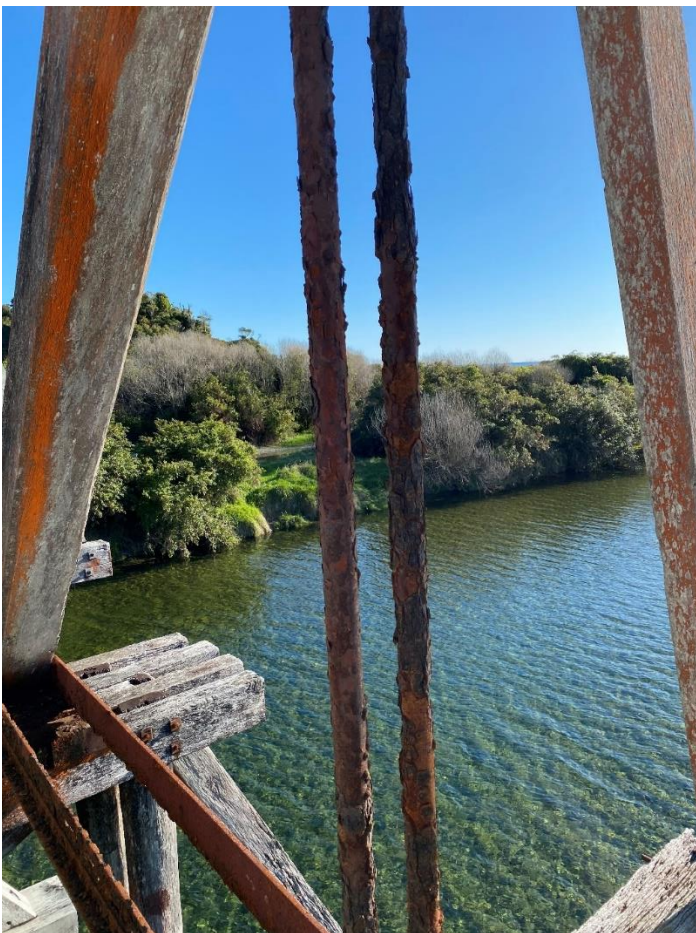
Tension rods corroded. Needs replacing

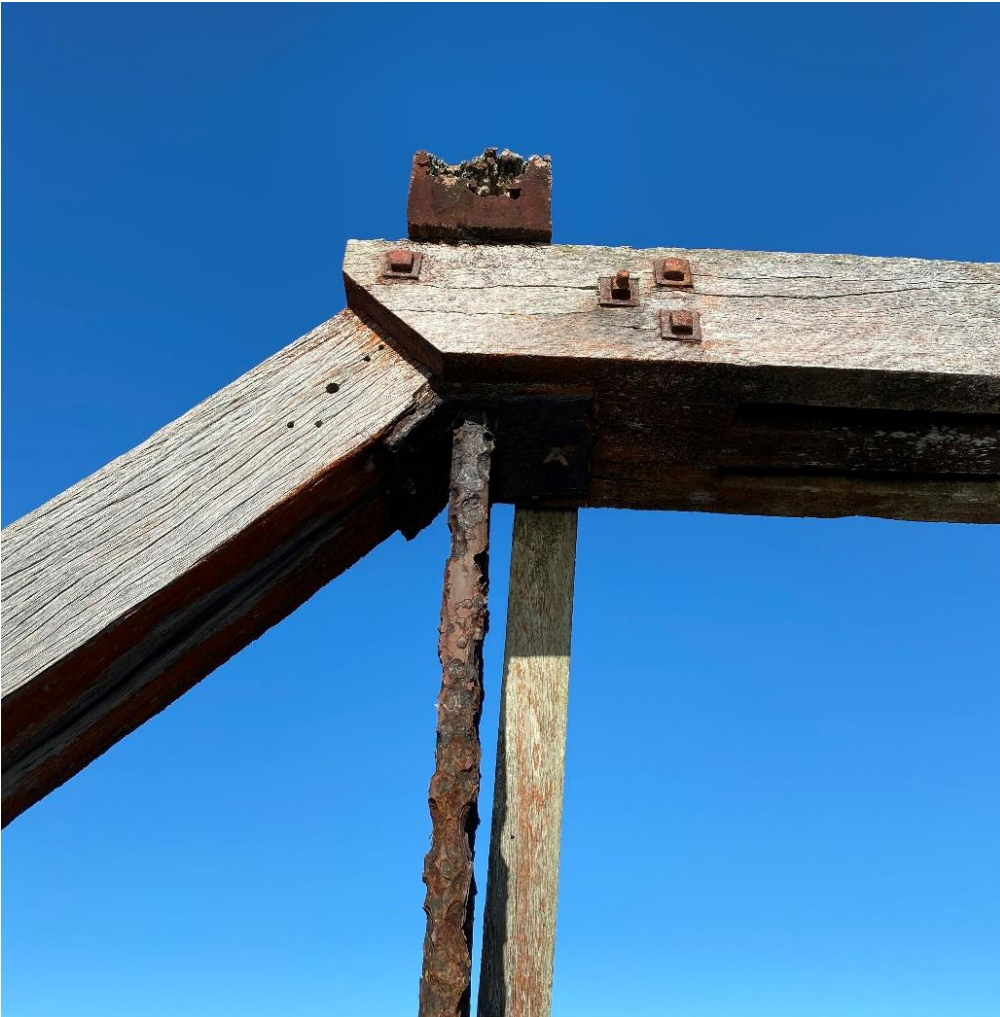
Saddle block timber decay.
Tension rod corroded.

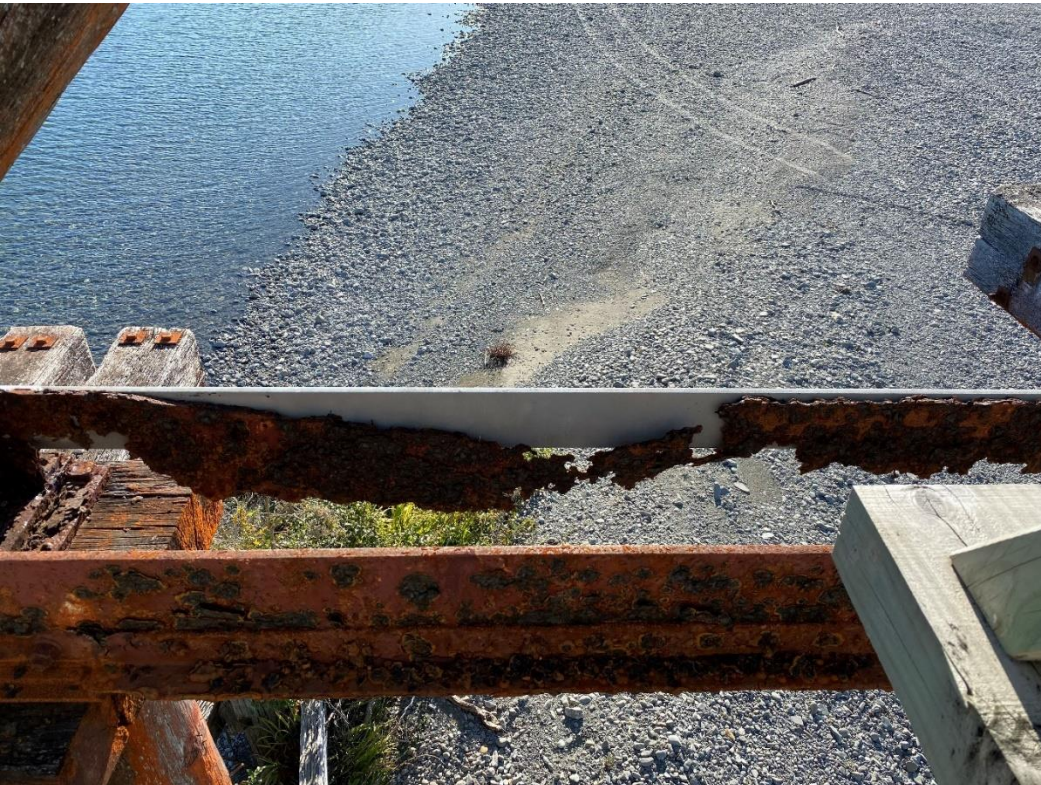
Bottom cord corroded. Previous repair visible.

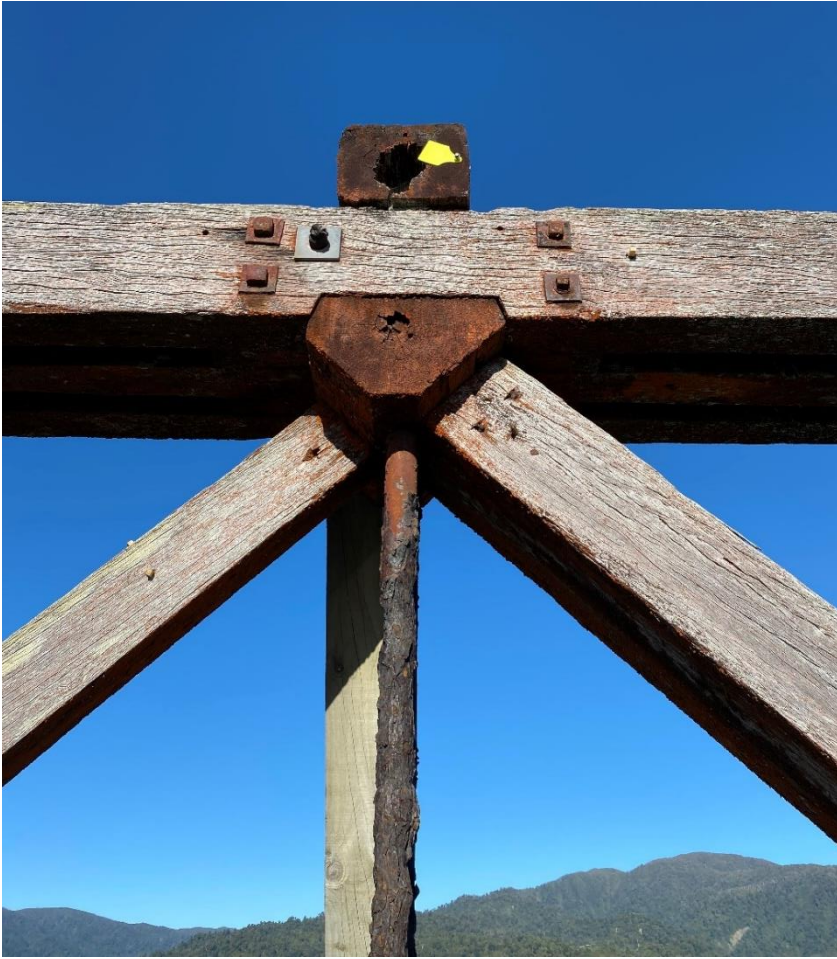
Saddle block with tunnel rot.

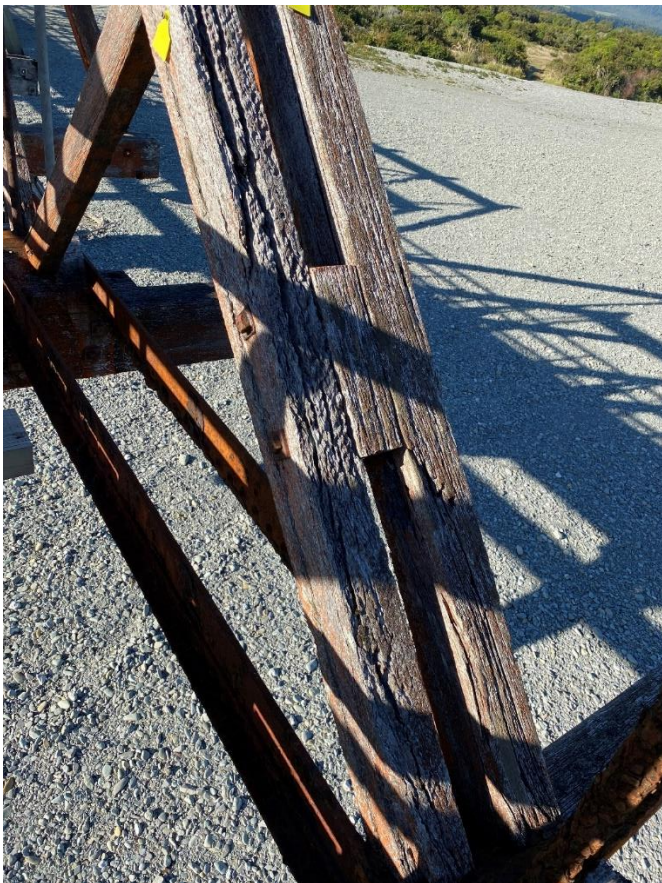
Surface loss on timber strut

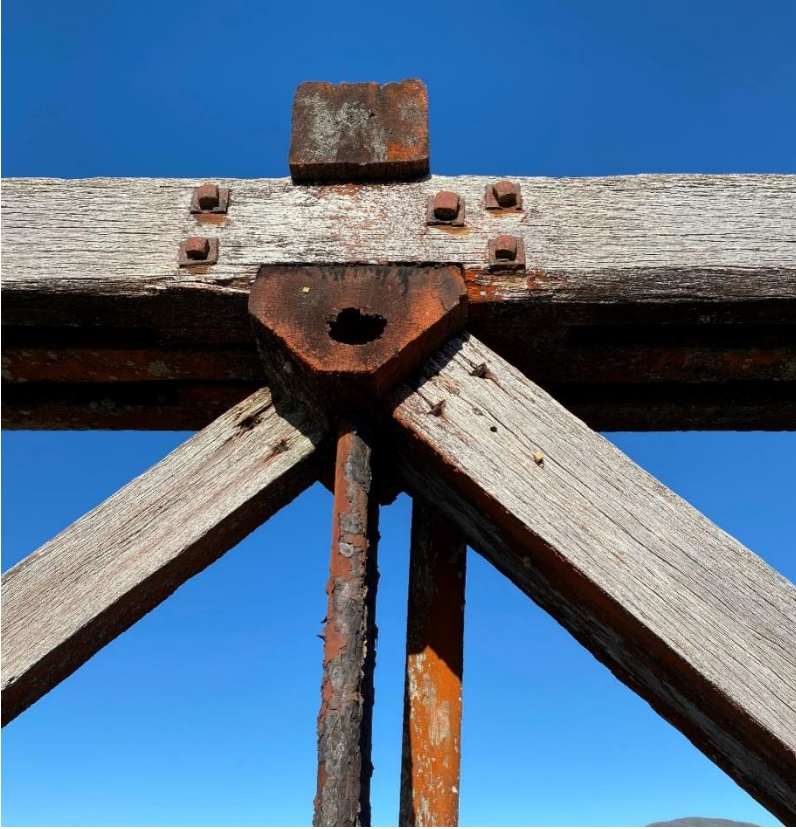
Tiber A block with tunnel rot.

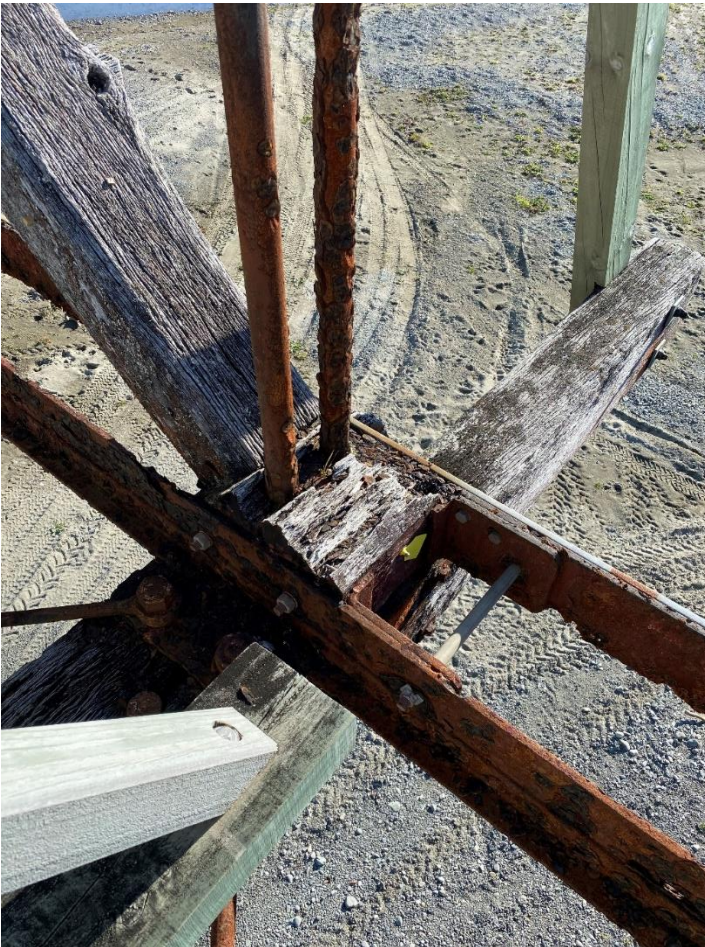
Timber thrust block with timber decay.

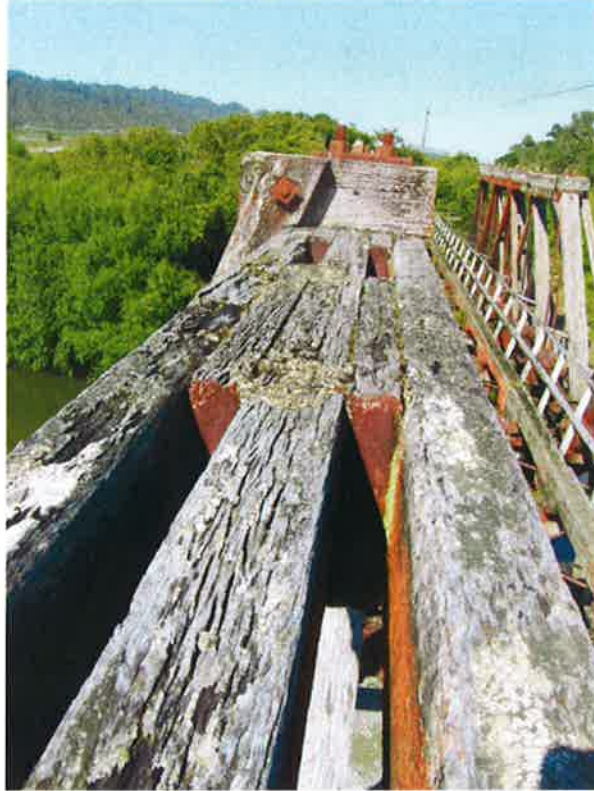
Figure 5-1 : Top Chord of Timber Trusses – Minor Weathering / Splitting Only, “Sound”

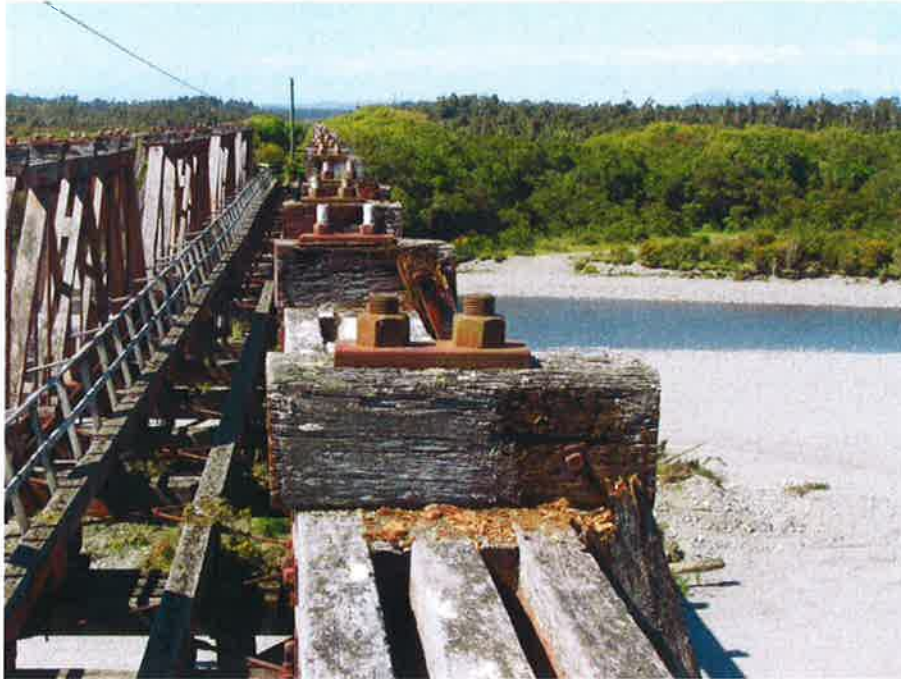
Figure 5-3 : Lateral Braces – Members Completely Decayed at Ends, “Requires Replacement”

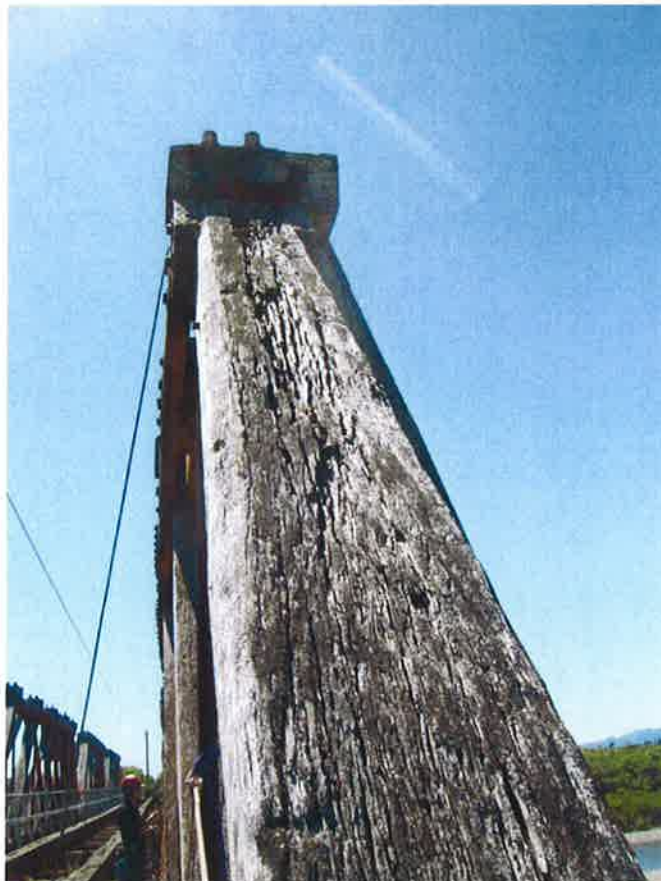
Figure 5-4 : King Strut – Significant Surface Decay, Pocket Decay and Splitting, “Investigate Further”

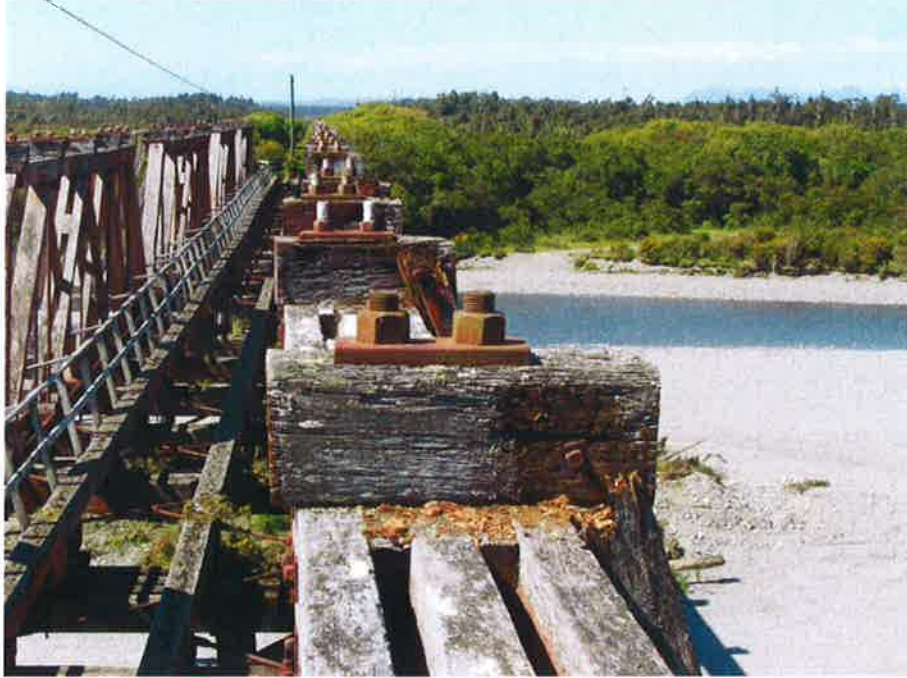
Figure 5-3 : Lateral Braces – Members Completely Decayed at Ends, “Requires Replacement”
