AGENDA

NOTICE OF AN ORDINARY MEETING OF

COUNCIL

to be held on **Thursday, 29 August 2024** commencing at **1 pm** in the Council Chambers,
36 Weld Street, Hokitika and via Zoom

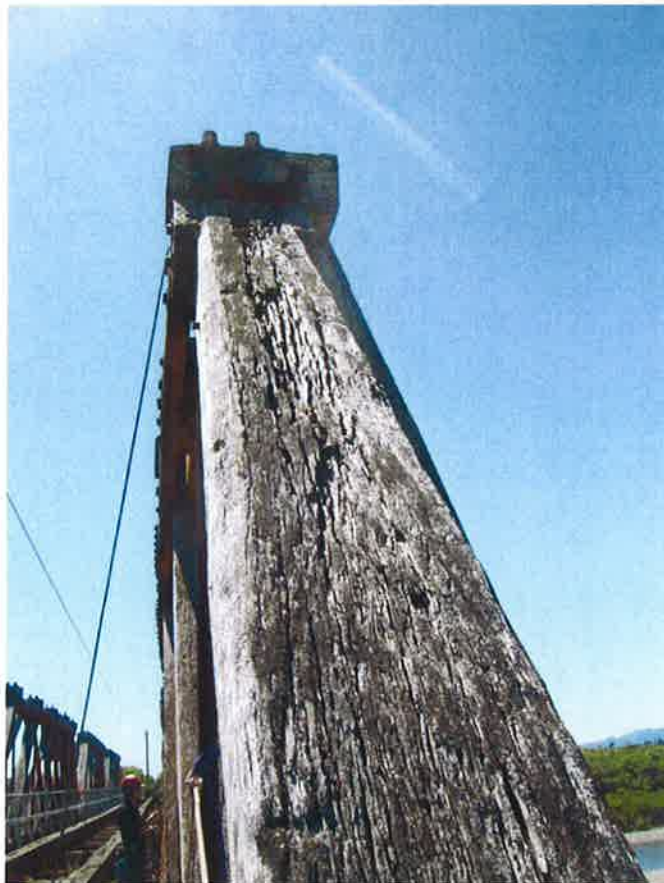
Figure 5-4 : King Strut – Significant Surface Decay, Pocket Decay and Splitting, “Investigate Further”
