# DSA Summary Report

**36 Weld Street, Hokitika**

Prepared for Westland District Council  
503048

Eliot Sinclair & Partners Limited (Eliot Sinclair) has completed a Detailed Seismic Assessment (DSA) of the Westland District Council building at 36 Weld Street, Hokitika. This report is a brief summary prepared at the Council's request. It covers only those parts of the building that scored below 34%NBS, and discusses the consequences if those elements reach their probable capacity.

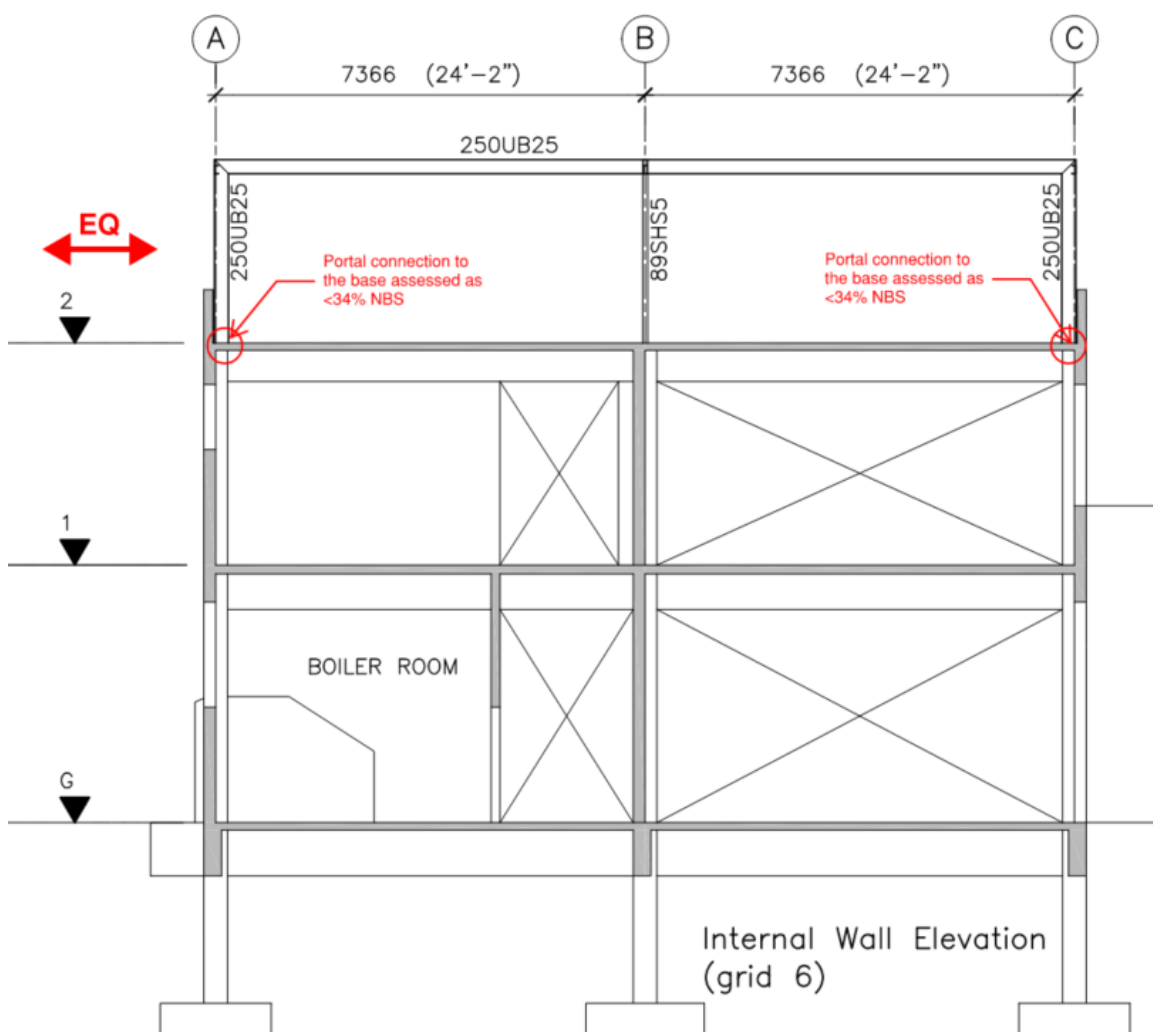
**Element description:** The roof is supported vertically and laterally by steel frames. The legs of these frames are fixed down to the concrete floor by what are likely to be shallow embedded anchors.

**Risk:** In an earthquake shaking across the building, the seismic demands on the anchors could exceed their assessed capacity, and the anchors could pull out. The frames could then lean and sway excessively. In this scenario localised sections of the roof and/or associated ceiling systems could collapse, mostly in open areas that have no timber-framed walls to hold the roof up.

**Basis of analysis:** The anchor type and installation method are unknown. However, given the age of the building and the seismic provisions in place at the time, the anchors are likely to comprise shallow embedded mechanical expansion fixings and are unlikely to comply with the seismic requirements for post-installed anchors as per current requirements.

Figure 2. Typical Portal Frame elevation highlighting the hold down connection rated as less than 34% NBS

- **Foundations:** new concrete pads under the building so it stays supported even if the piles fail. Pads sitting on the existing fill suit firm, gravelly fill. Pads on new short piles suit soft, loose fill.
- **Top floor roof frames:** Install new fixings for the frame legs on grids A and C.
- **Top floor walls:** Install new fixings for the steel braced frame on grid B and new steel braced frames in the outer walls on grids A and C.
- **Boiler room wall:** Add new reinforced concrete layer added to the inside face of the Grid 7 wall.
- **South stairwell connection to the floor –** Add a new collector beam to transfer the loads.
- **South library extension (reception area) Rafter connection to the building –** install new epoxy anchors from the end plate of the rafters to the building.

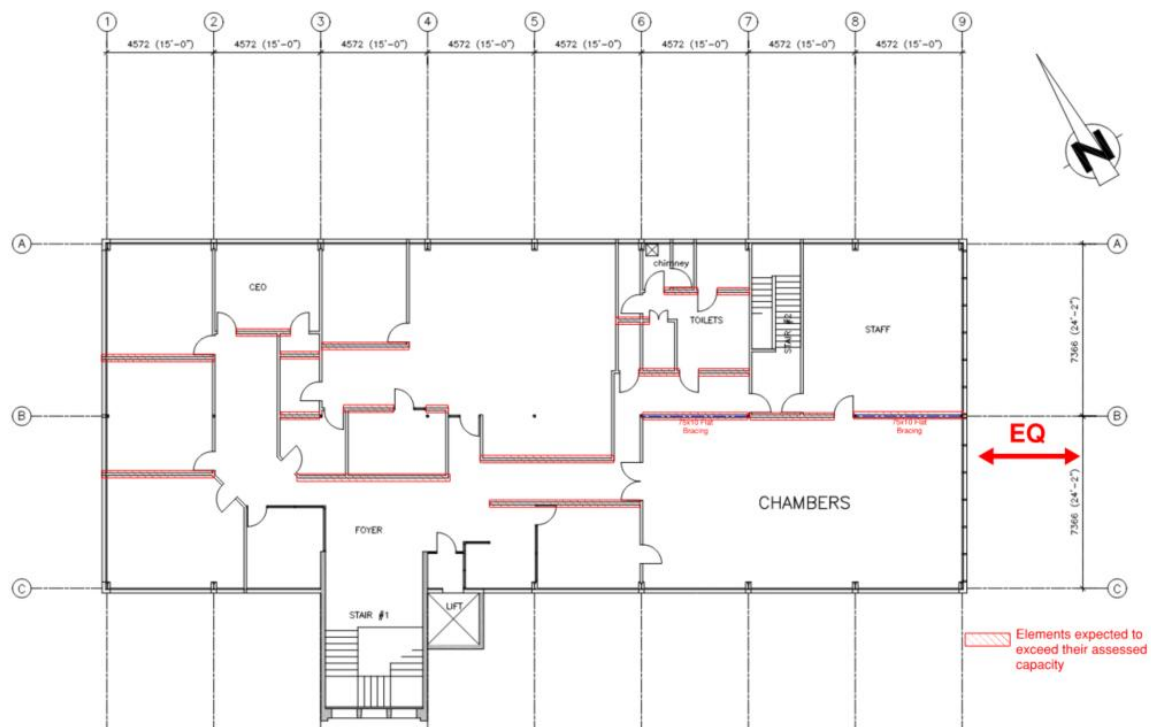
**Element description:** Along the building, the top floor relies on plasterboard-lined timber walls and thin steel bracing straps to resist sway.

**Risk:** In an earthquake shaking the building along its length, the seismic demand on these walls and straps could exceed their assessed capacity, and they could move excessively. In this scenario, localised sections of the roof and/or associated ceiling systems could collapse, particularly in open areas that have no timber-framed walls to hold the roof up.

**Basis of analysis:** No drawings were available for the construction of these walls or the connections of the steel straps to the floor. Hence, our analysis is based on site observations together with the adoption of probable strength properties derived from industry guidance documents, so the assessed rating is a best estimate.

Figure 3. Third floor plan – red hatch denotes items that are expected to exceed their assessed capacity.

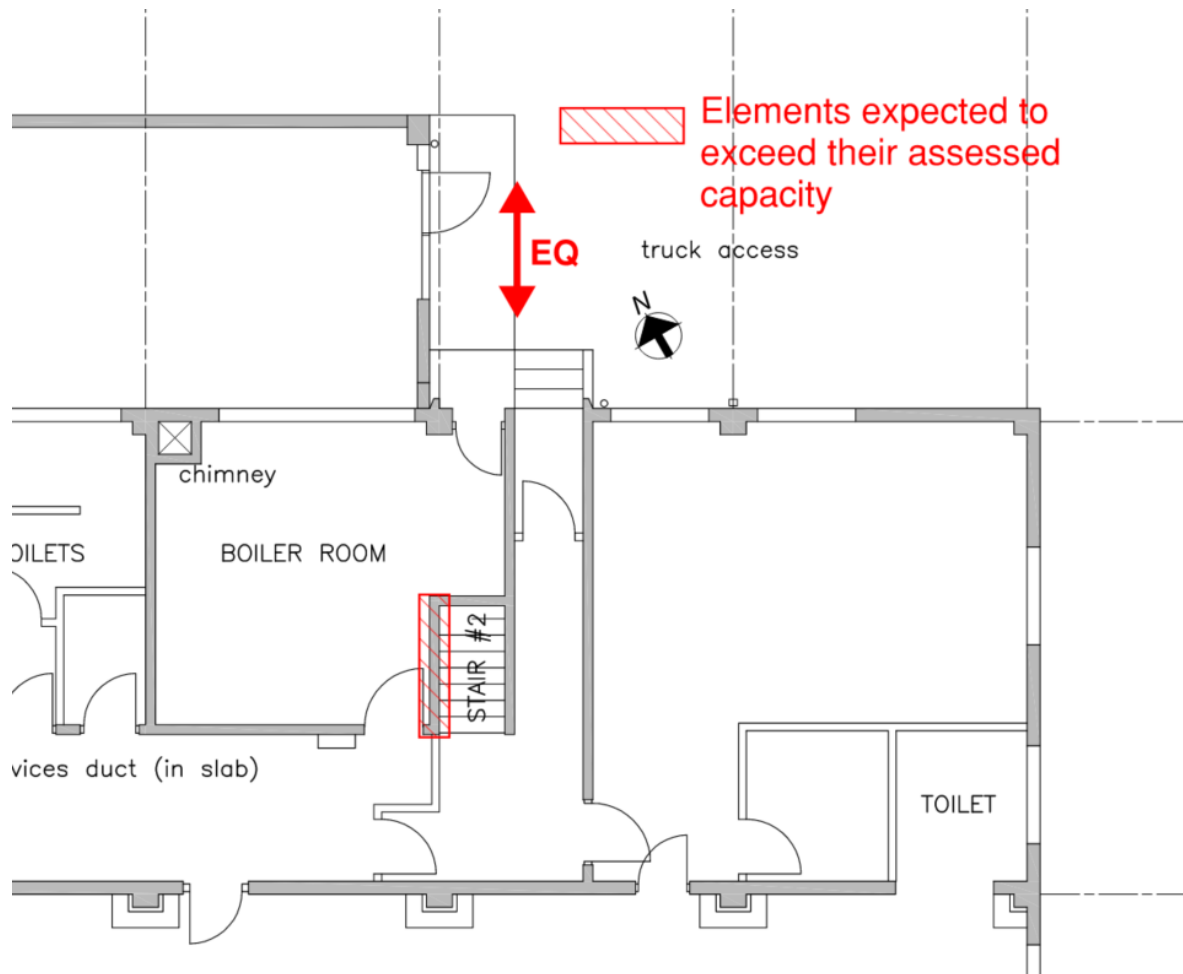
**Element description:** A concrete wall in the boiler room resists earthquake shaking across the building at ground floor level.

**Risk:** In an earthquake shaking across the building, the seismic demand on this wall is likely to exceed its assessed capacity. This could lead to extensive damage to the wall, and the loads are expected to redistribute to adjacent walls on the ground floor. Local concrete cracking and spalling is likely, however the floor structure above is expected to remain supported by the frames and adjacent walls.

**Basis of analysis:** Wall reinforcement and geometric details are based on the available existing drawings. The wall has been assessed using Section C5 of the NZSEE guidelines.

**Figure 4.** Ground floor plan – Wall adjacent to stairs in the boiler room is expected to exceed its assessed capacity.

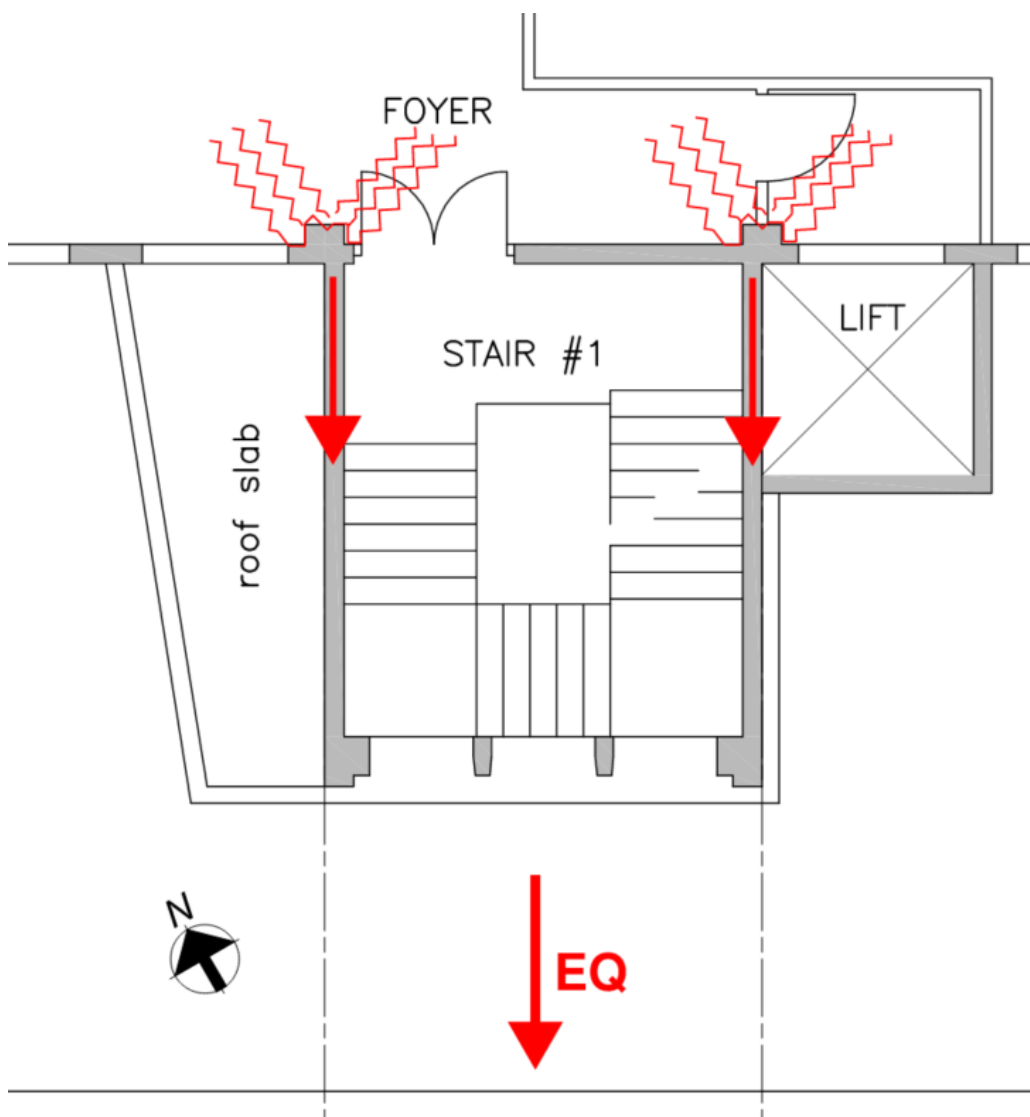
**Element description:** The south stairwell walls provide lateral support to the building, resisting seismic shaking at all levels.

**Risk:** In an earthquake shaking across the building, the seismic demand on the connections between the stairwell and the building could exceed their assessed capacity. This could cause parts of the stairwell to separate from the building, particularly where the stairs connect to the floors near columns. This is unlikely to cause the building to collapse, because the floors are expected to transfer the forces to other structural walls. However, parts of the stairs could be badly damaged, which could compromise the ability to exit the building via the stair following an earthquake.

**Basis of analysis:** Existing drawings were used to determine how the stairs connect to the building. No specific details were available for the connection between the stair wall and the columns, so this connection was assumed to be similar to other wall-to-column connections in the building, and that assumption was used to assess the connection capacity.

Figure 5. Plan view of the stairwell – connection between building and stairwell is rated at 25% NBS(IL2)

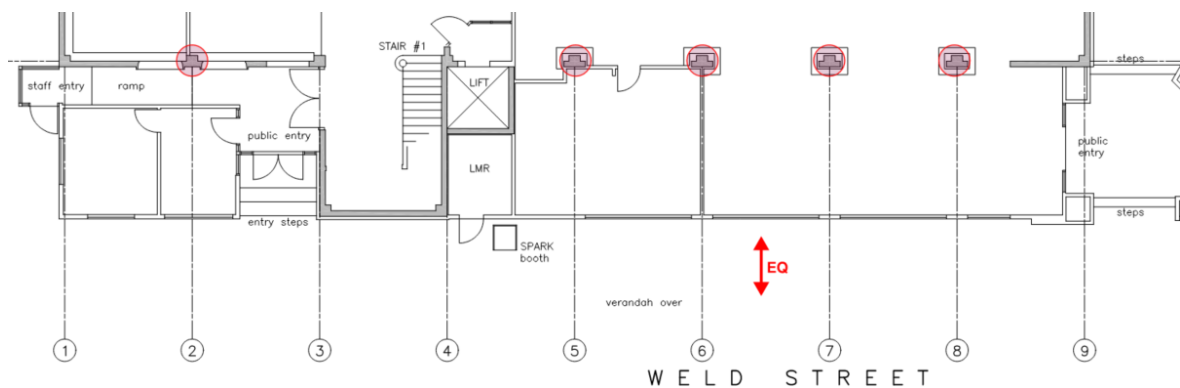
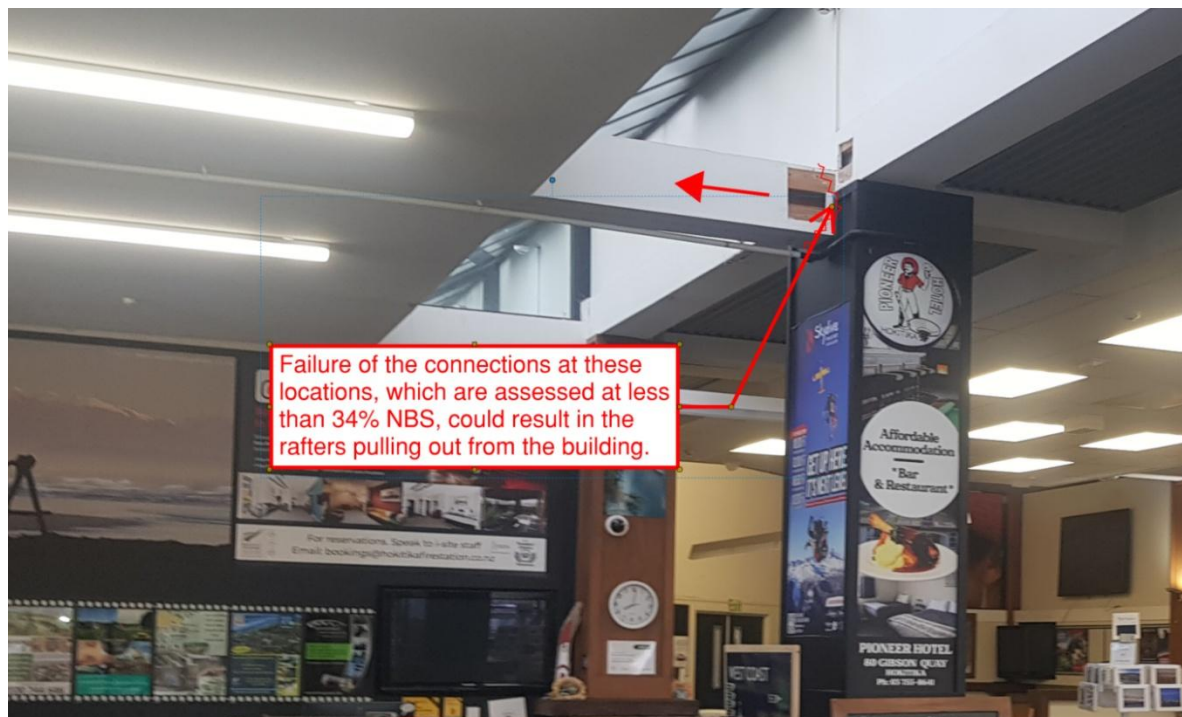
<sup>#</sup> The post installed anchor connecting the rafters to the main building are unlikely to meet the C2 requirements for post installed anchors in cracked concrete should be strengthened to meet current seismic provisions for post installed anchors. Their capacity are difficult to quantify and the failure could result in collapse of the roof structure and are hence assessed as being less than 34%NBS.

**Element description:** The rafters of the south library extension (now reception area) are connected to the main building, which supports the roof structure and resists seismic shaking in the across direction.

**Risk:** During an earthquake, the seismic demand on the connections holding the roof-supporting beams (rafters) to the building could exceed their assessed capacity. Failure of the connections is likely to be brittle and without warning. As a result, the rafters could come loose, which could cause the part of the roof they support to collapse.

**Basis of analysis:** The anchor type and installation method are unknown. However, given the age of the building and the seismic provisions in place at the time, the anchors are likely to comprise shallow embedded mechanical expansion fixings and are unlikely to comply with the seismic requirements for post-installed anchors as per current requirements.

Figure 6. Ground floor plan view (top) – rafter to building connection highlighted in red circle are expected to be less than 34%NBS(IL2). Rafter picture with arrow pointing towards direction of force (bottom).
