Memorandum

To	Erle Bencich
Copy	Mark Smith, Kathie Ragg
From	Rem Markland
Office	Greymouth
Date	19 June 2024
File/Ref	6-WWES5.02
Subject	Totara Rail Bridge - Summary Assessment 2024

Project Number: 6-WWES3.98

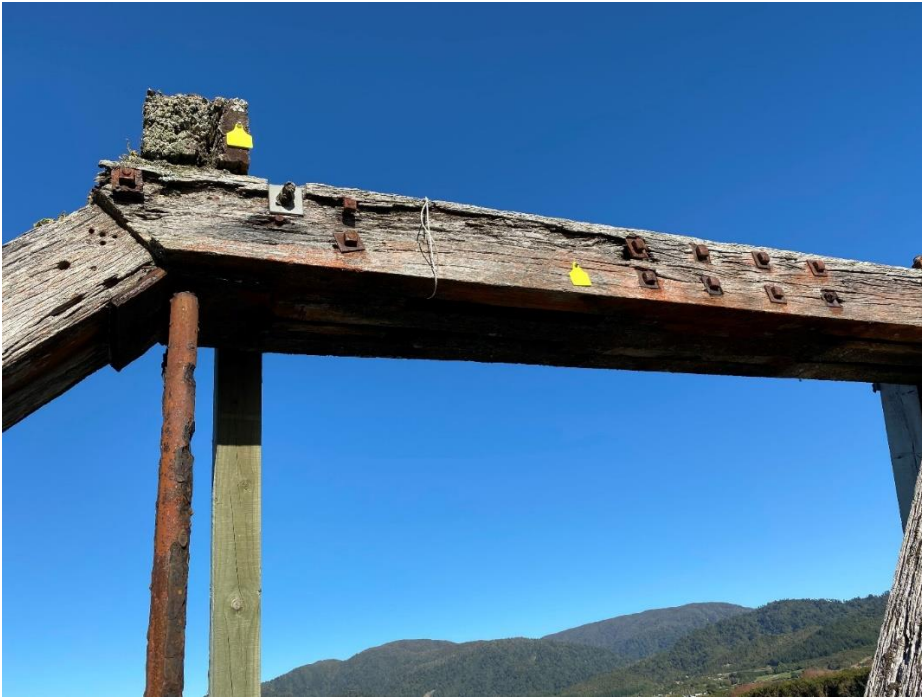
Top Cord Surface loss
Saddle block split in timber and timber decay.

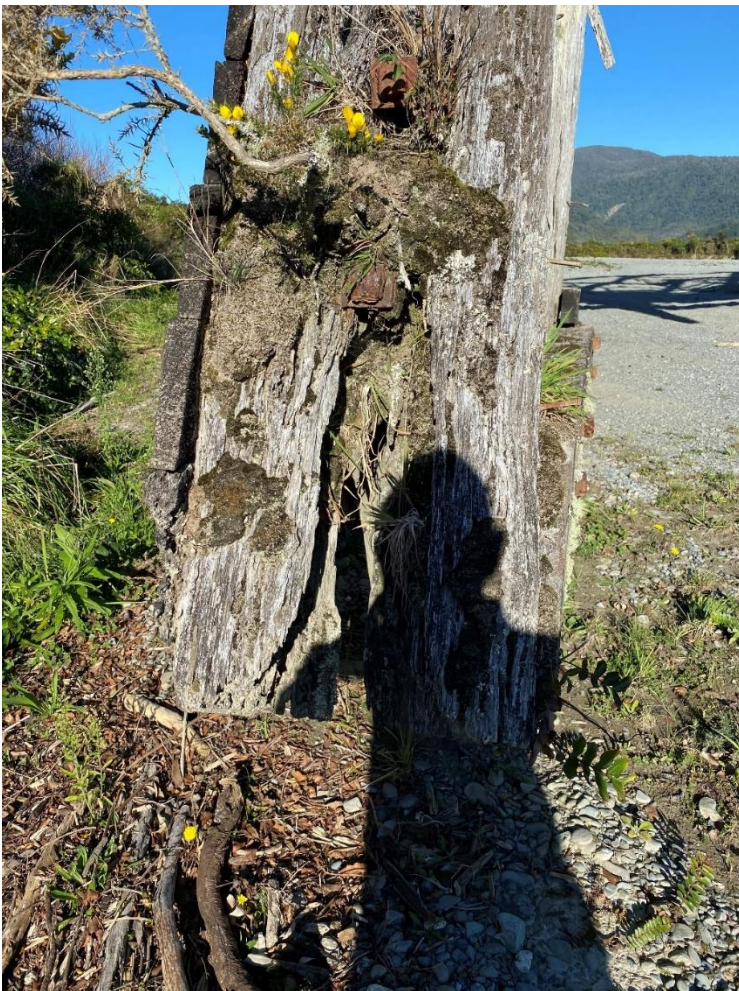
Raking pile timber split and timber decay.

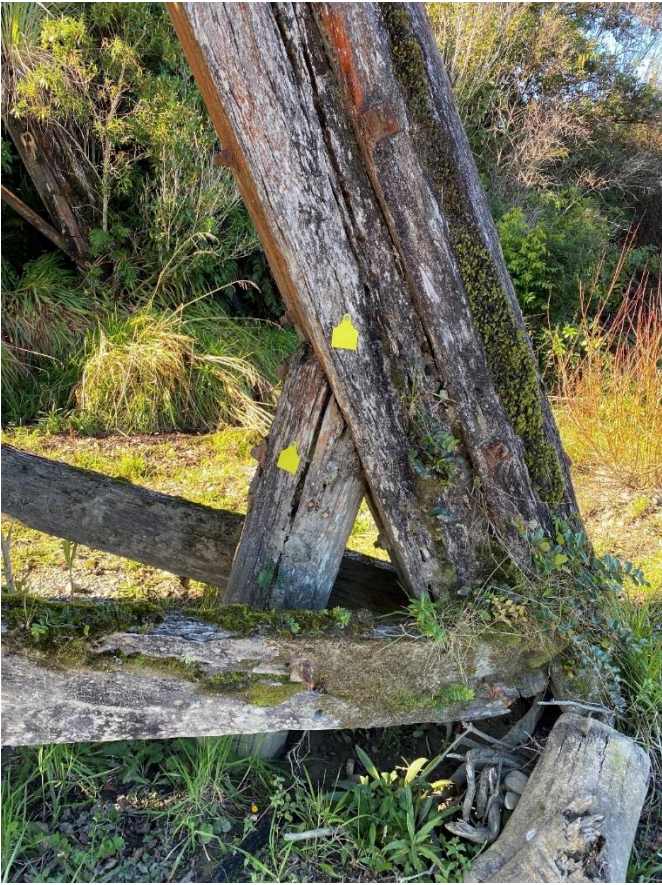
Raking pile timber surface decay

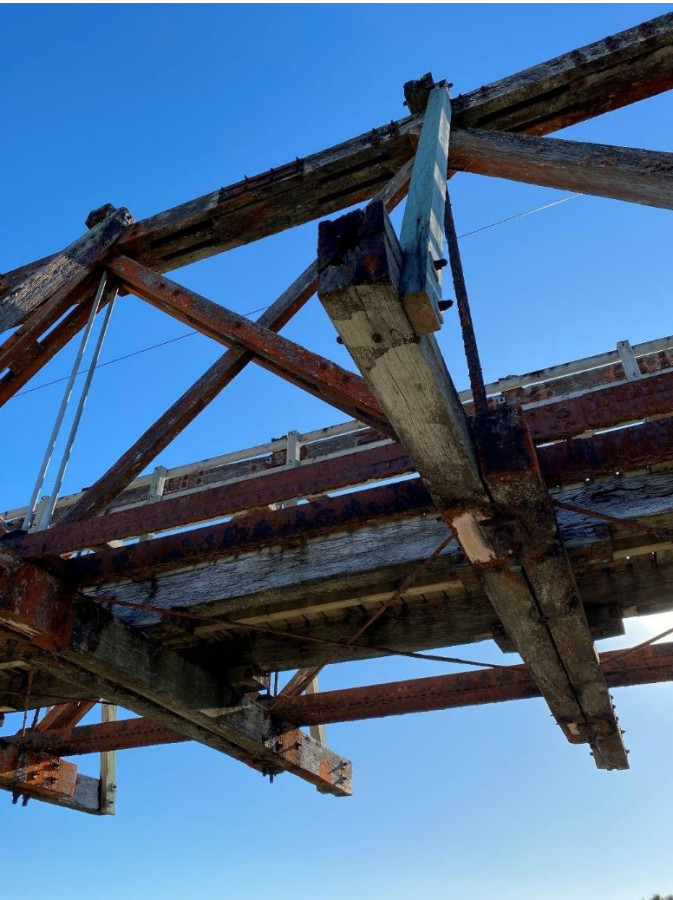
Transom end timber decay.

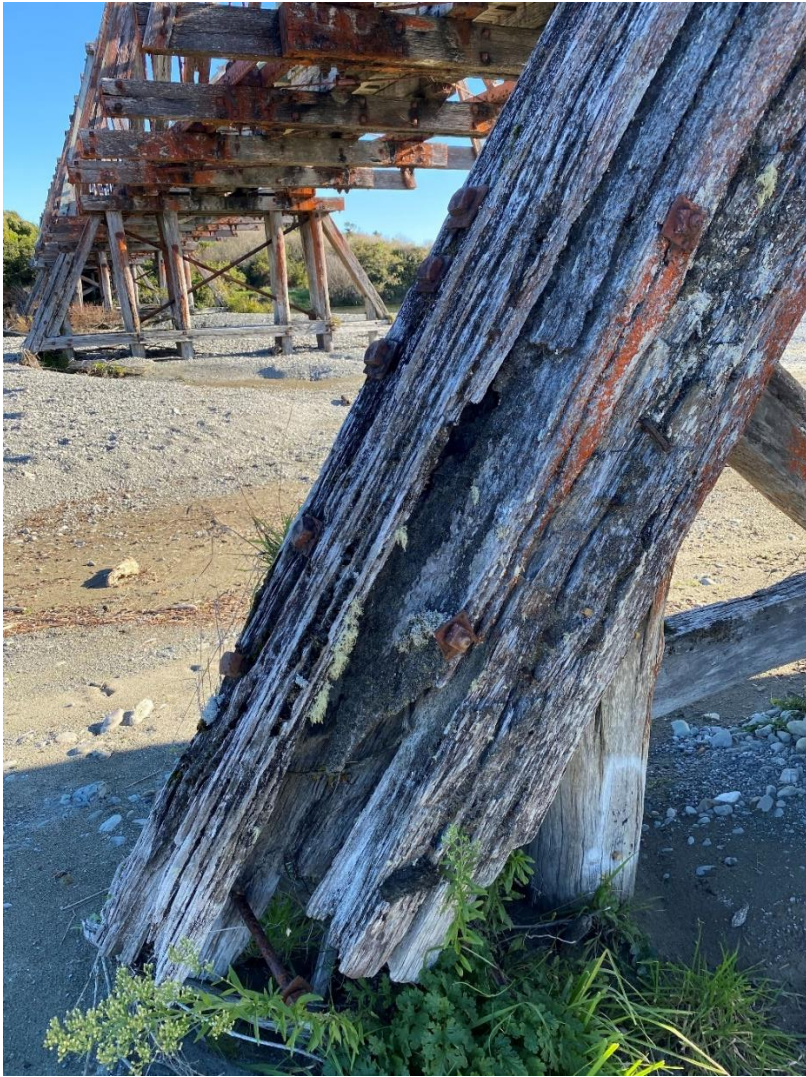
Raking pile timber decay.

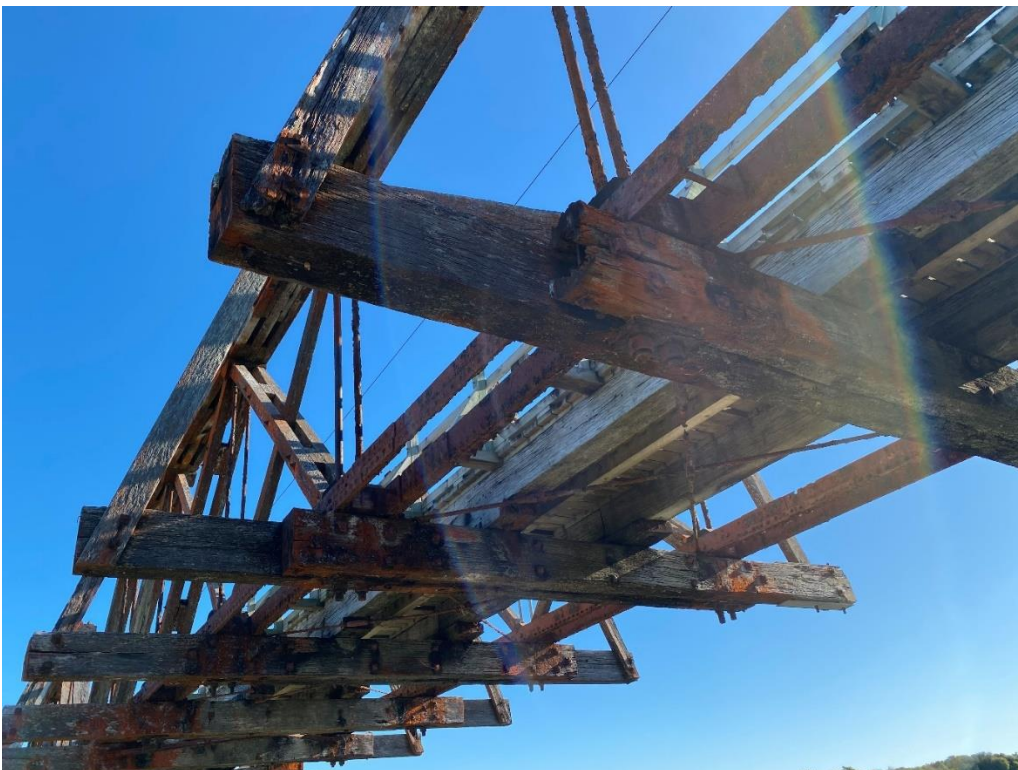
Transom Timber decay and timber split

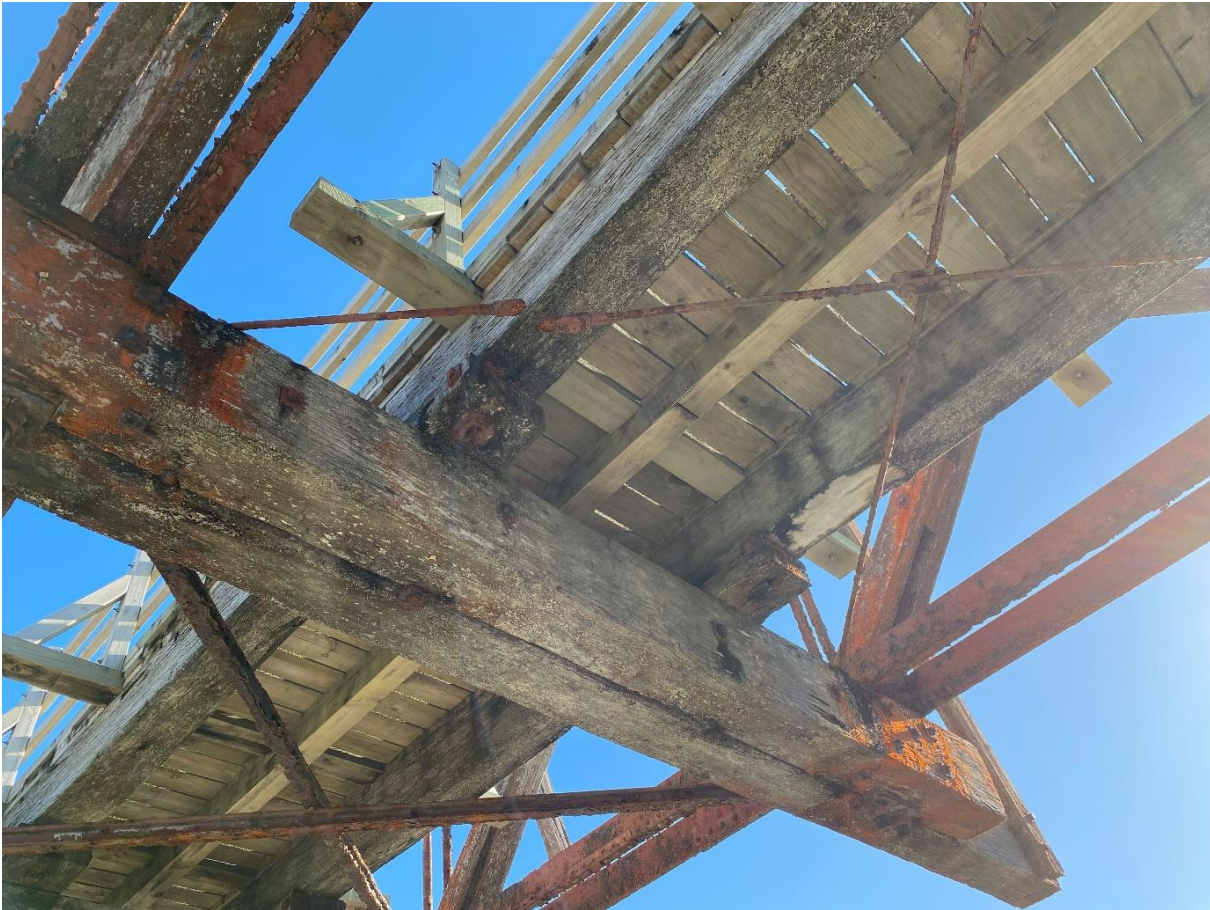
Cross bracing corroded away.

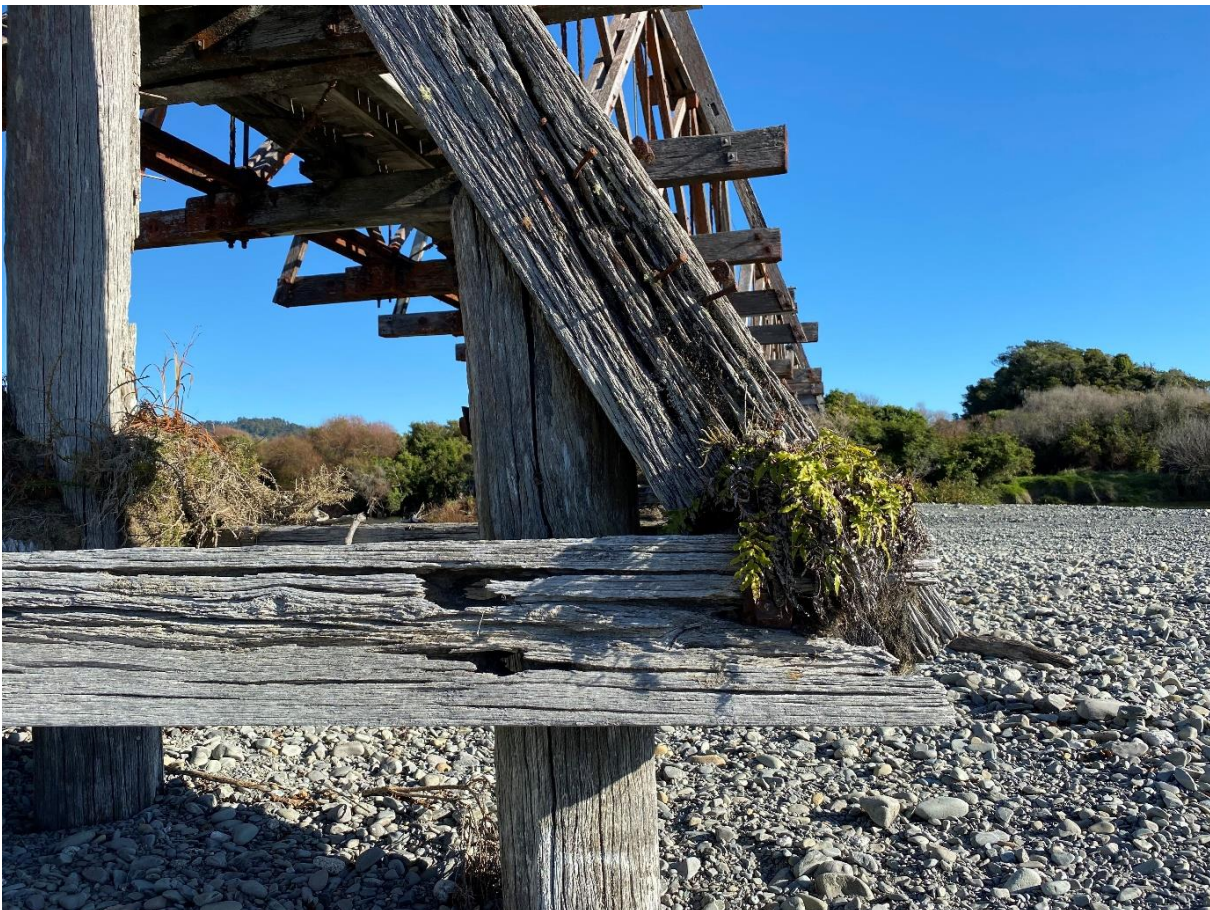
Timber loss and decay.

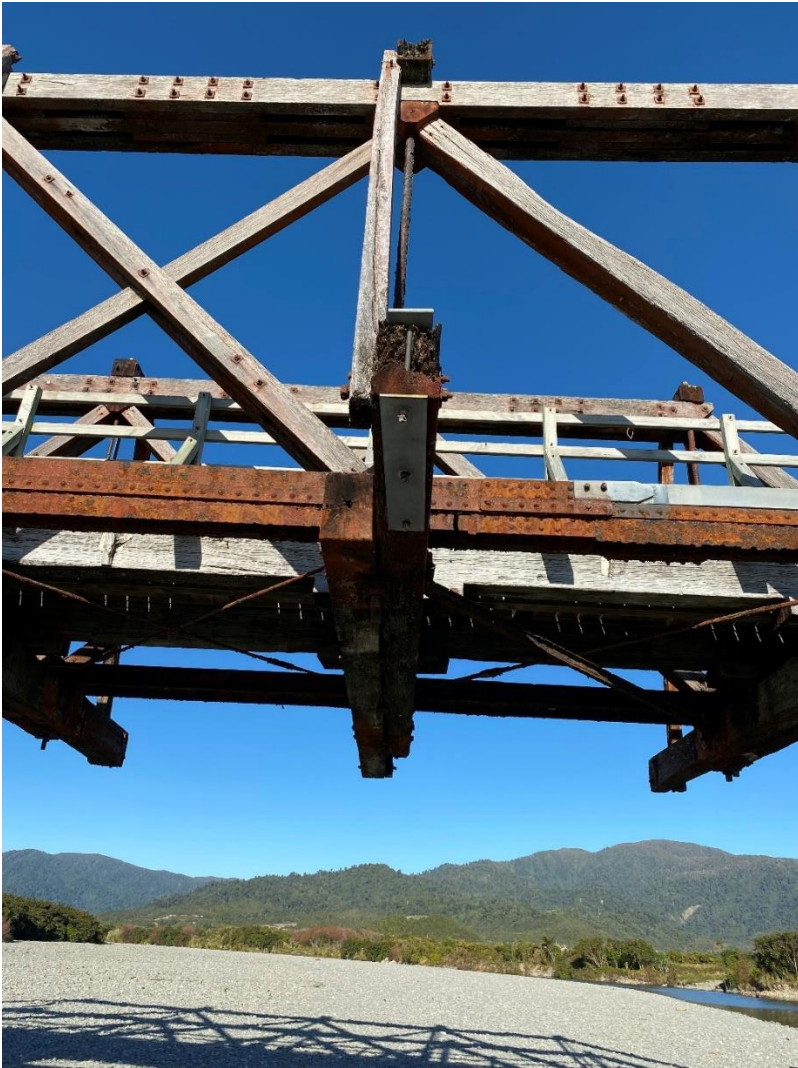
Previous repair to transom end.
More timber decay present

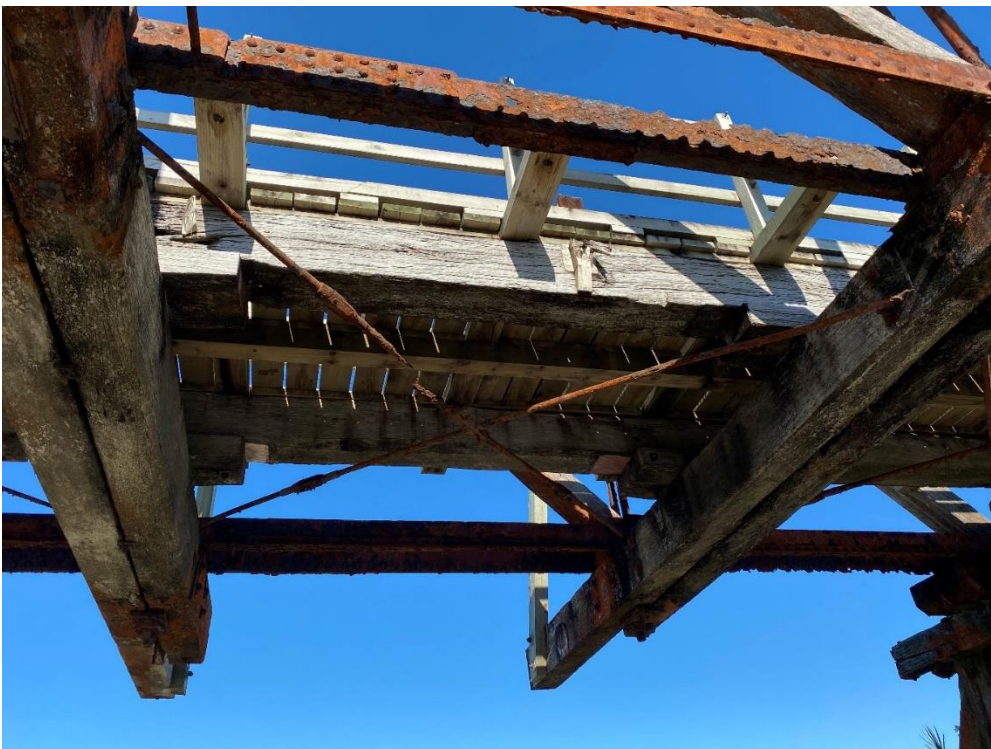
Steel cross bracing needs replacing

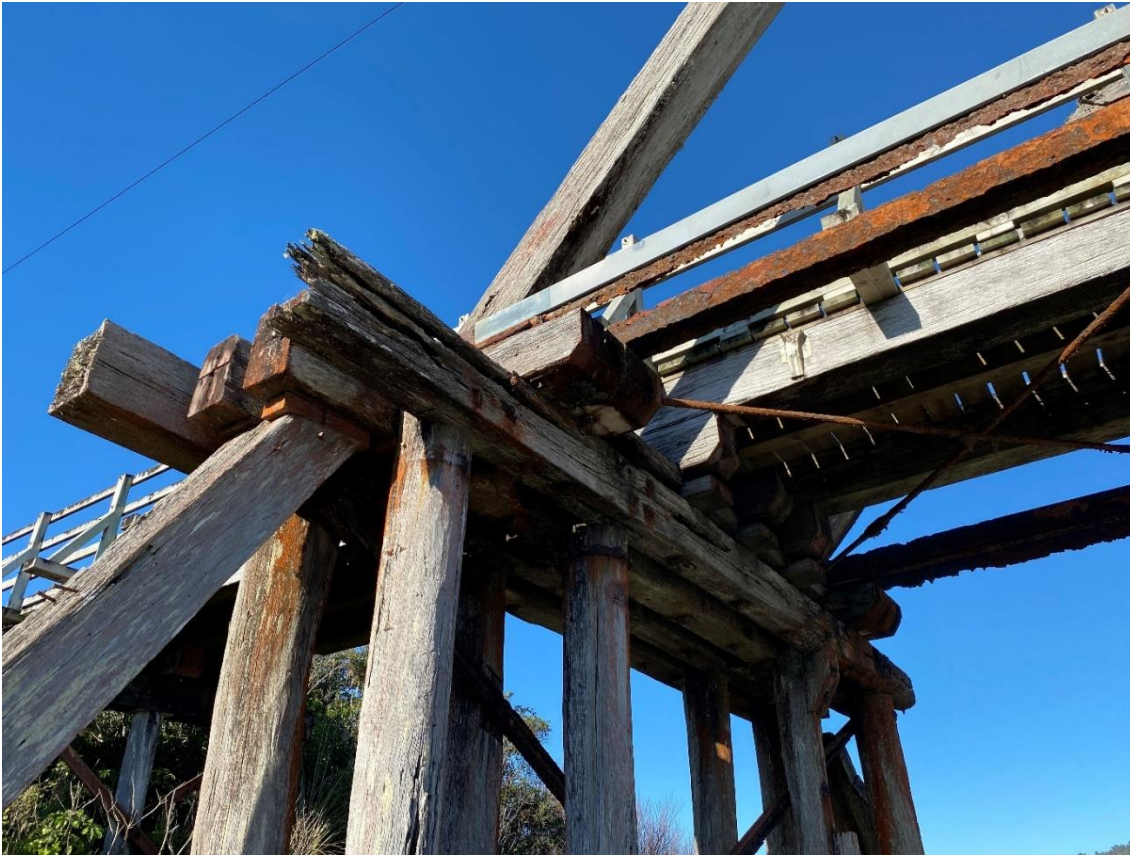
Transom timber end decay
Bottom cord corroded. Previous repair visible

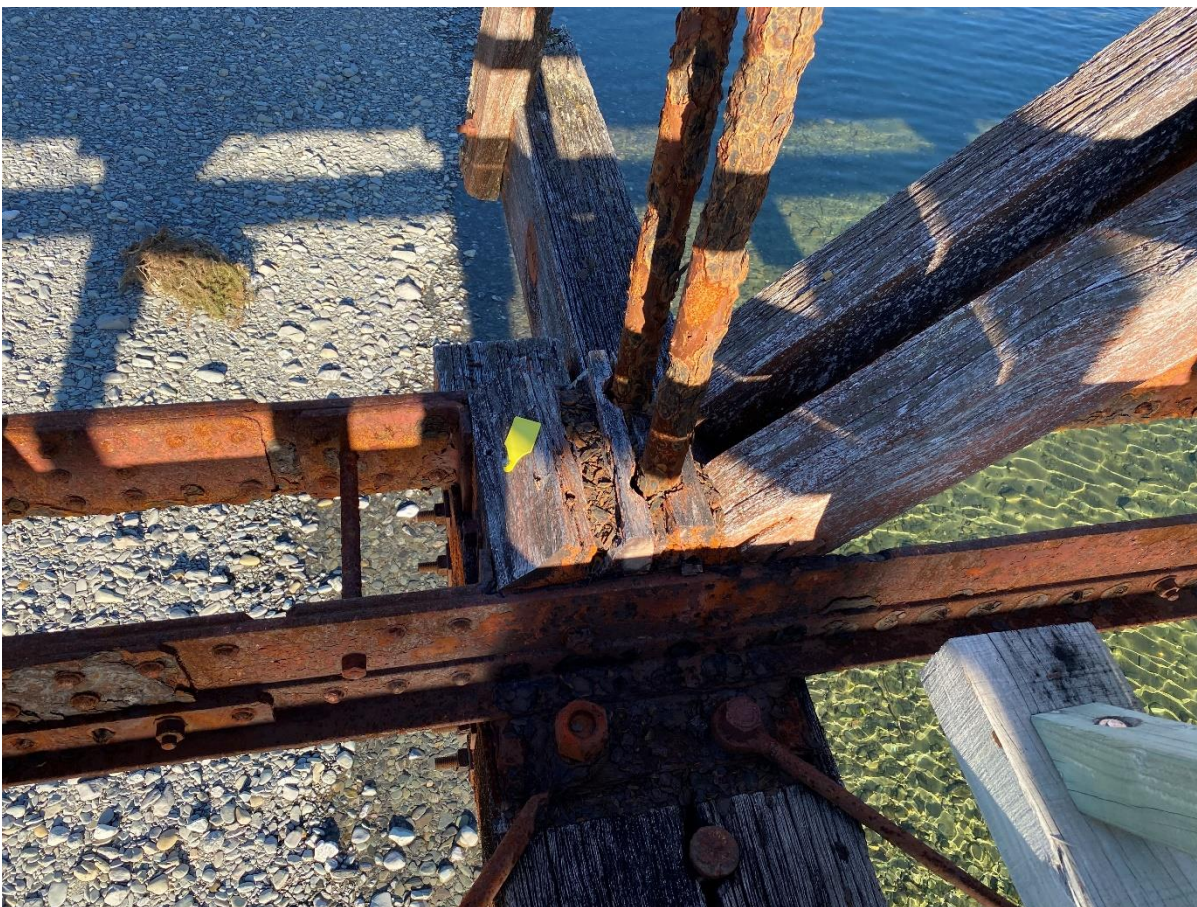
Timber thrust block decay and timber split.
Steel tension rods corroded.

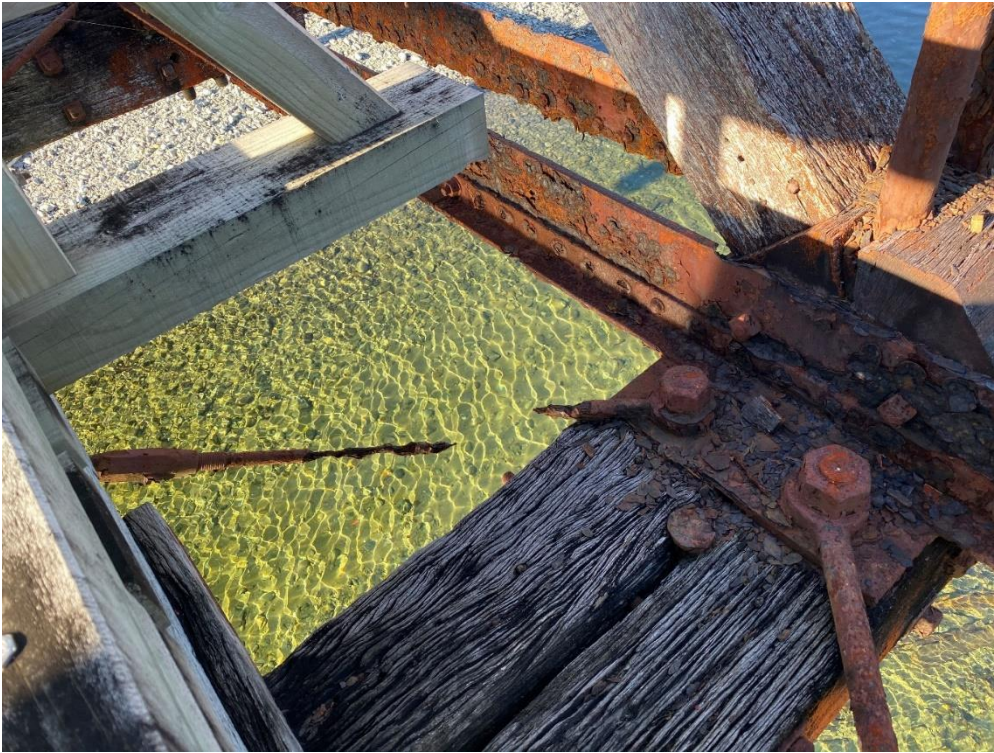
Steel cross bracing corroded. Needs replacing

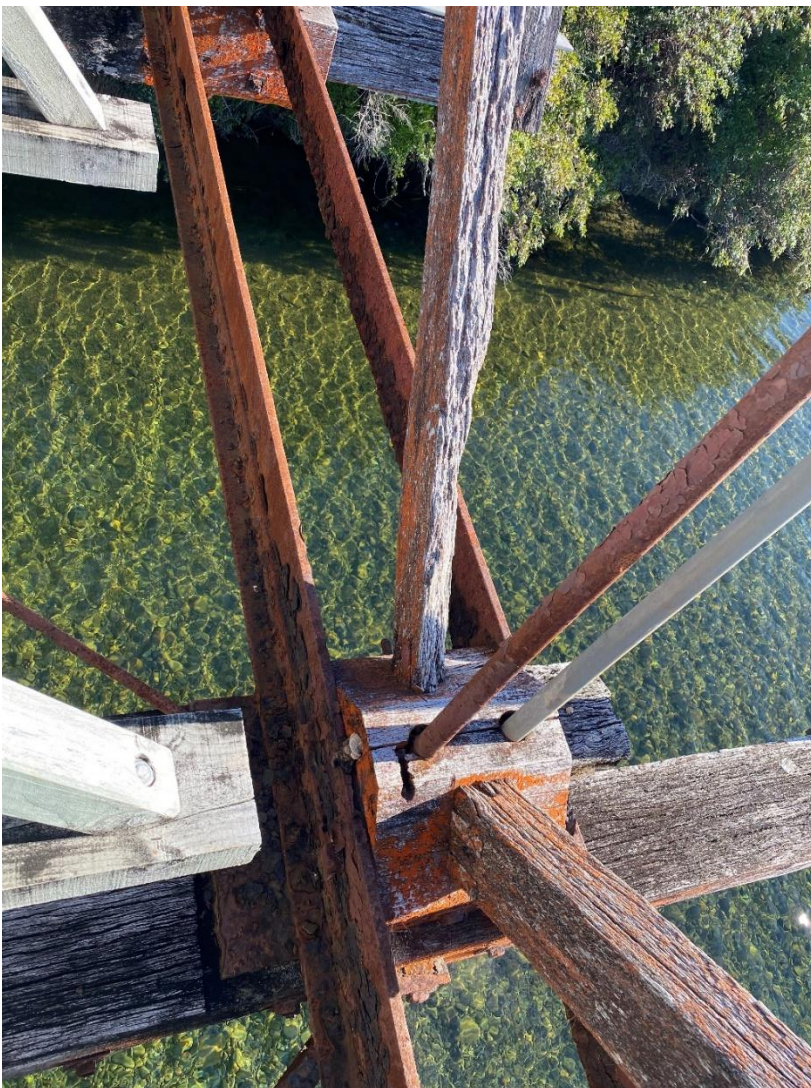
Loss of section on timber strut.

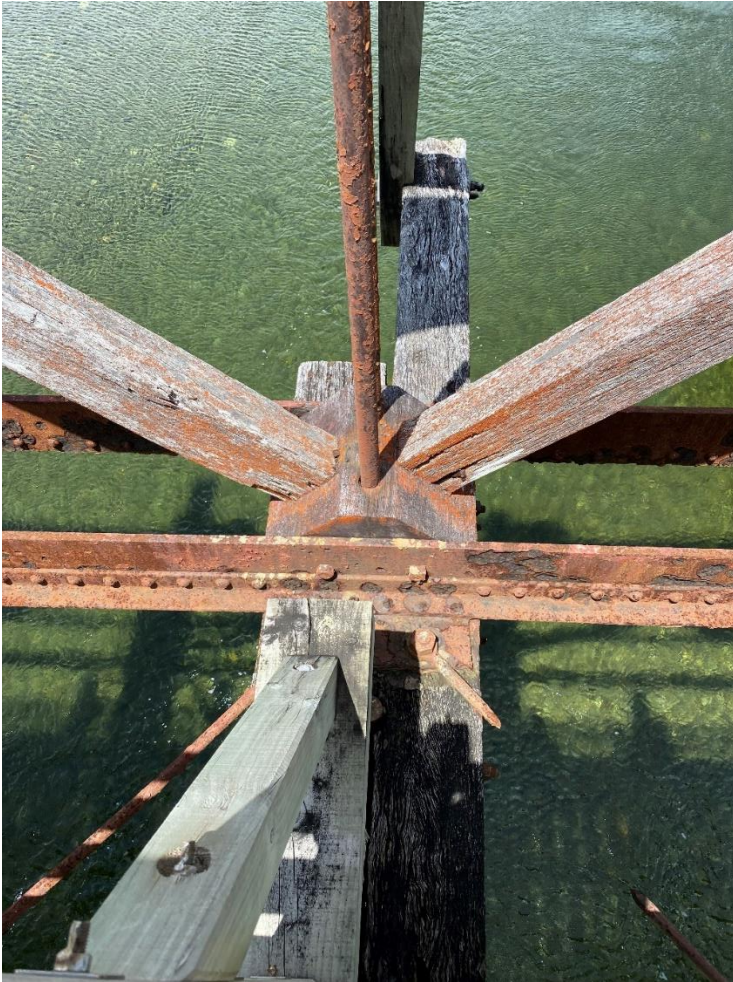
Steel cross bracing corroded. Needs replacing

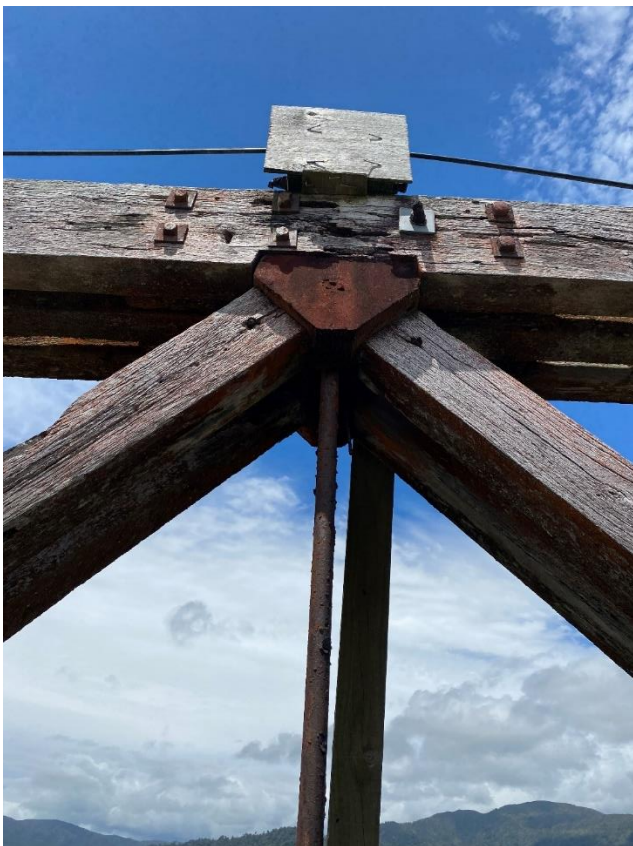
Saddle block needs replacing.

Saddle block split

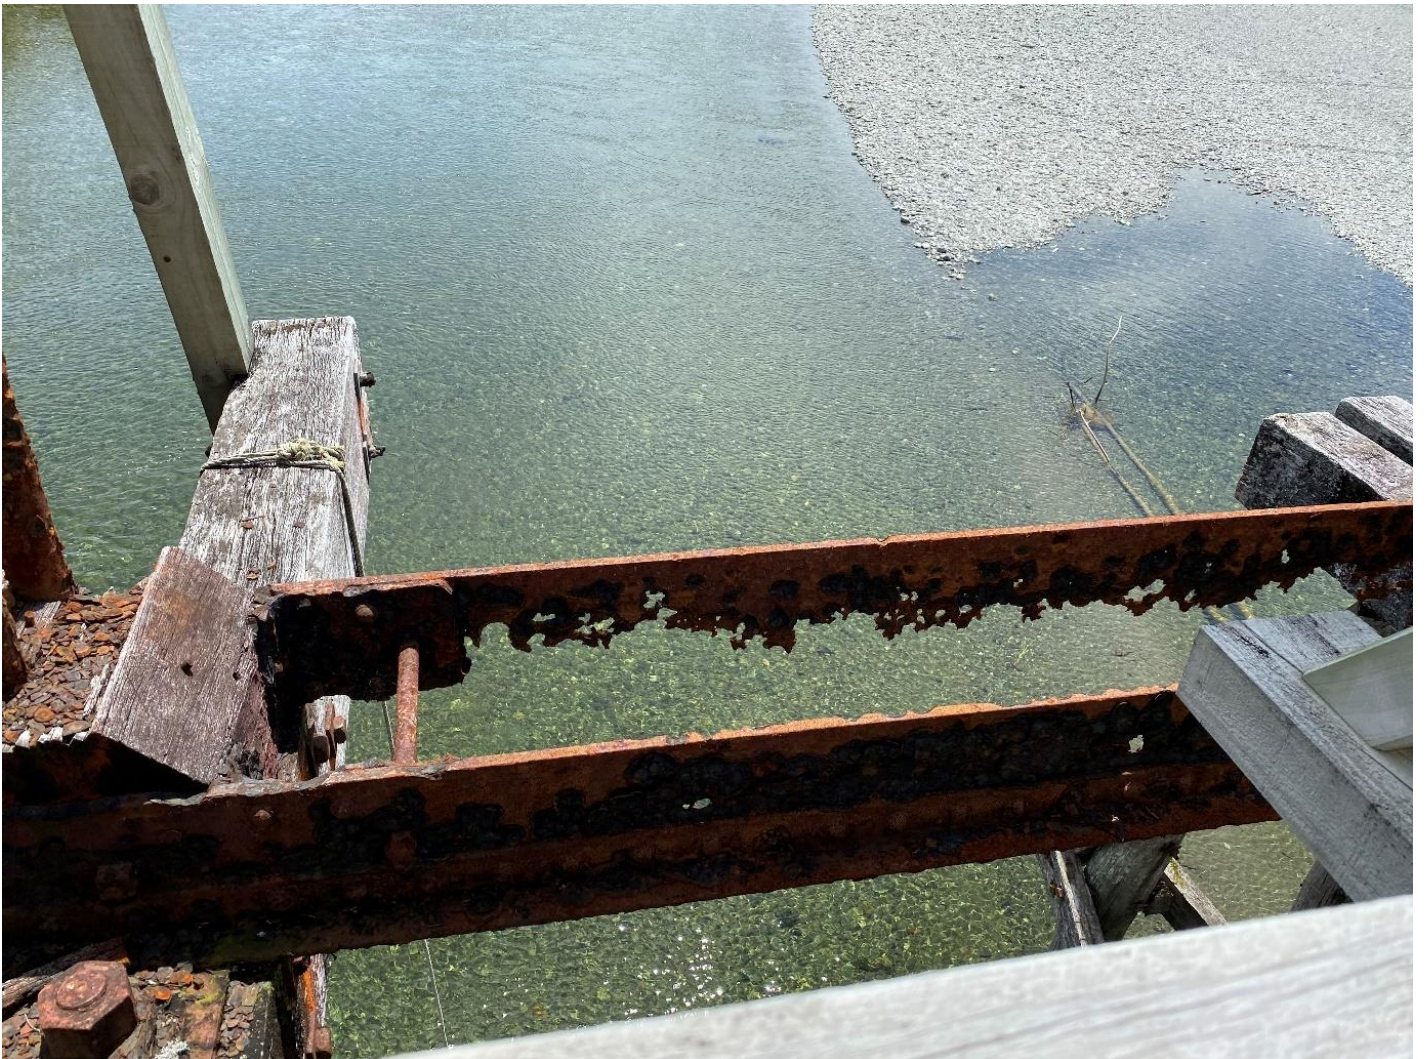
Bottom cord corroded, needs replacing

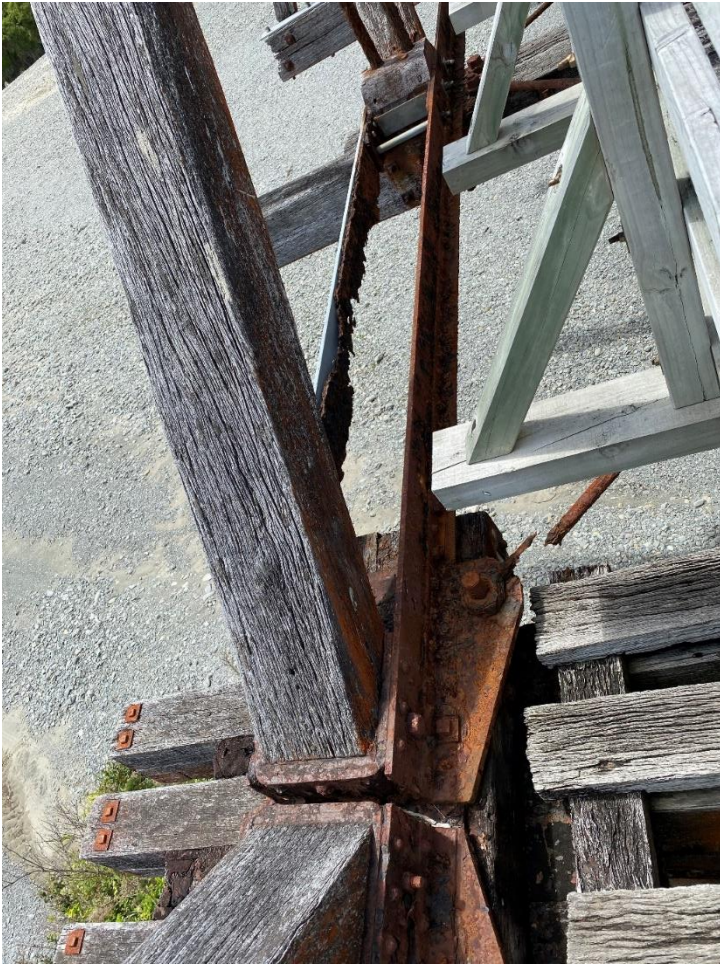
Bottom cord corroded, needs replacing.
Cross bracing corroded needs replacing

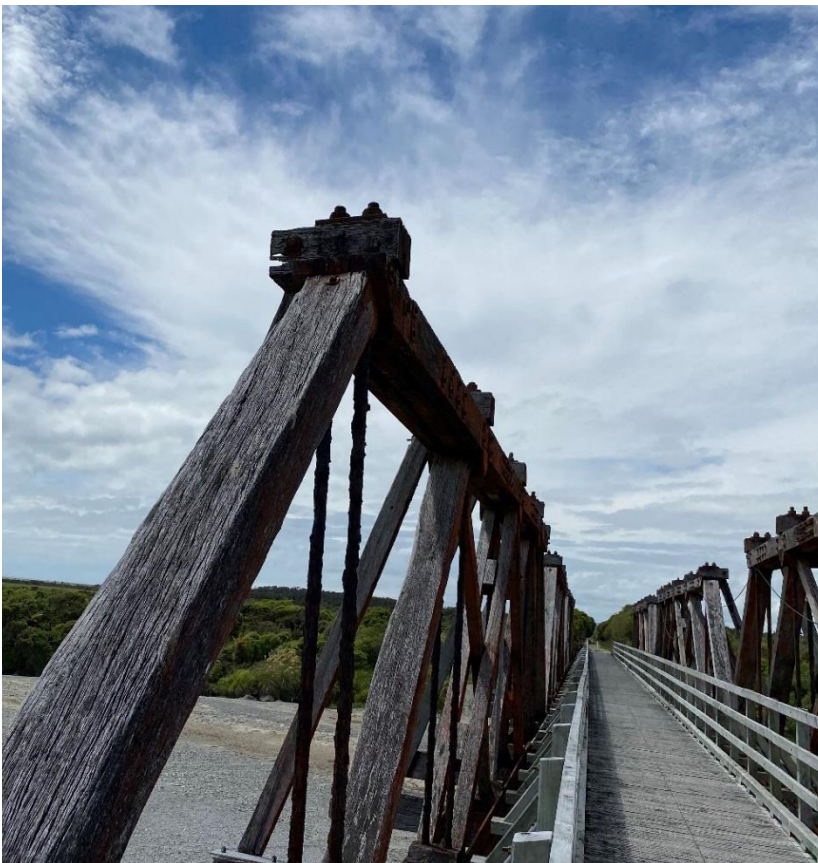
Saddle block decay and split.

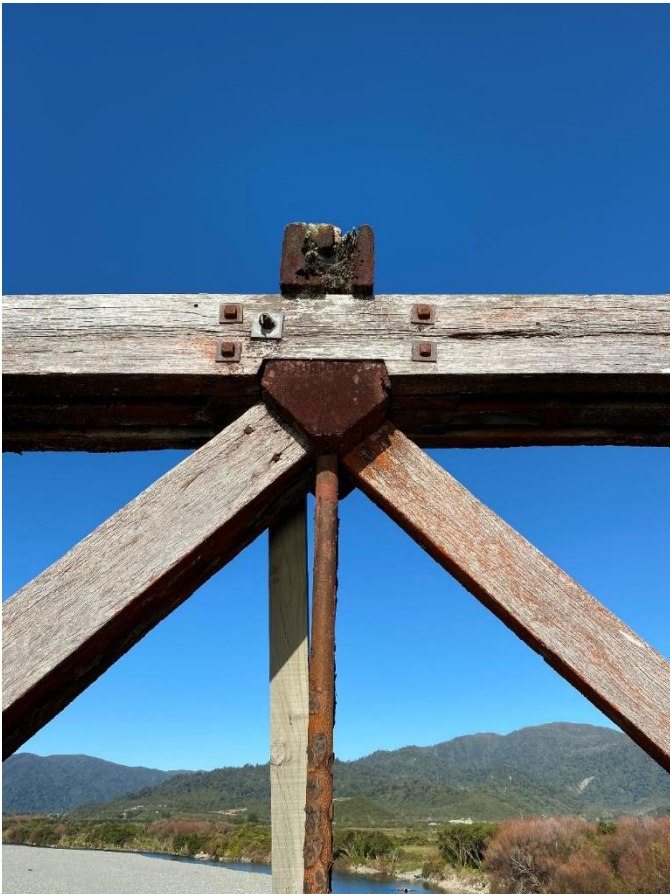
Saddle block timber split.

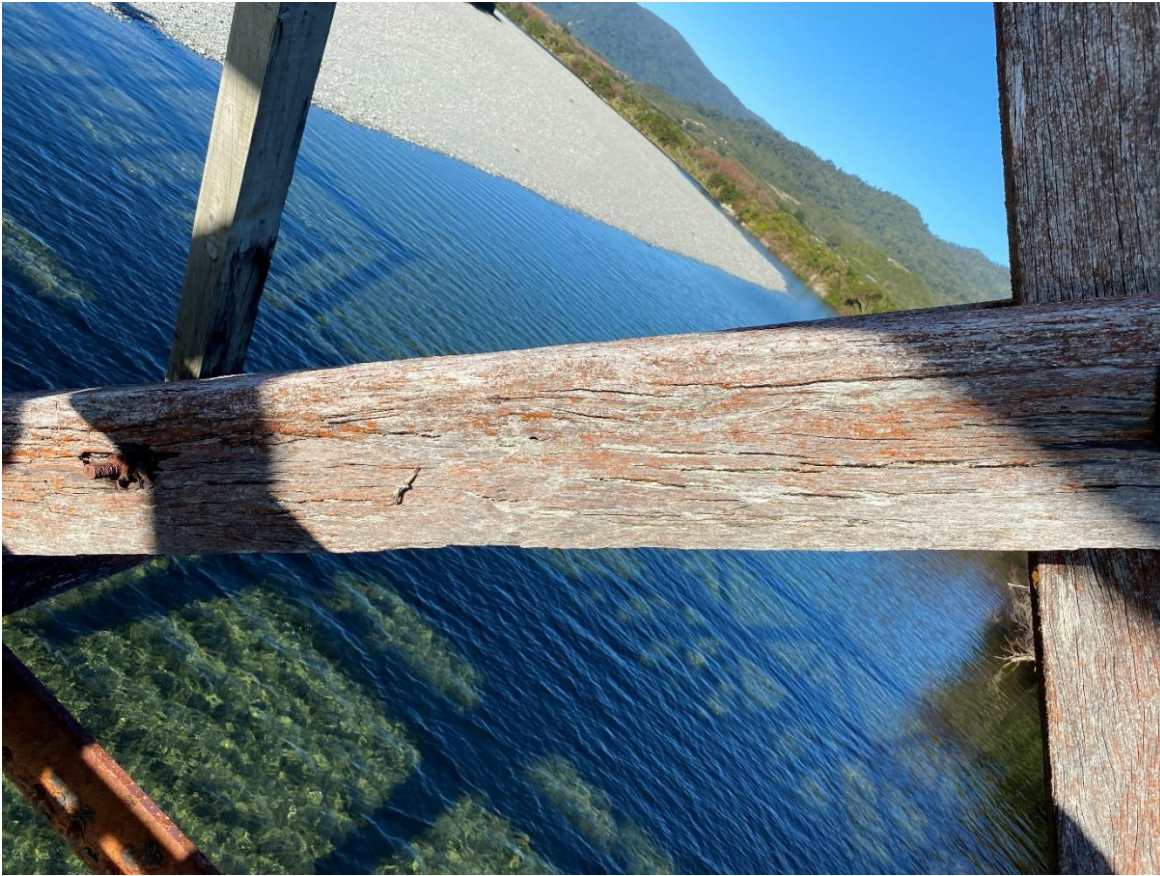
Centre strut timber decay.

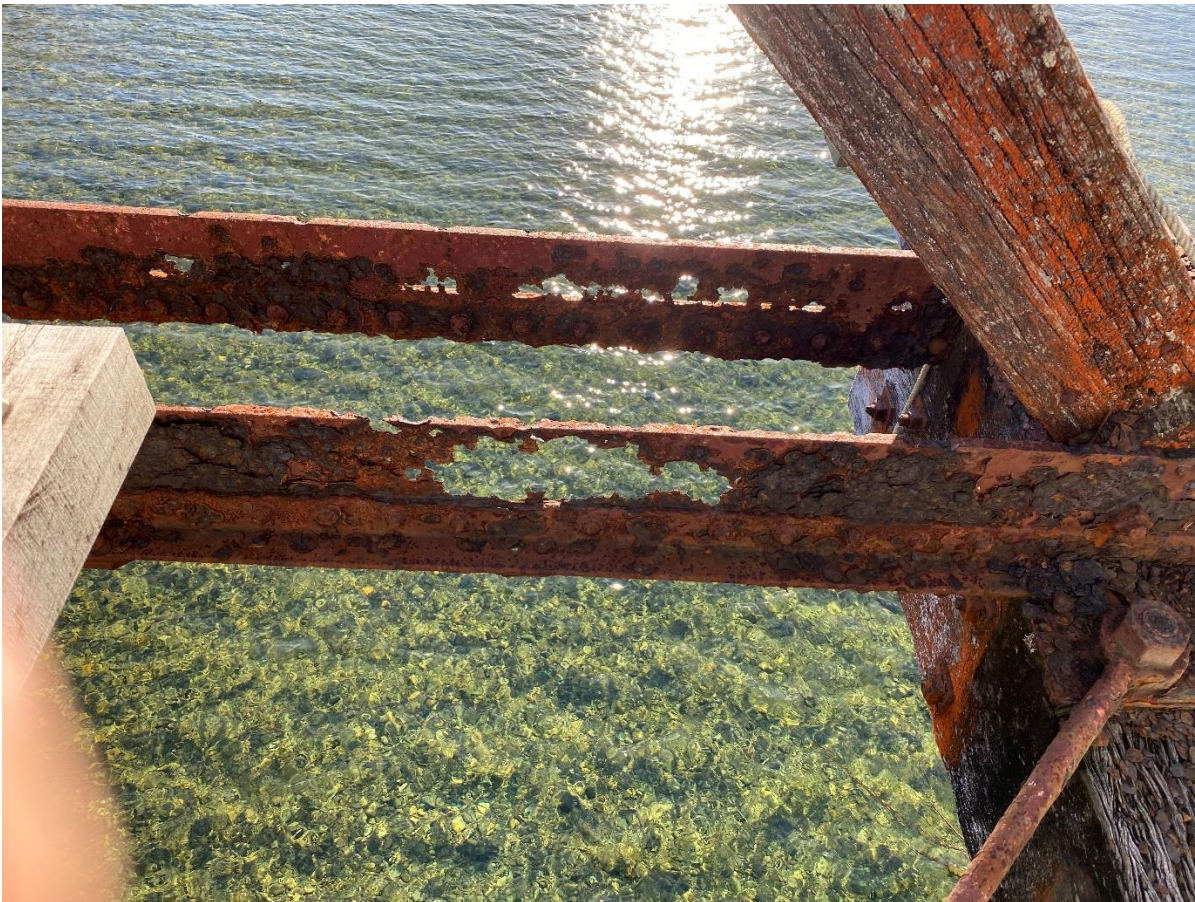
Bottom cord corroded. Needs replacing

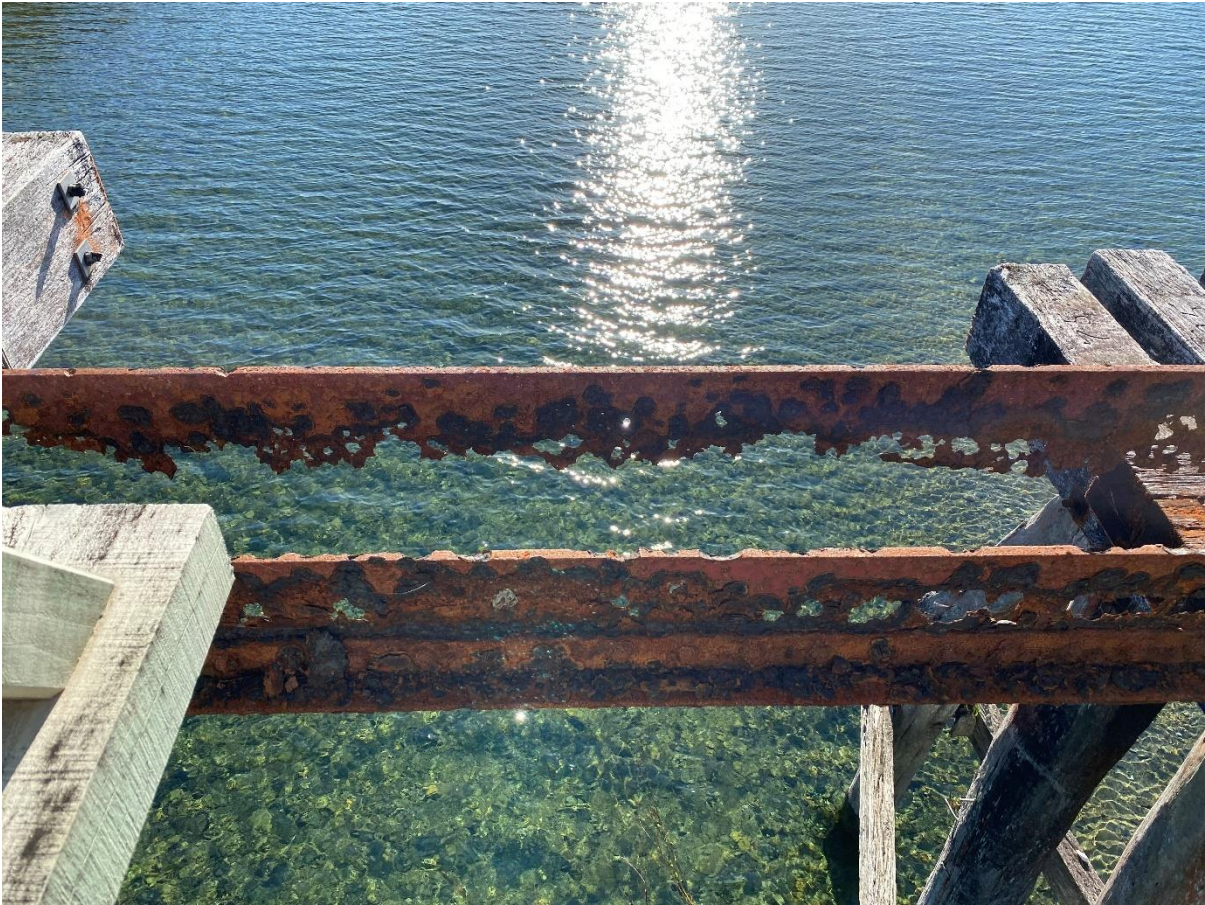
Bottom cord corroded. Needs replacing.

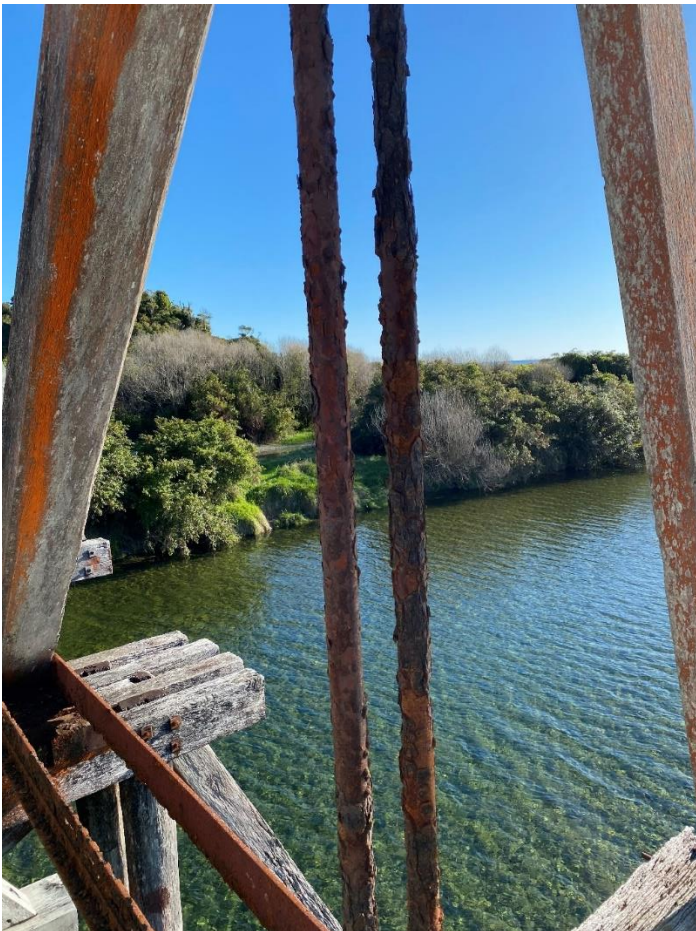
Tension rods corroded. Needs replacing

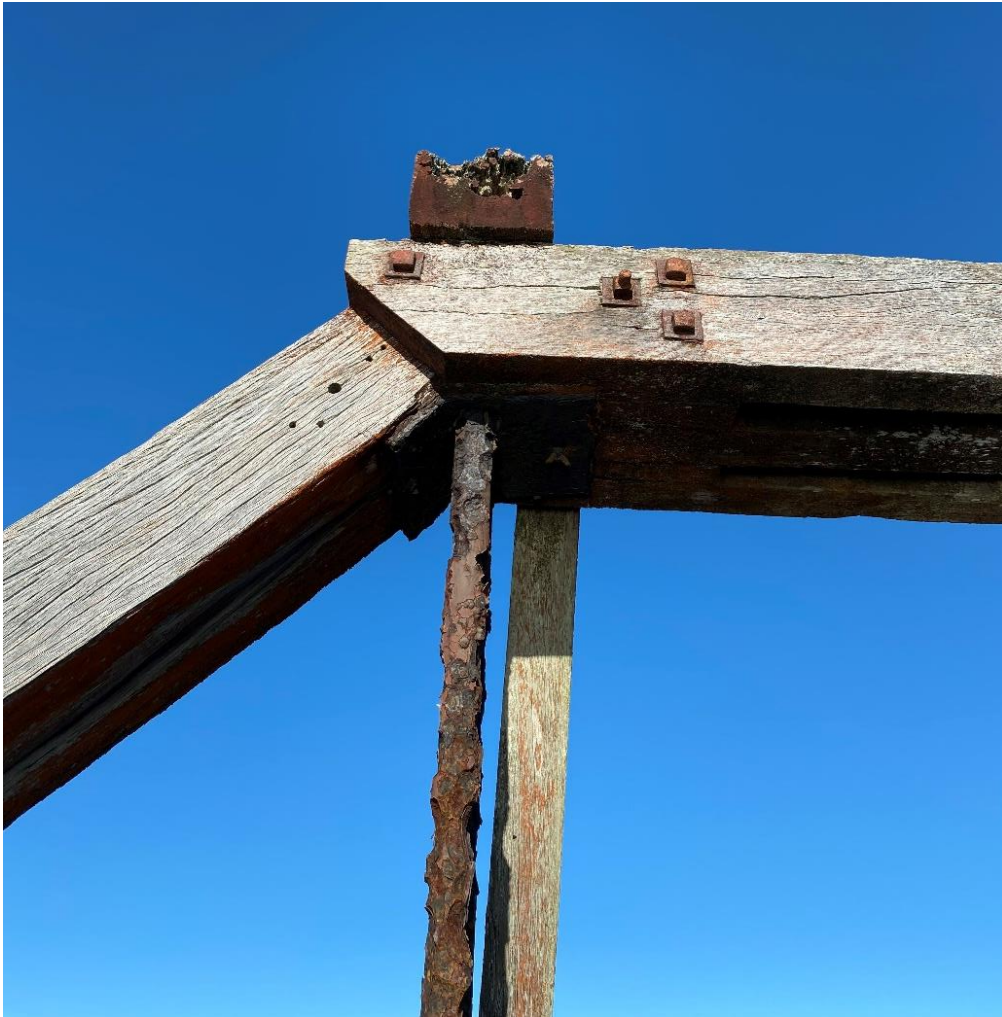
Saddle block timber decay.
Tension rod corroded.

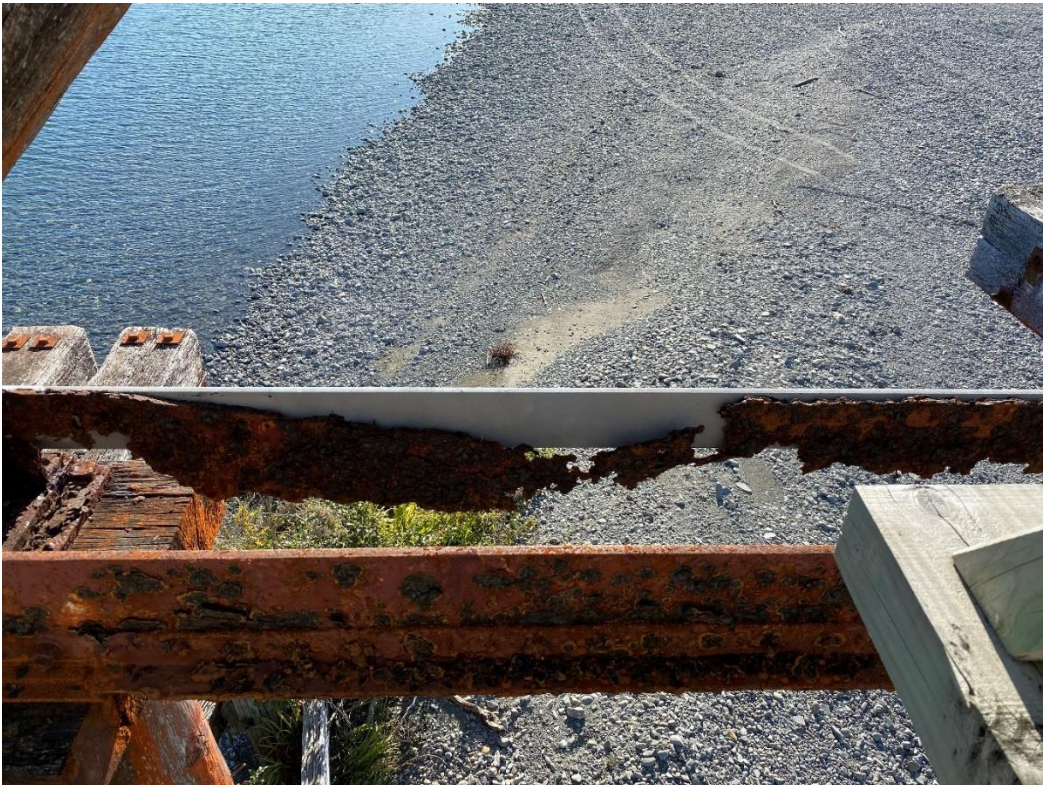
Bottom cord corroded. Previous repair visible.

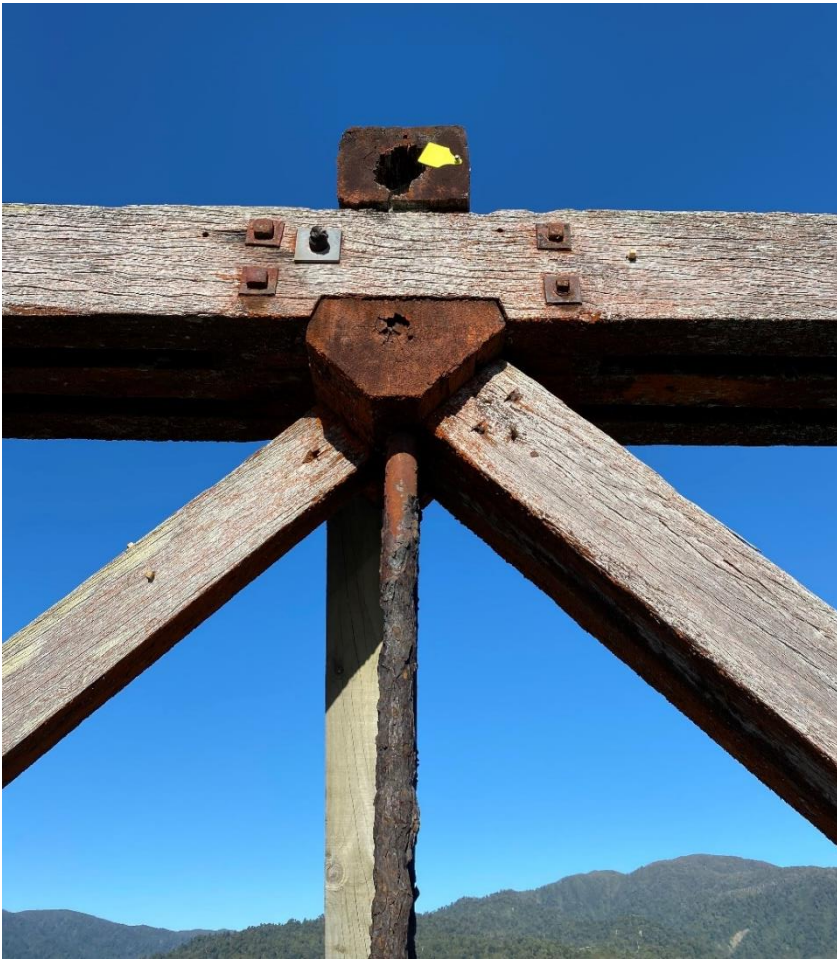
Saddle block with tunnel rot.
