Memorandum

To	Erle Bencich
Copy	Mark Smith, Kathie Ragg
From	Rem Markland
Office	Greymouth
Date	19 June 2024
File/Ref	6-WWES5.02
Subject	Totara Rail Bridge - Summary Assessment 2024

Project Number: 6-WWES3.98

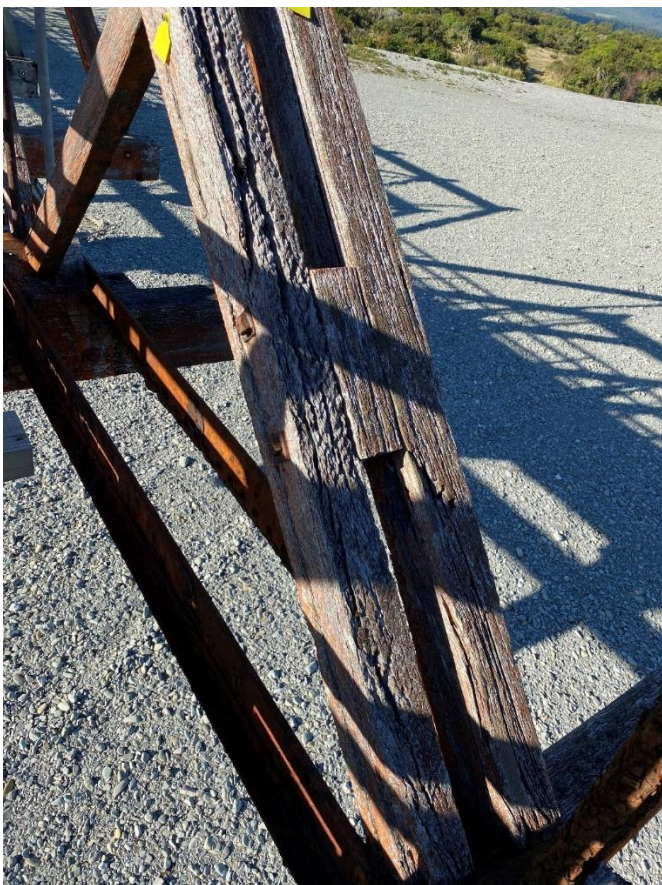
Surface loss on timber strut

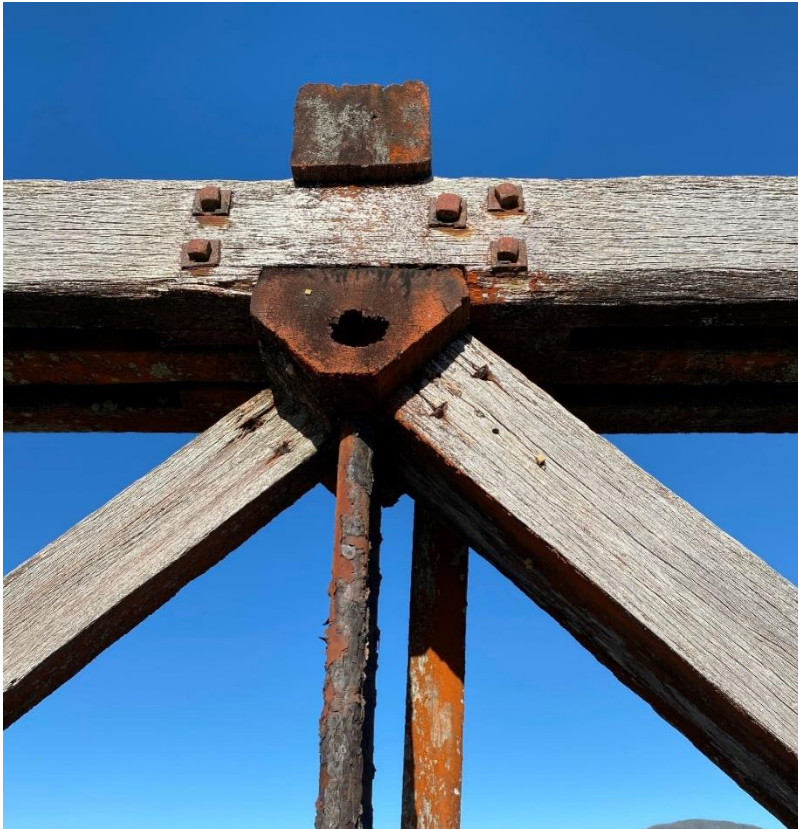
Tiber A block with tunnel rot.

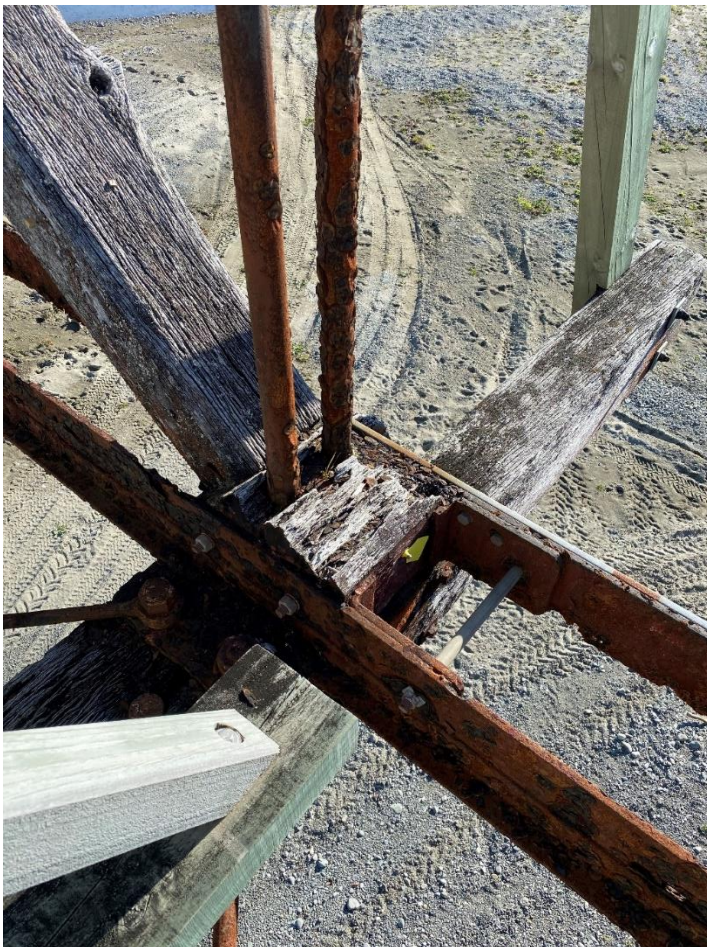
Timber thrust block with timber decay.

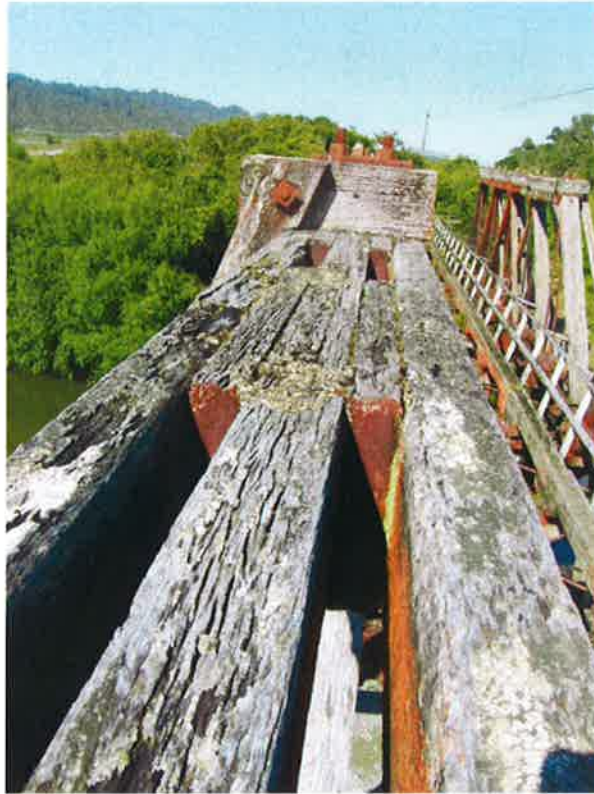
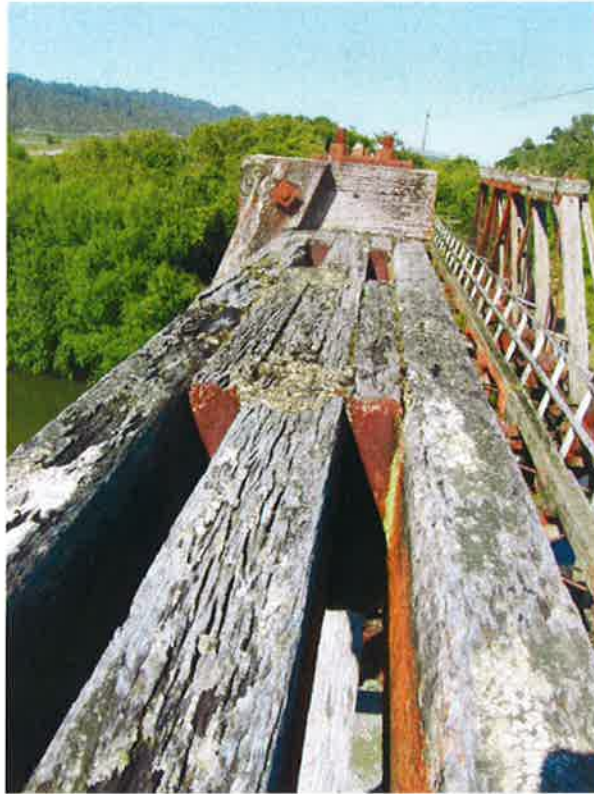
Figure 5-1 : Top Chord of Timber Trusses – Minor Weathering / Splitting Only, “Sound”

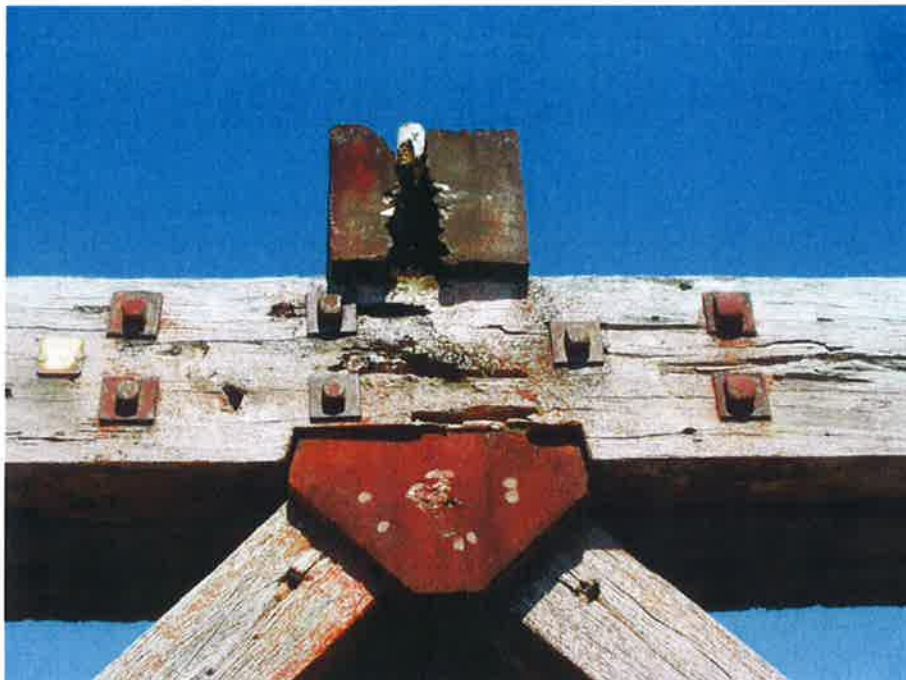
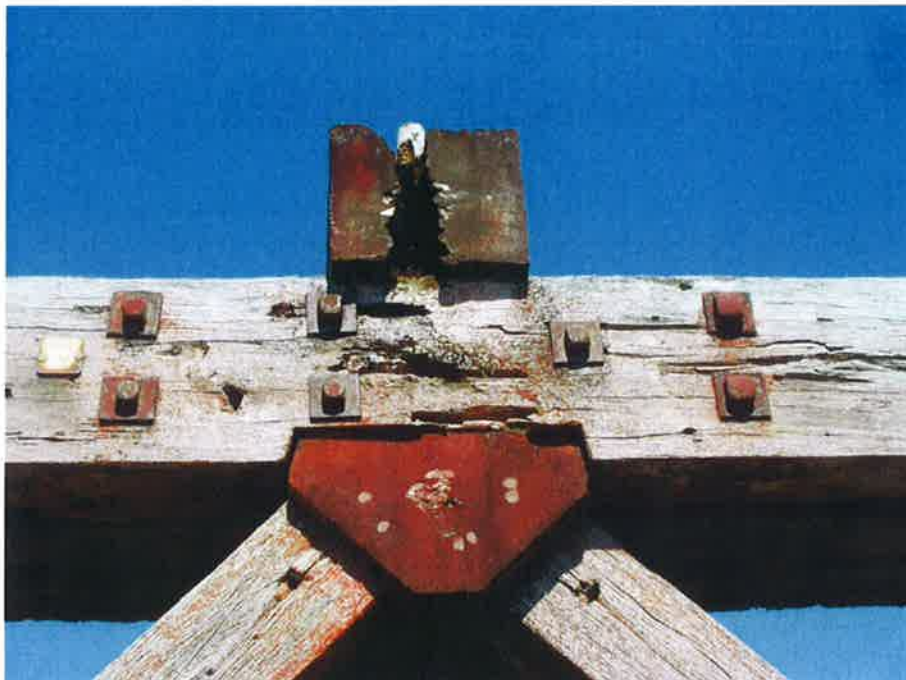
Figure 5-2 : Saddle Block – Large Centre Decay Back Beyond Tension Rod, “Requires Replacement”; A-Block (Top Thrust Block), “Sound”

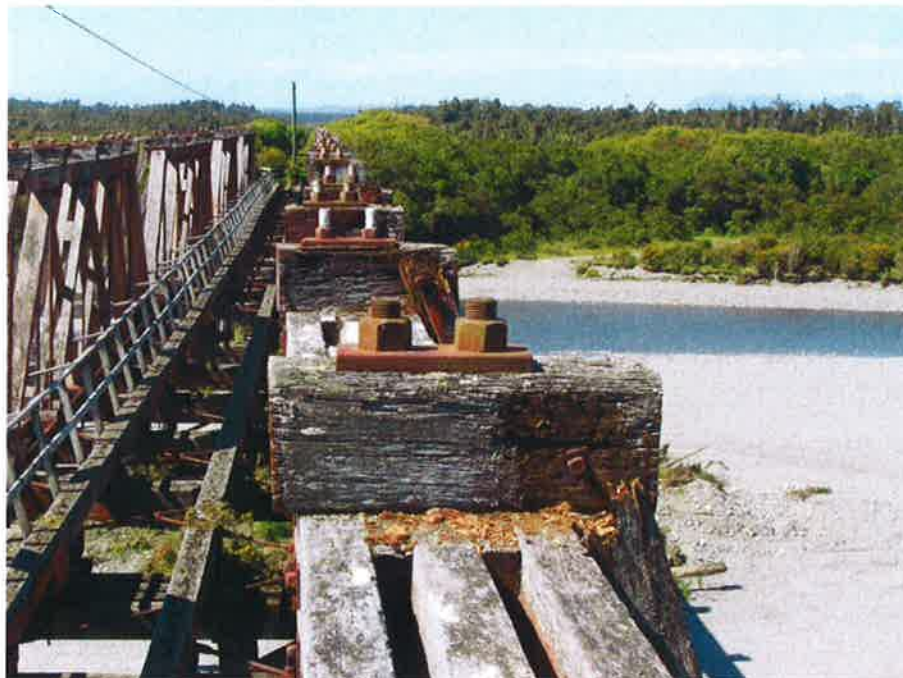
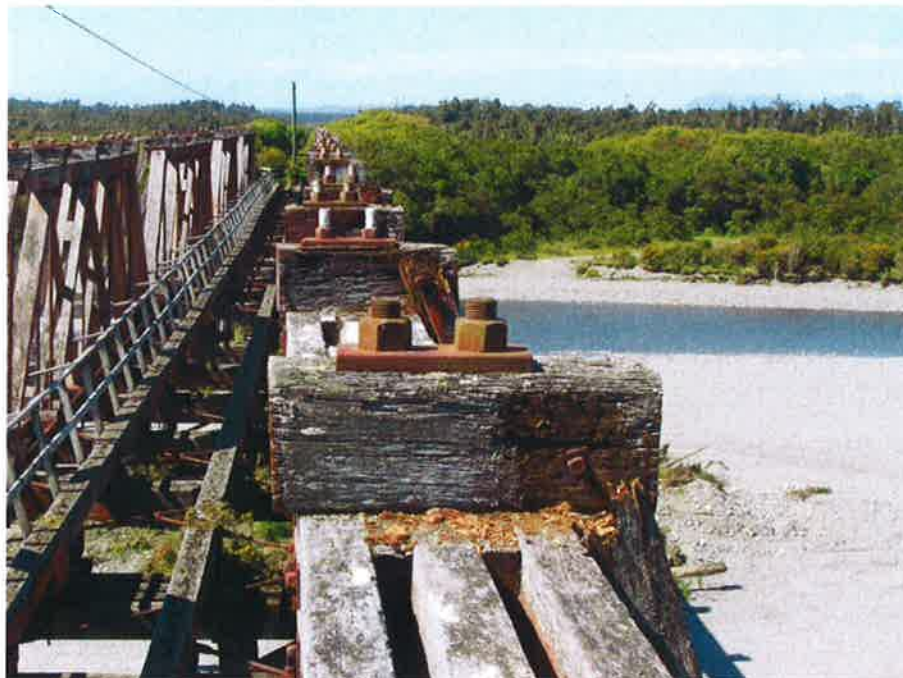
Figure 5-3 : Lateral Braces – Members Completely Decayed at Ends, “Requires Replacement”

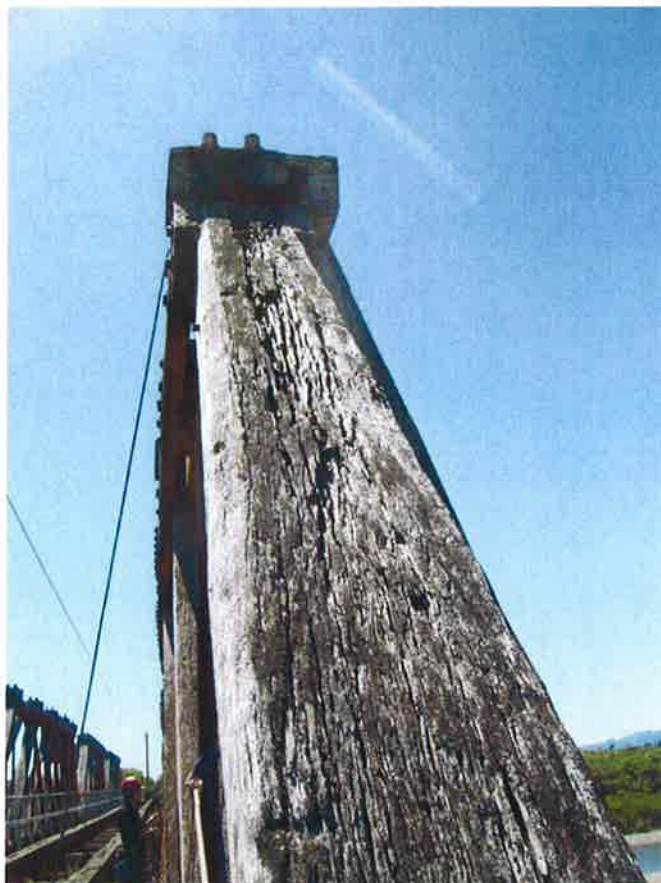
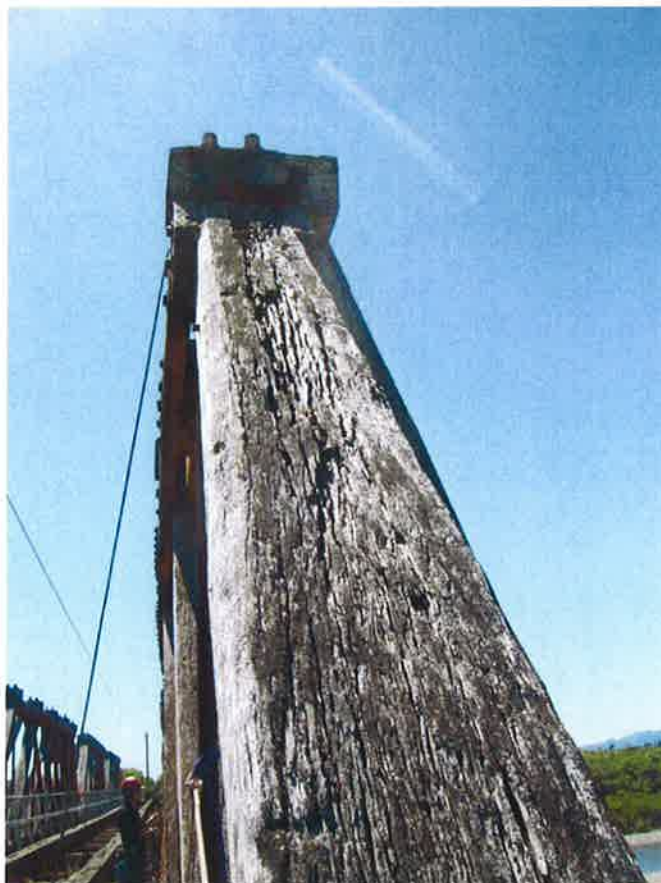
Figure 5-4 : King Strut – Significant Surface Decay, Pocket Decay and Splitting, “Investigate Further”

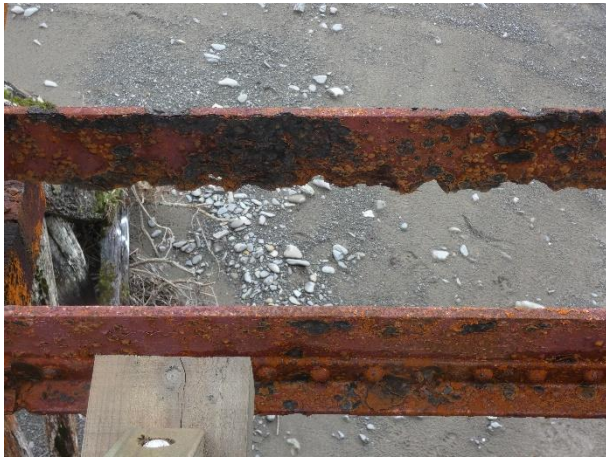
Moderate to Heavy Bottom Chord Corrosion.

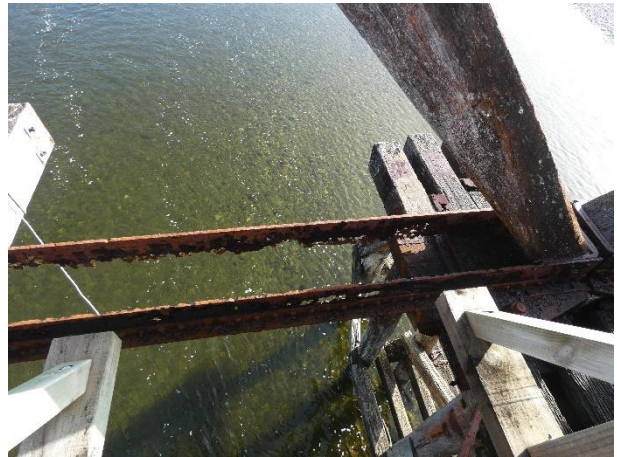
Critical Bottom Chord Corrosion.

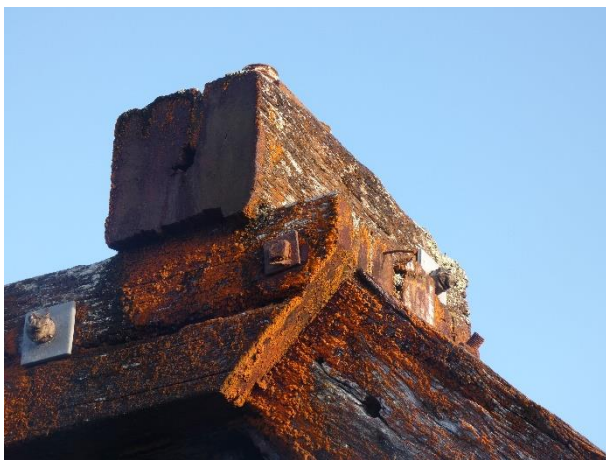
Typical Timber Splitting – Top Chord Shown.

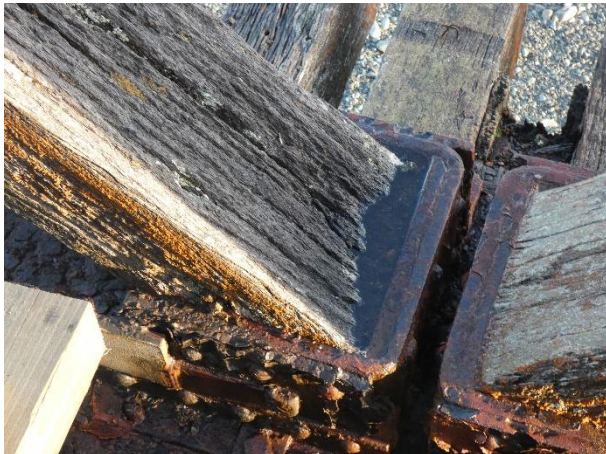
Typical Weathered Timber and Ponding Moisture.

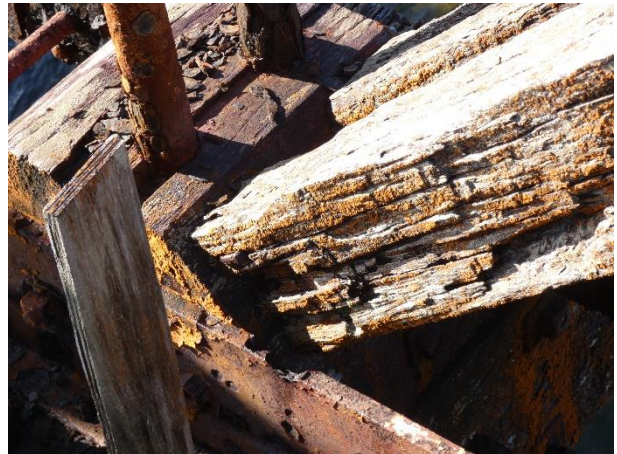
Typical Weathered Timber.

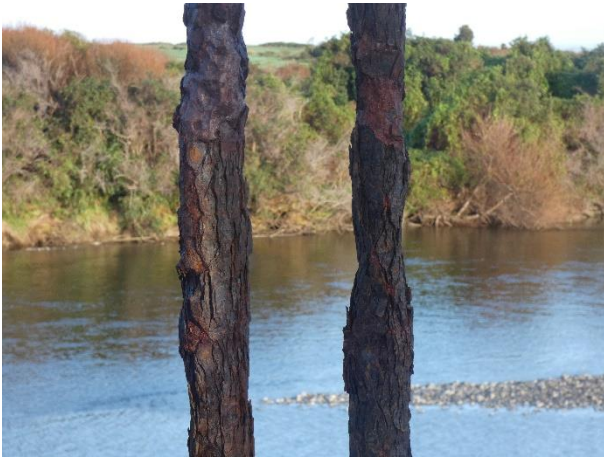
Typical Corroded (Pack Rusting) Hanger Rods – Heavy to Critical Corrosion Shown.

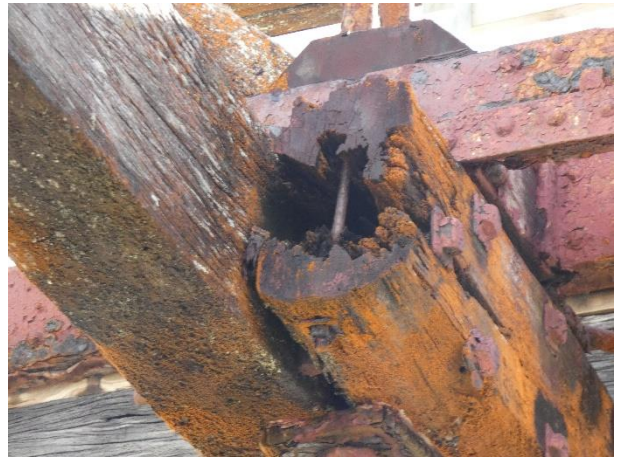
Timber Decay – Heavy to Critical Decay Shown.

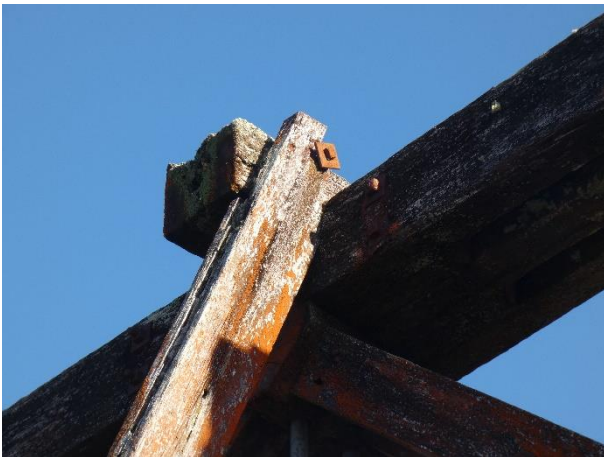
Typical Decay and Loss of Timber Section at Connections – Top of Wind Brace Shown.

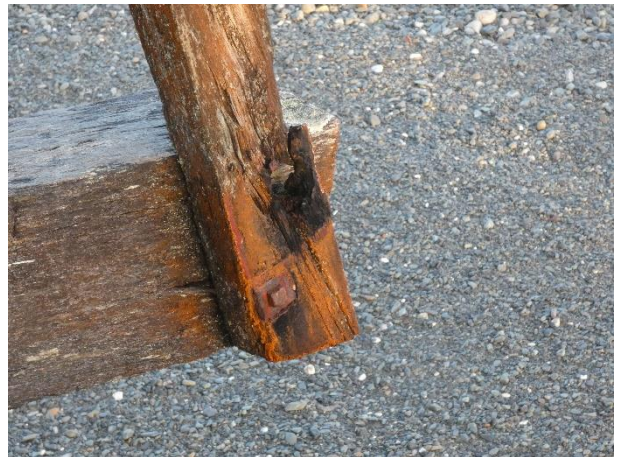
Typical Decay and Loss of Timber Section at Connections – Bottom of Wind Brace Shown.

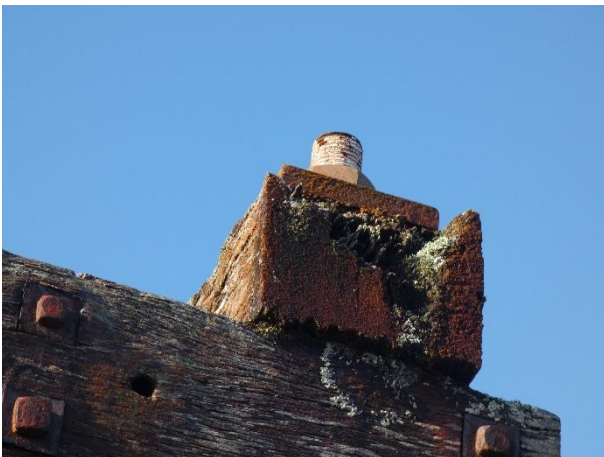
Typical Decay of Top Blocks.

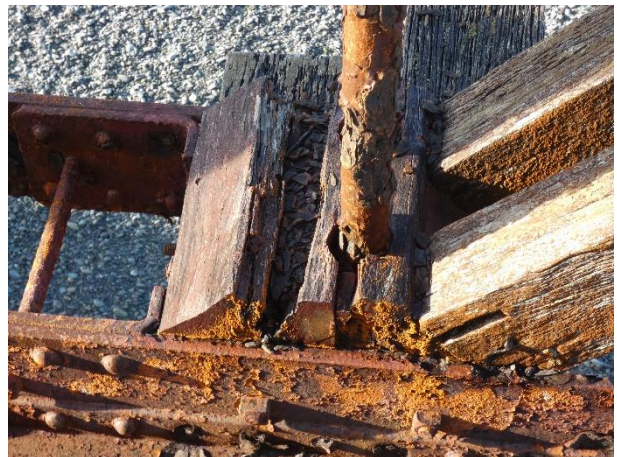
Typical Splitting and Section Loss of Thrust Blocks.

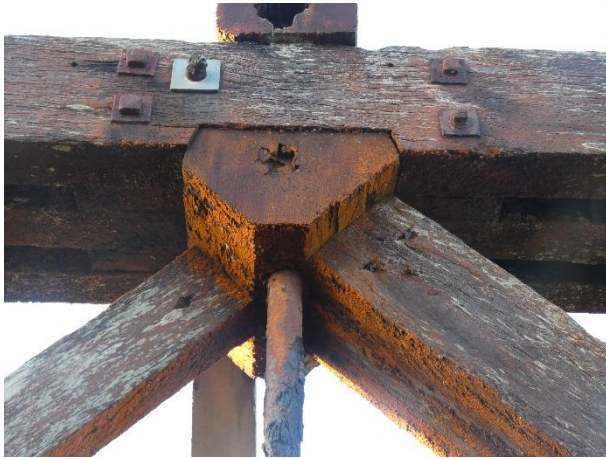
Typical Moderate Decay of 'A' Block.

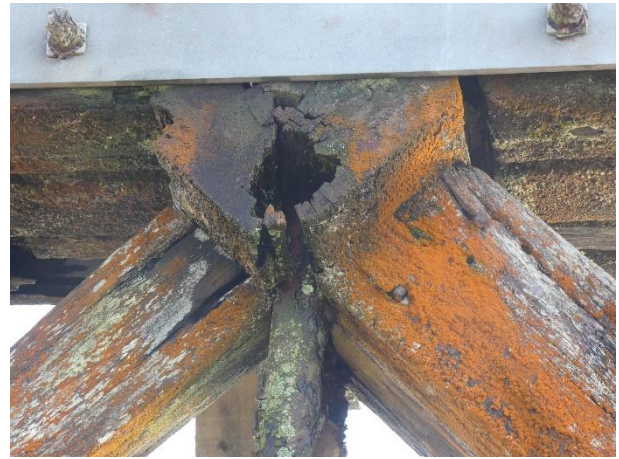
Typical Heavy to Critical Decay of 'A' Block.

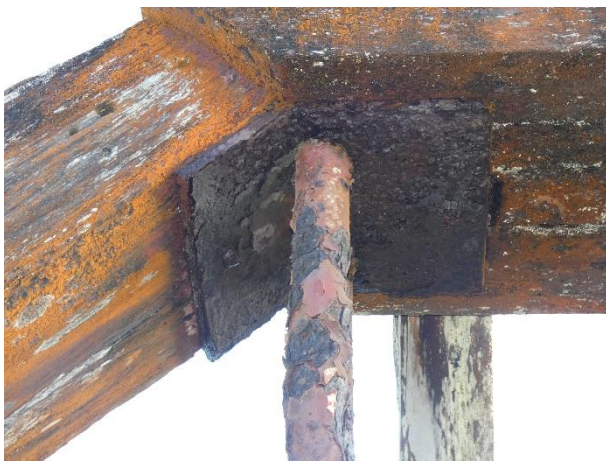
Corrosion of Truss Connection Plates.

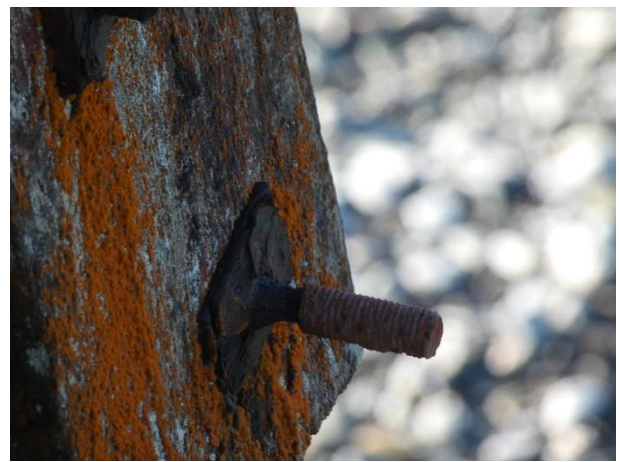
Corrosion and Loss of Fixing Components. Missing Nut and Necked Bolt Shown.

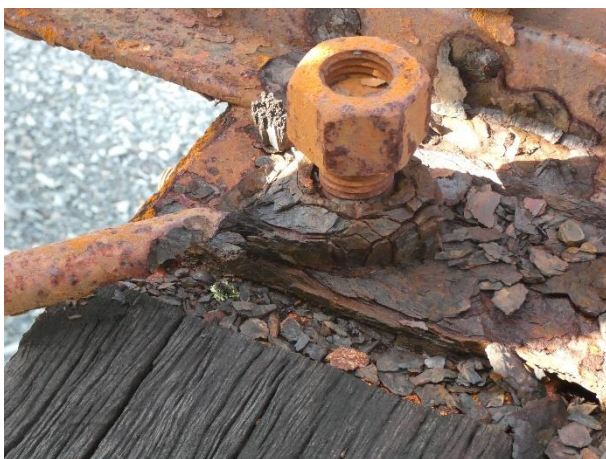
Typical Loose Fixings. Corroded Steel Components.

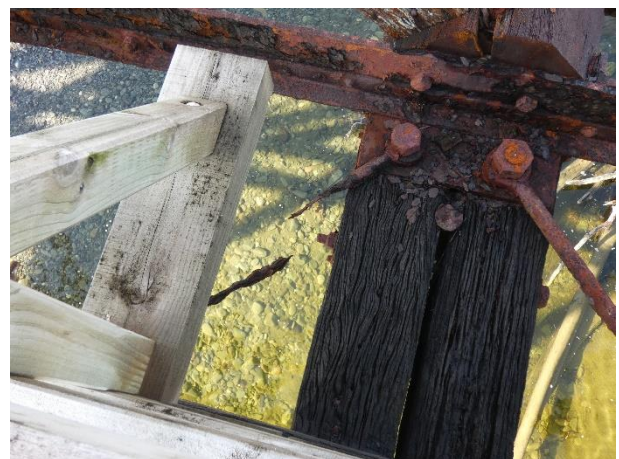
Widespread Loss of Deck Bracing Due to Corrosion.

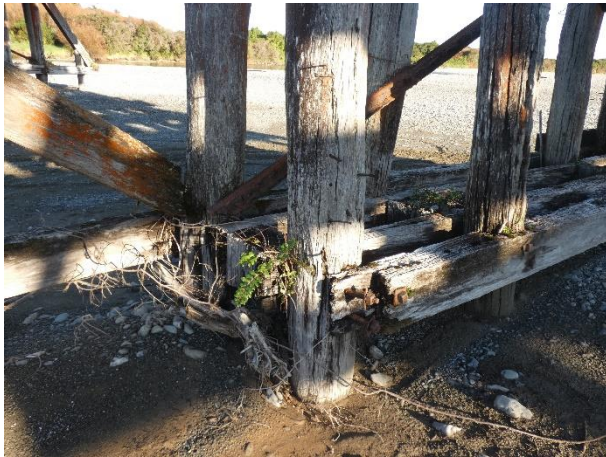
Missing Pier Waling Timbers

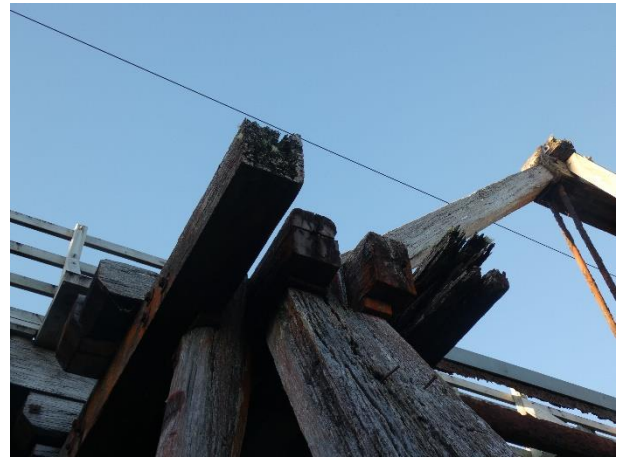
Typical Decay of Pier Cap Timbers

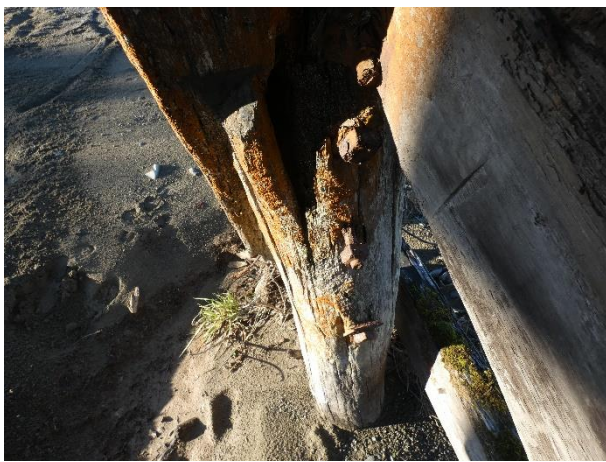
Typical Decay of Pier Piles

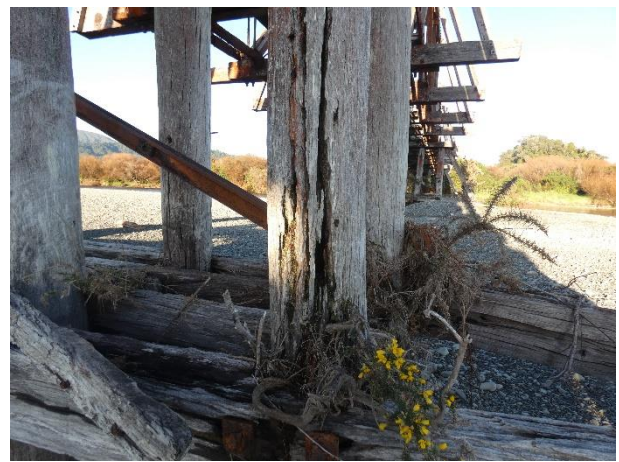
Typical Splitting and Decay of Pier Piles

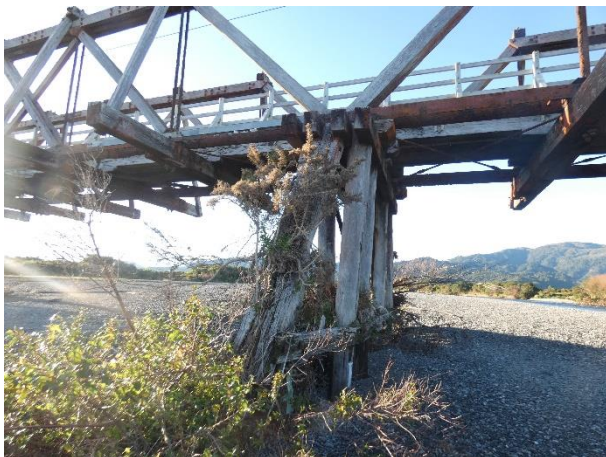
Vegetation Growth From Timber Decay Pockets

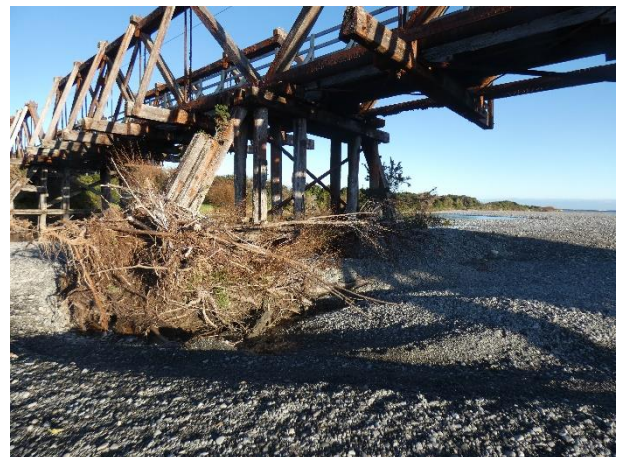
Debris Caught on Piers Causing Local Scour.

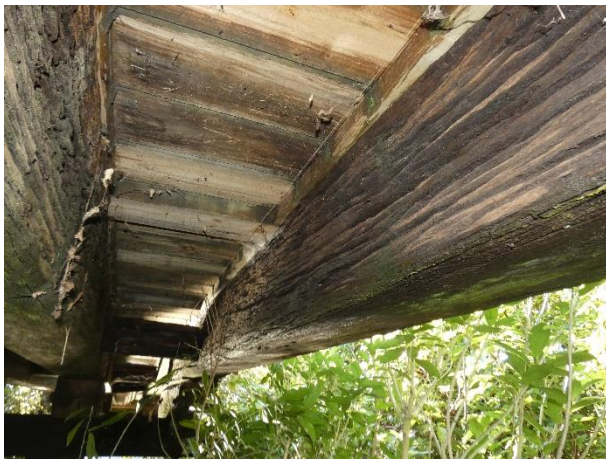
Moisture in Timber Components. Reduced Air Flow for Drying due to Vegetation.

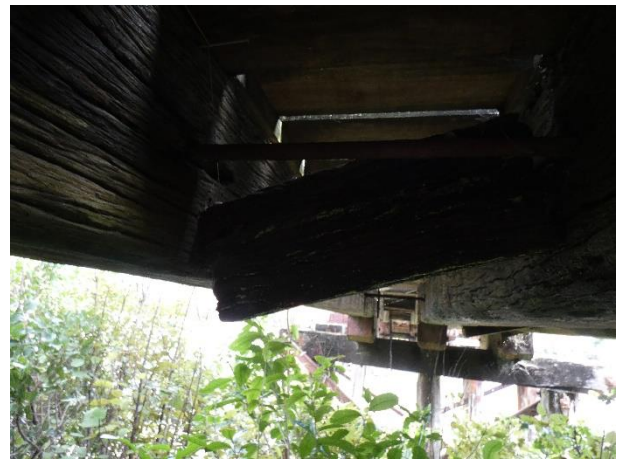
Dislodged and Missing Timber Bracing Blocks Typical.

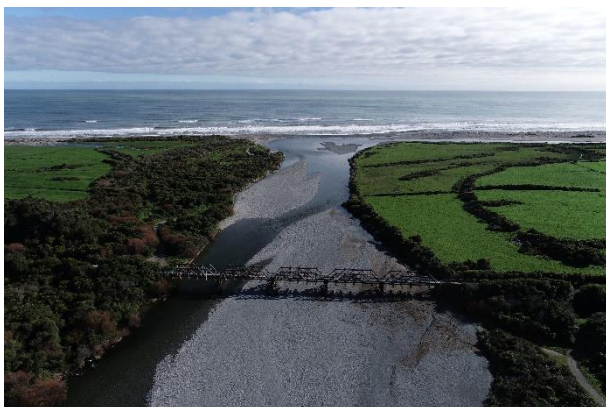
Observation – Flow Favours True Left of River as this is the Outside of the Curved Alignment. Significant Gravel Deposition.
