# DSA Summary Report

**41 Weld Street, Hokitika**

Prepared for Westland District Council  
503051

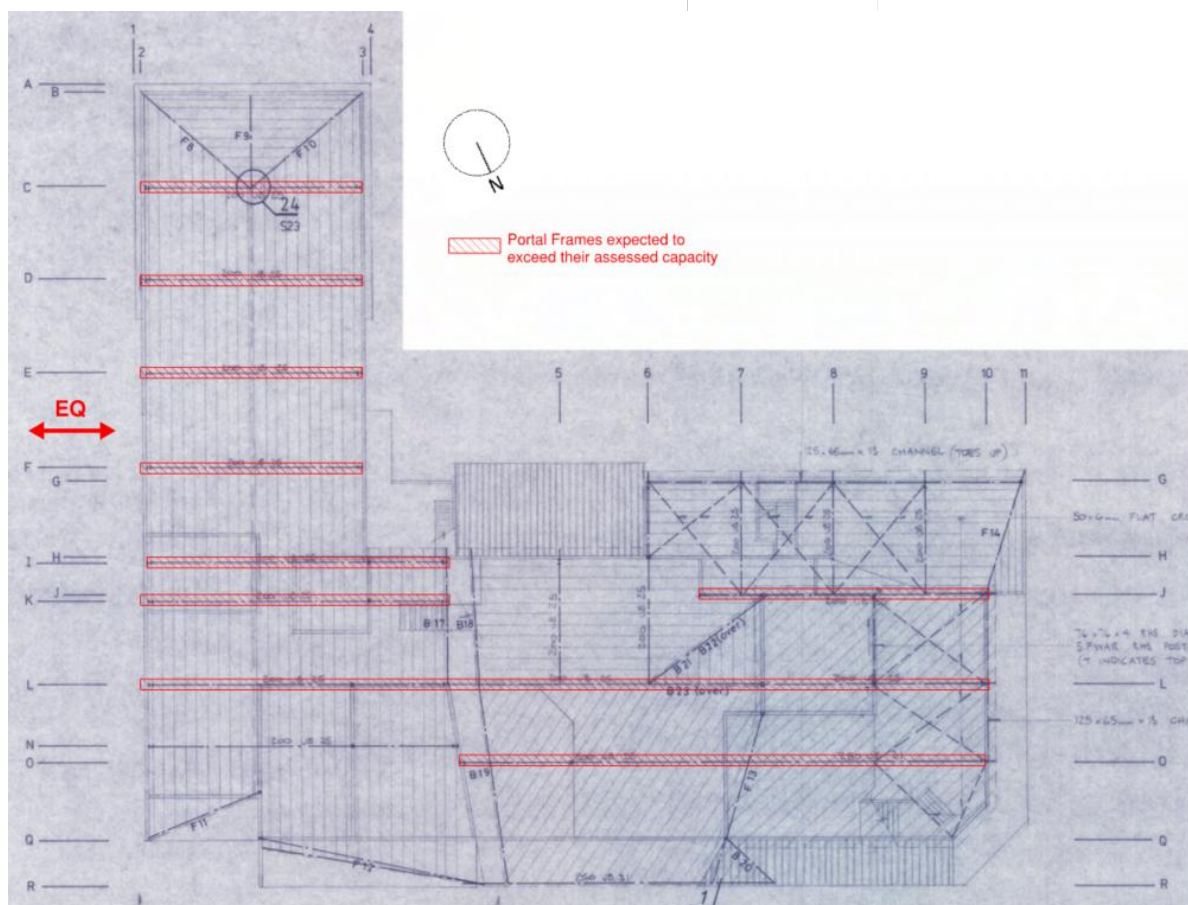
**Risk:** If the seismic demand on these portal frames exceeds their assessed capacity, the portal beams and columns could fail in bending resulting in excessive displacements. In this scenario localised sections of the roof (D1, D2 and D3) and the first floor (D3) could collapse, mostly in open areas that have no timber-framed walls to hold the roof up. Some timber-framed elements may provide a secondary load path for the first-floor frames. However, because they were not designed for this purpose, their load-carrying capacity would be limited by their connections to the roof bracing system.

**Basis of analysis:** The analysis is based on the available existing building drawings. Because of the vertical irregularity, with a stiff ground floor and a lightweight upper floor, the upper structure is expected to sway more because of dynamic effects and higher-mode responses.

**Figure 2. Steel portal frames rated lower than 34% NBS**

The lateral capacity of the first floor of the D1 & D2 areas, and the ground & first floors of the D3 area, is limited by the lateral stiffness and flexural strength of the existing portal frame structures.

- **Transverse Direction:** Enhance the strength & stiffness of the existing portal frames by the installation of additional steel frames placed strategically within and connected to the existing frames. This methodology promotes the future flexibility of the building by largely retaining the existing open interior spaces. In selected locations to the building perimeter, tension only cross-braces are proposed.
- **Longitudinal Direction:** Install new steel braced frames to be constructed within or against existing exterior and interior walls.
- Improve load distribution with new RB20 Reid brace roof bracing.

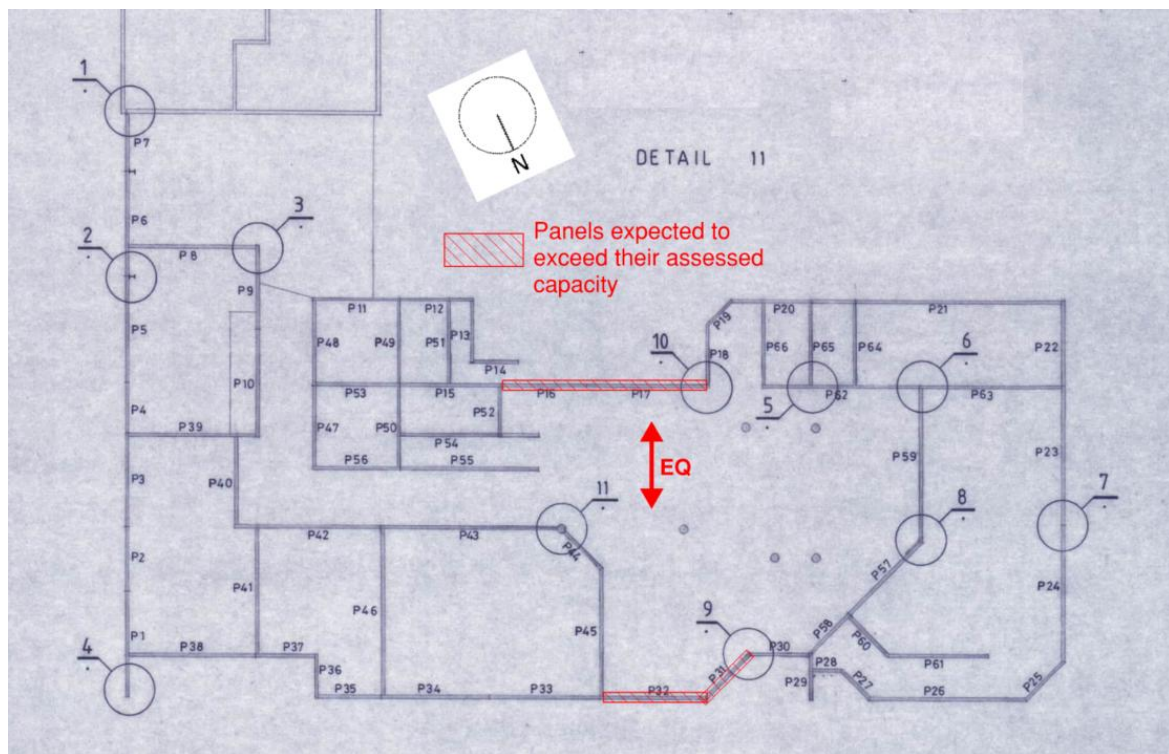
**Element description:** Panels P16-P17 and P31-P32 (Out-of-plane performance)

**Risk:** Because there is no floor structure between areas D1 and D2, these panels span further than the other panels, but do not appear to have been detailed to withstand the additional out-of-plane seismic loads. If a panel bends and fails, part of the panel, and possibly some of the connected roof structure, could collapse.

**Basis of analysis:** The %NBS rating depends on variations in concrete strength, reinforcement spacing and similar factors. However, the lack of a robust load path to stabilise the panels under out-of-plane loads, combined with the consequences of failure, is considered to justify a rating of less than 34%NBS.

Figure 3. Concrete panels rated as less than 34% NBS under out-of-plane loads

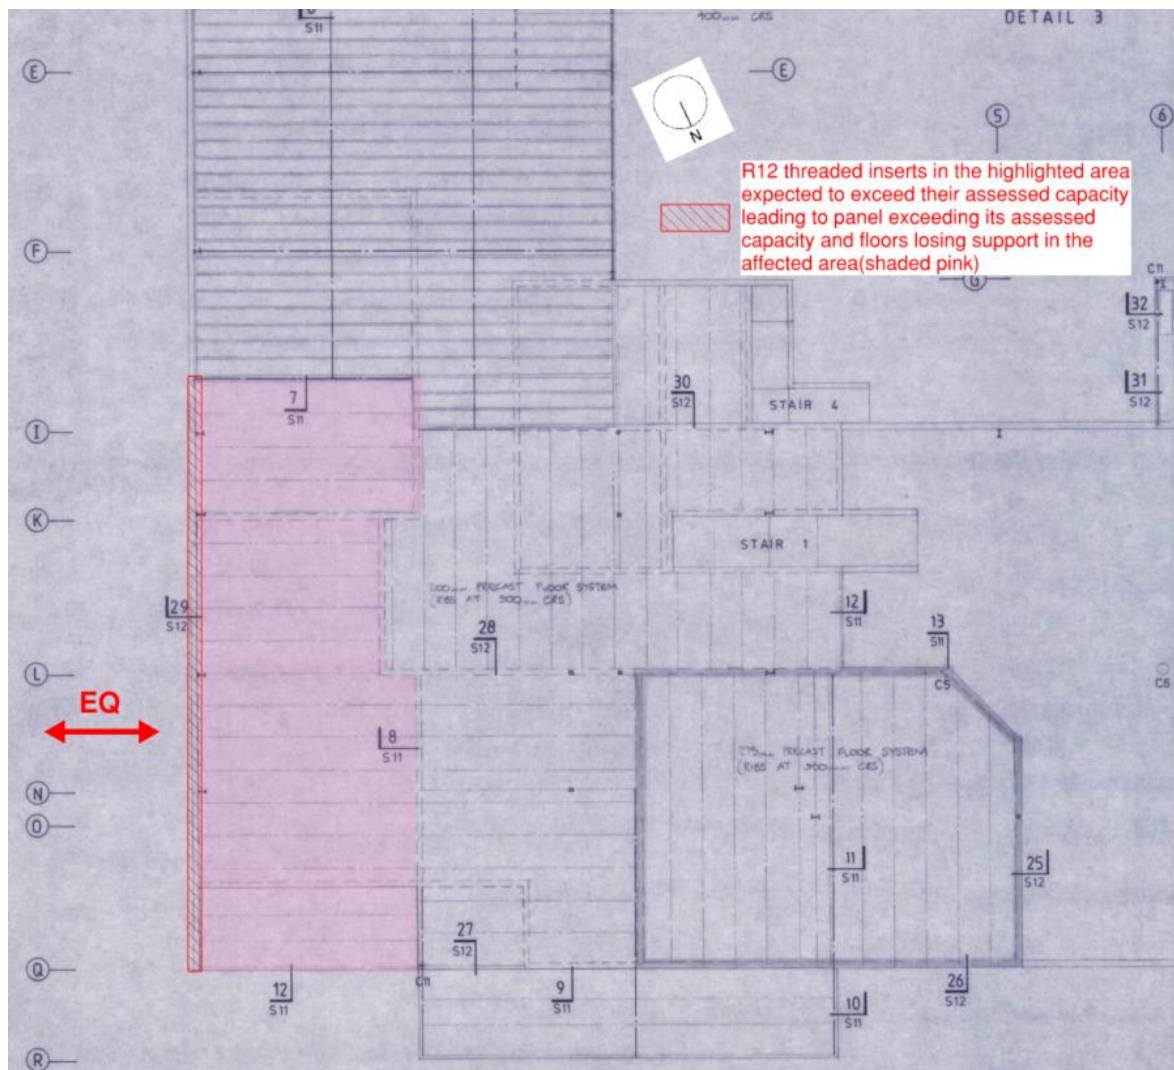
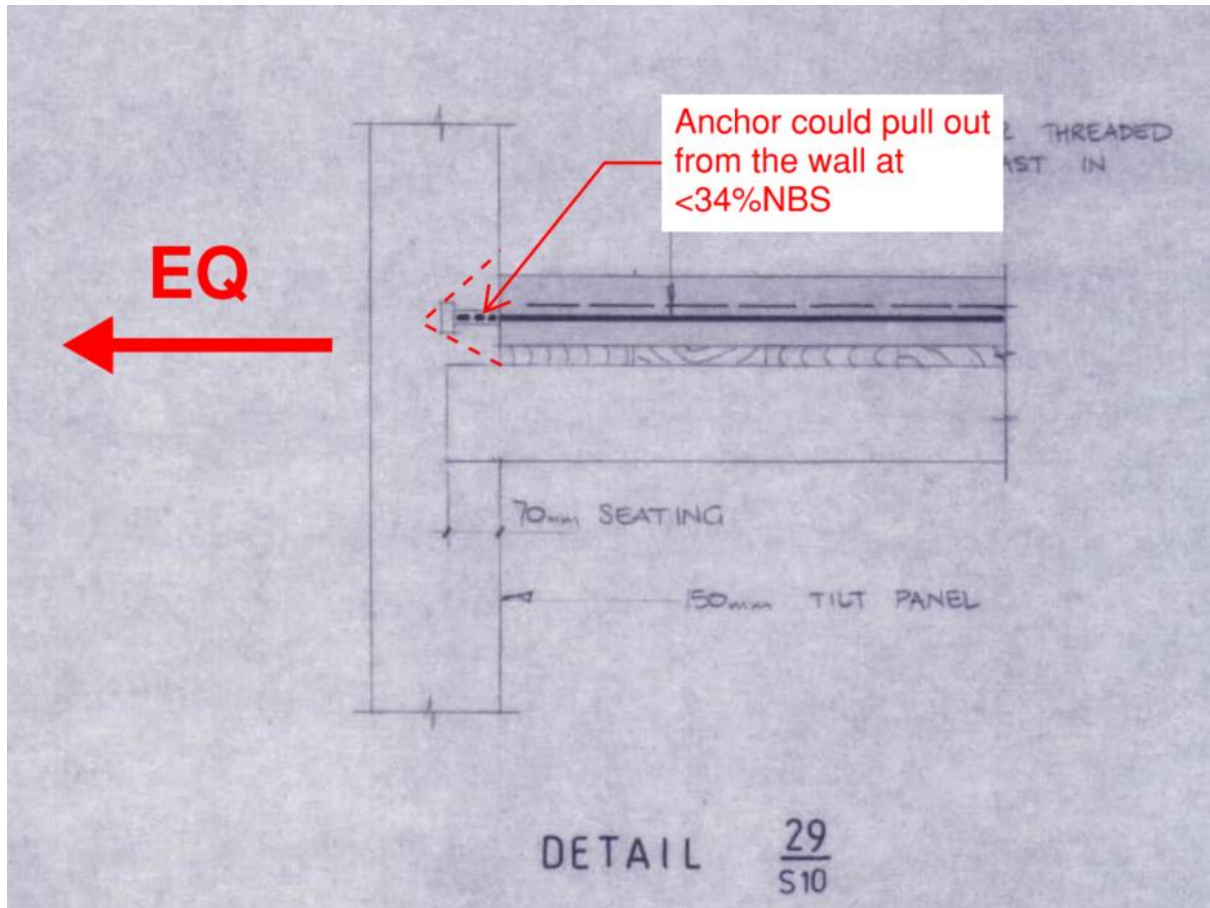
**Element description:** Along Grid line 2 (refer to Figure 4 below), M12 threaded inserts have been used to tie the floor diaphragm into the external panel shear walls. The pull-out strength of the inserts is rated at 25%NBS.

**Risk:** If the ties connecting the floor structure to the supporting panels pull out, the Stahlton rib-and-infill floors could lose their support and collapse. The external double-height panels could also fail in bending without the ties securing them to the first floor. In addition, in most areas the current support provided to the Stahlton ribs does not meet the minimum seating length required for a new building.

**Basis of analysis:** We have based our analysis of the pull-out strength on available structural drawings, however the drawings do not indicate the exact spacing of TCM R12 threaded Bar starters. Further investigation on site with a rebar locator could potentially affect the reported rating.

**Figure 4. Plan view of the floor and detail to TCM12 threaded rod connection to floor diaphragm.**

- Provide new seating angles beneath ribs where seating does not comply (refer to seismic strengthening drawings sheet S04).
- Provide additional shear connections to ensure adequate load transfer from diaphragm into shear-walls (refer to seismic strengthening drawings sheet S04). – *Note that additional investigation of existing ties may eliminate this requirement.*
- Provide new transom beams across atrium between D1 & D2 areas to restrain full-height panels out-of-plane (refer to seismic strengthening drawings S04).

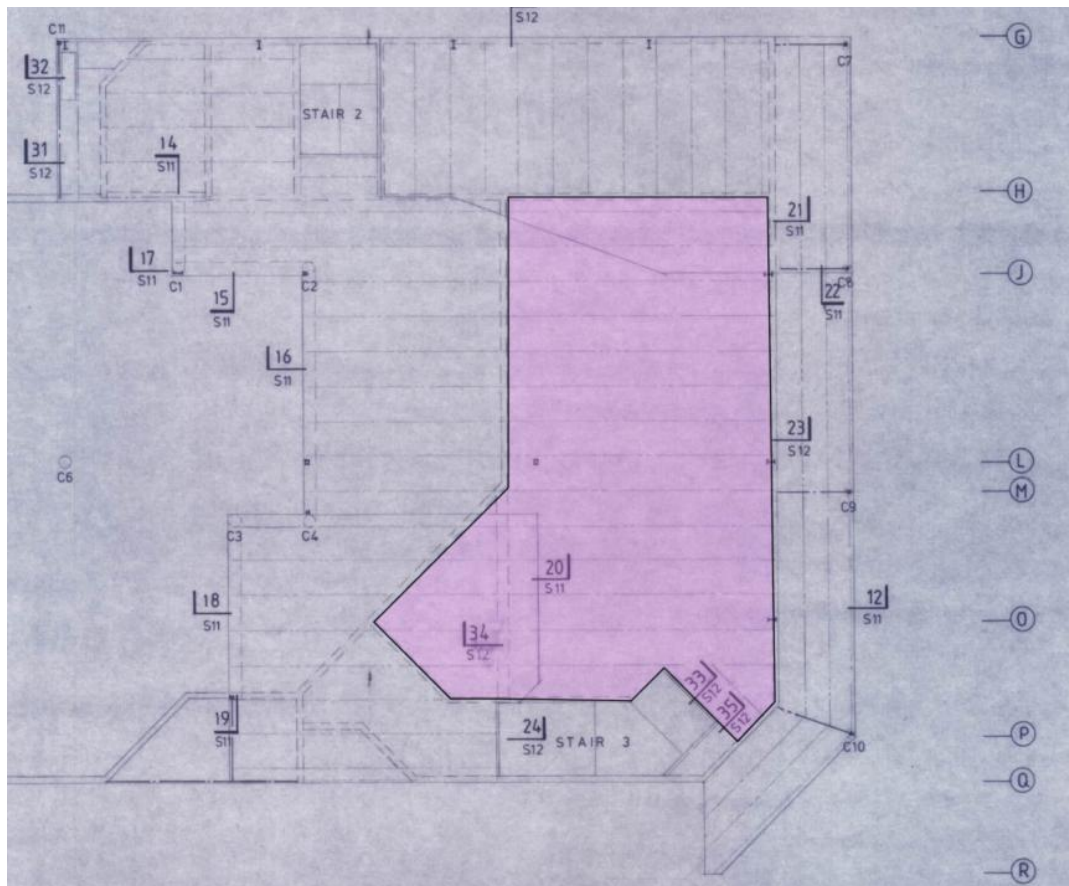
This ground-floor area comprises reinforced concrete wall panels supported on a concrete piled foundation system. The wall panels support a reinforced concrete floor above. No elements within this area have been assessed as having an NBS rating below 34%. However, elements of the steel structure on the floor above the concrete café structure are rated below 34% NBS. This indicates a potential high risk for these elements to fail in a significant earthquake, which may result in local or global collapse of the roof above.

Notwithstanding this, it is considered unlikely that collapse of the lightweight roof above the concrete café structure would create a life-safety risk for occupants of the ground-floor area described above. This is an assessment-based opinion and does not guarantee that risk is absent.

Figure 5. Ground floor of D1 building area (shaded pink)

If the occupancy decision is based on a 34% NBS target, continued use of this ground-floor area may be possible, provided suitable mitigation measures (e.g. propping or shoring) are implemented to reduce the effects of a potential roof collapse. Specific engineering advice should be obtained to confirm these measures.
