AGENDA

NOTICE OF AN ORDINARY MEETING OF

COUNCIL

to be held on **Thursday, 29 August 2024** commencing at **1 pm** in the Council Chambers,
36 Weld Street, Hokitika and via Zoom

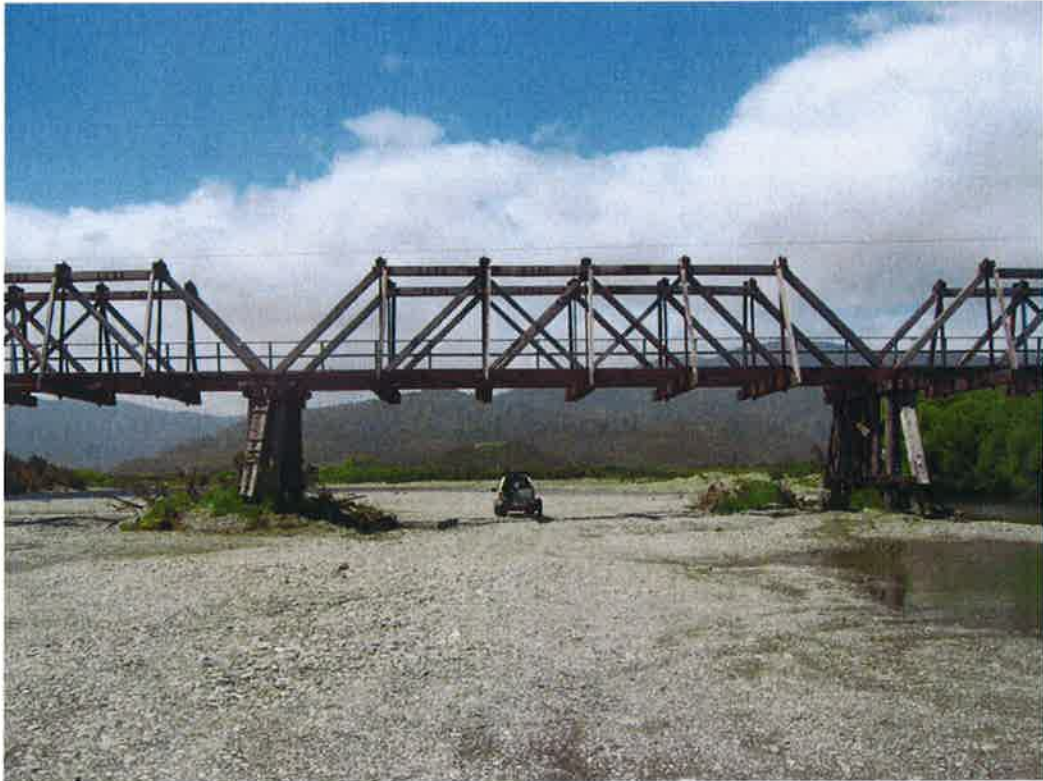
Figure 4-1 : Typical Howe Truss Span (Span 6 – Downstream)

The bridge is made up of nine spans with the first two spans constructed using simply supported timber beams and the central five spans, being much longer are Howe Trusses. Figure 4-1 on the following page shows a typical Howe Truss and Table 4-1 below shows the construction of each span.

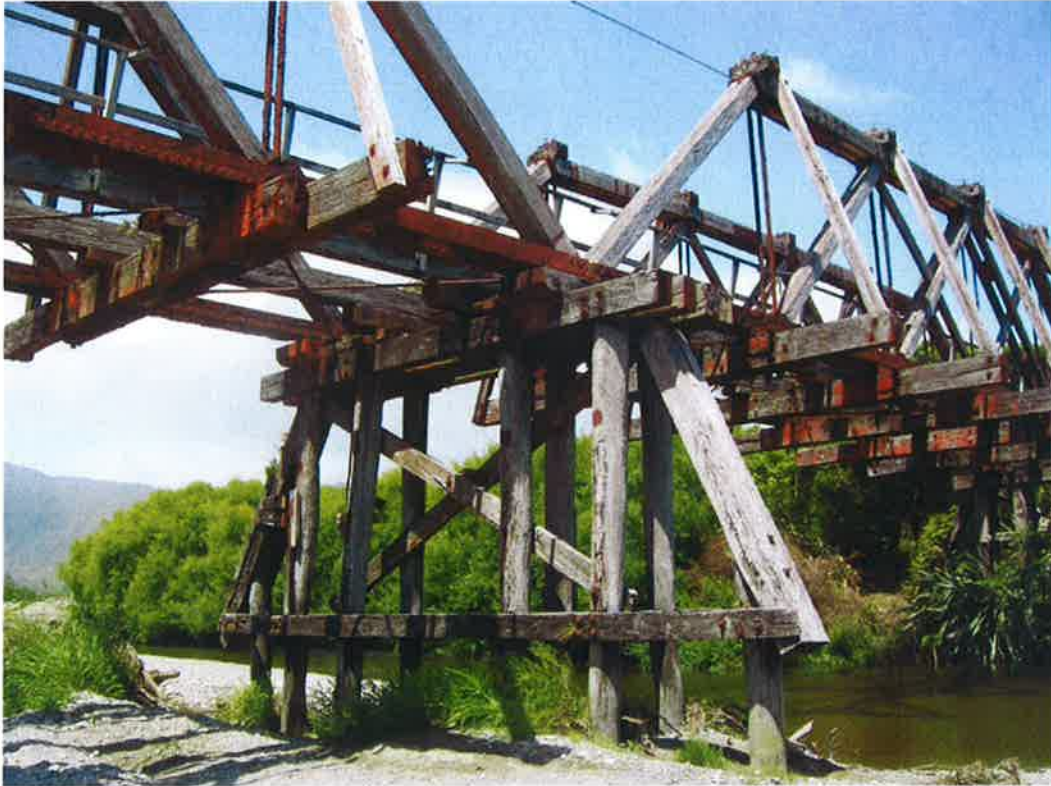
Figure 4-3 : Typical River Pier (Pier No. 7)

The bridge superstructure is supported on timber piers. The timber piers supporting the longer Howe truss spans (river spans) consist of ten piles and the piers supporting the shorter simply supported spans (land spans) and forming the abutment walls consist of five and three piles respectively. Figures 4-2 and 4-3 on the following pages show typical piers supporting both river and land spans.

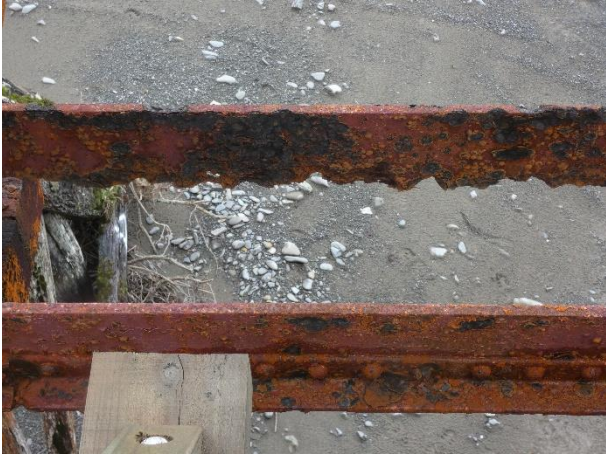
Moderate to Heavy Bottom Chord Corrosion.

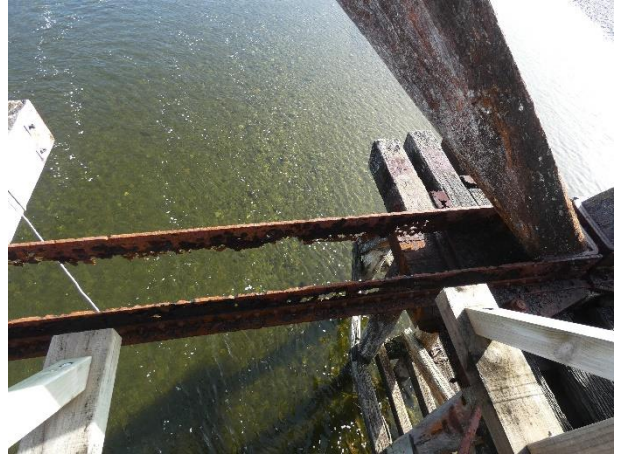
Critical Bottom Chord Corrosion.

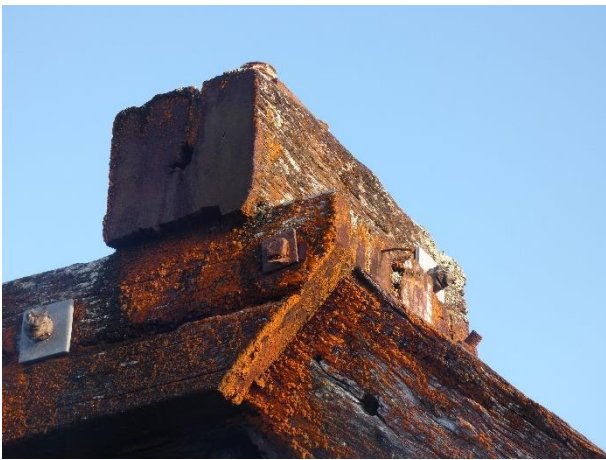
Typical Timber Splitting – Top Chord Shown.

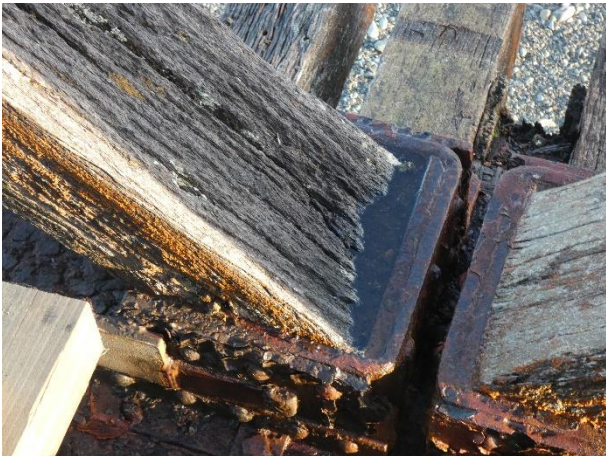
Typical Weathered Timber and Ponding Moisture.

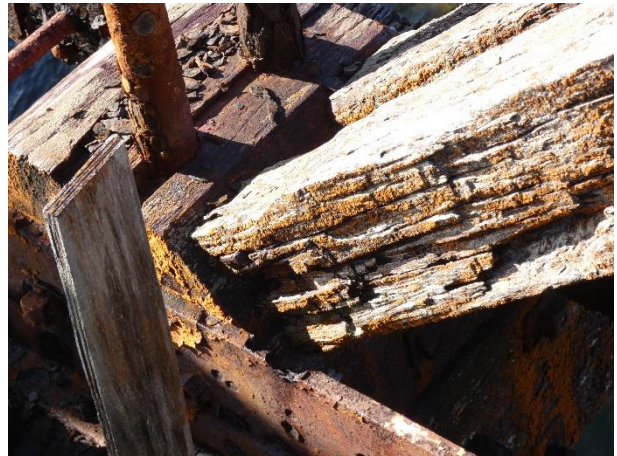
Typical Weathered Timber.

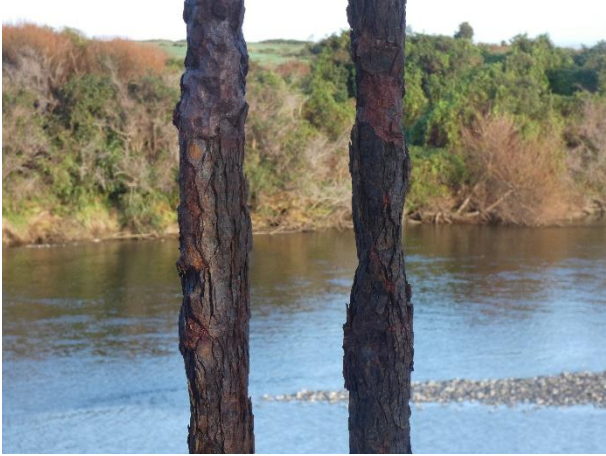
Typical Corroded (Pack Rusting) Hanger Rods – Heavy to Critical Corrosion Shown.

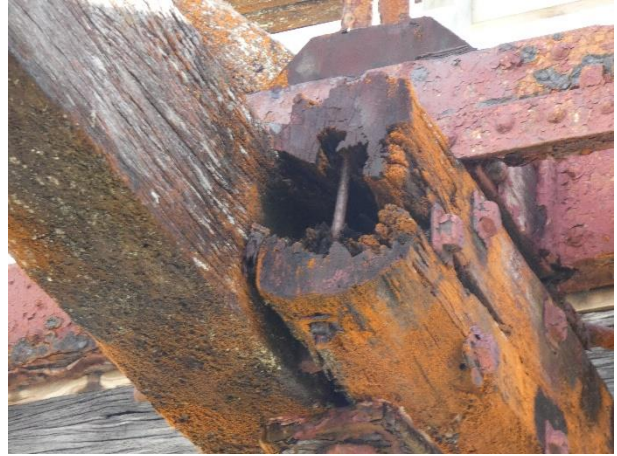
Timber Decay – Heavy to Critical Decay Shown.

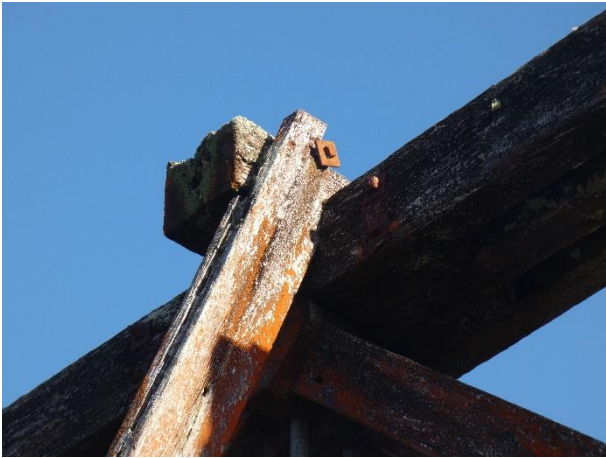
Typical Decay and Loss of Timber Section at Connections – Top of Wind Brace Shown.

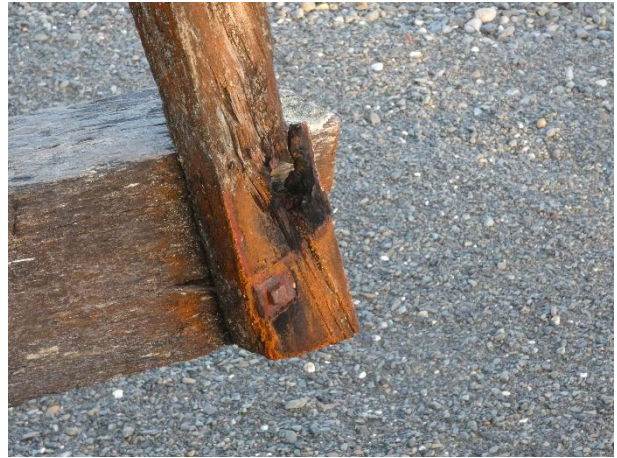
Typical Decay and Loss of Timber Section at Connections – Bottom of Wind Brace Shown.

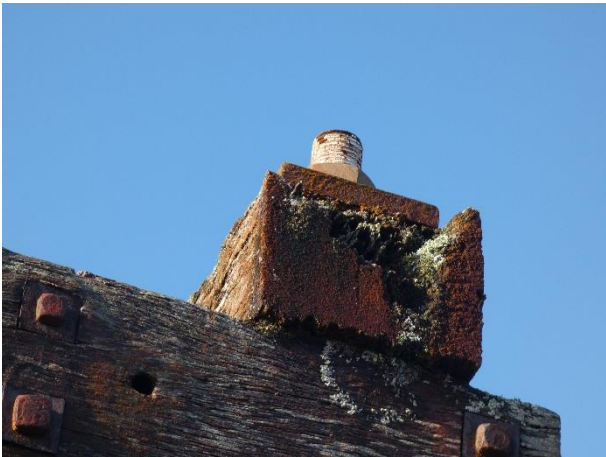
Typical Decay of Top Blocks.

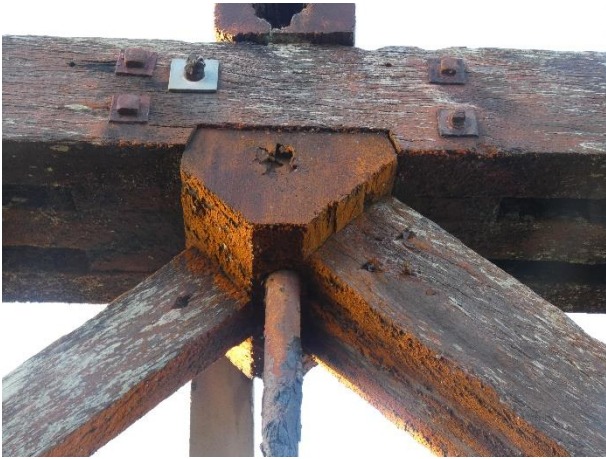
Typical Moderate Decay of 'A' Block.

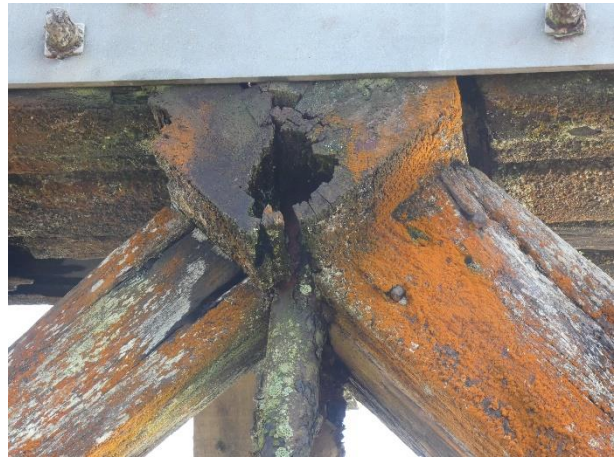
Typical Heavy to Critical Decay of 'A' Block.

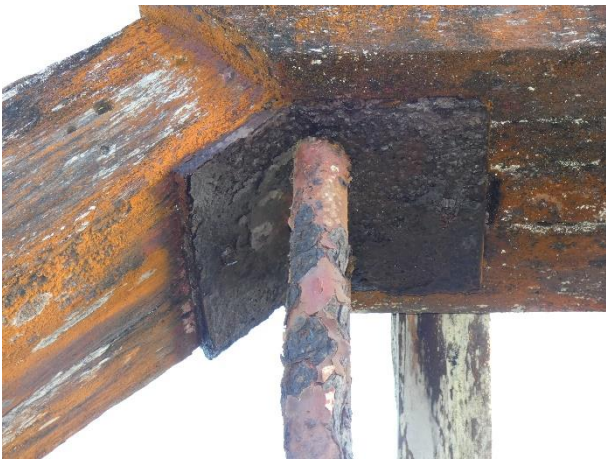
Corrosion of Truss Connection Plates.

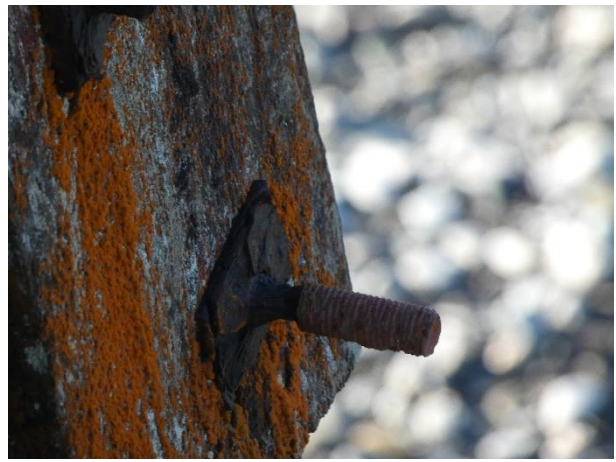
Corrosion and Loss of Fixing Components. Missing Nut and Necked Bolt Shown.

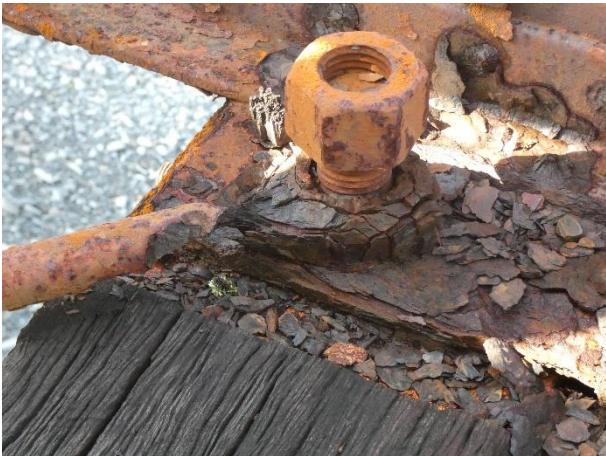
Typical Loose Fixings. Corroded Steel Components.

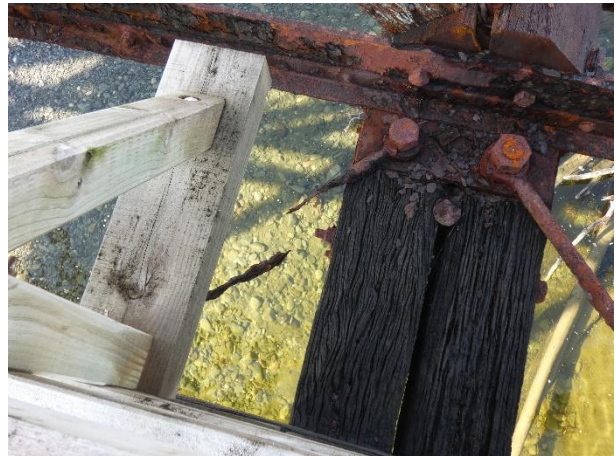
Widespread Loss of Deck Bracing Due to Corrosion.

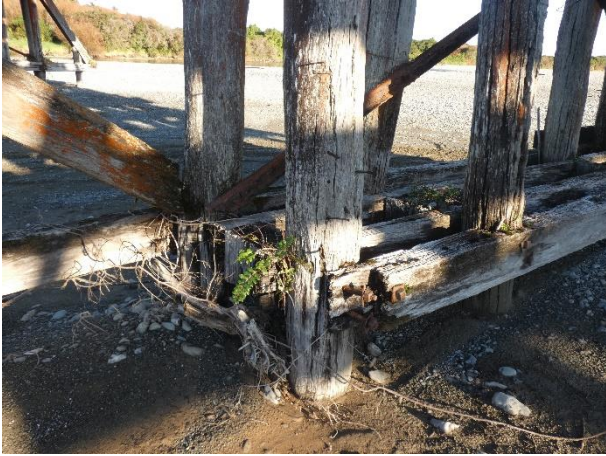
Missing Pier Waling Timbers

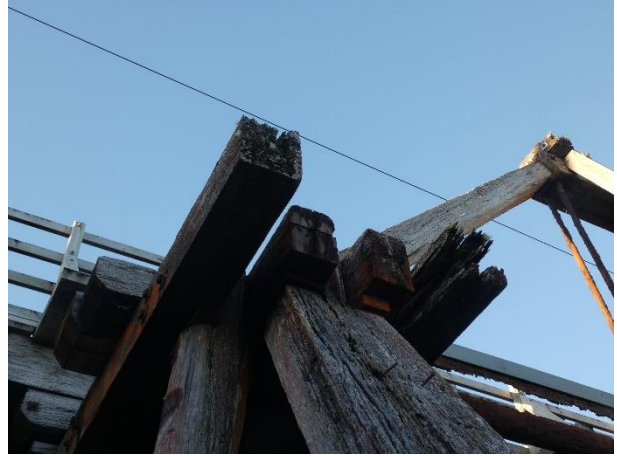
Typical Decay of Pier Cap Timbers

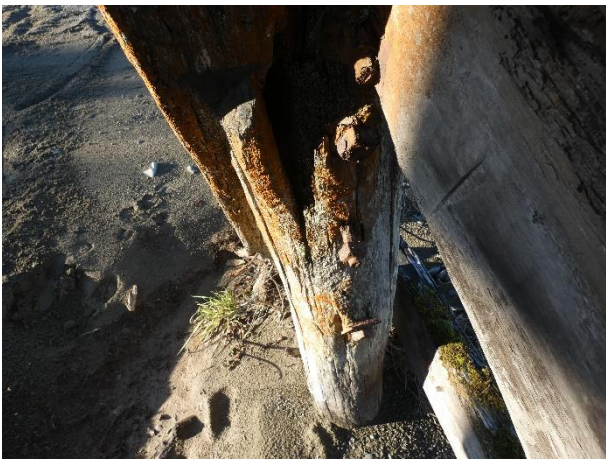
Typical Decay of Pier Piles

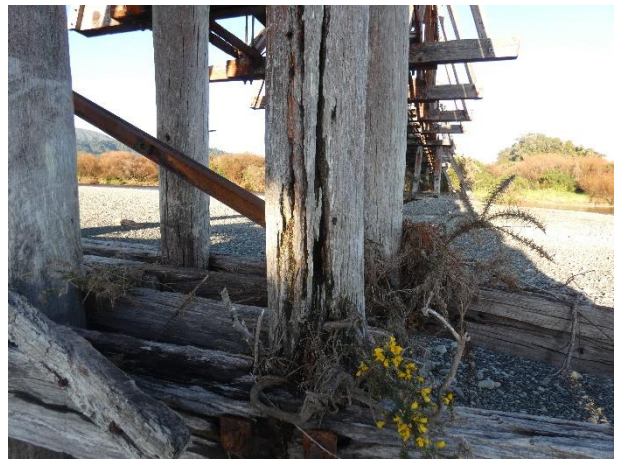
Typical Splitting and Decay of Pier Piles

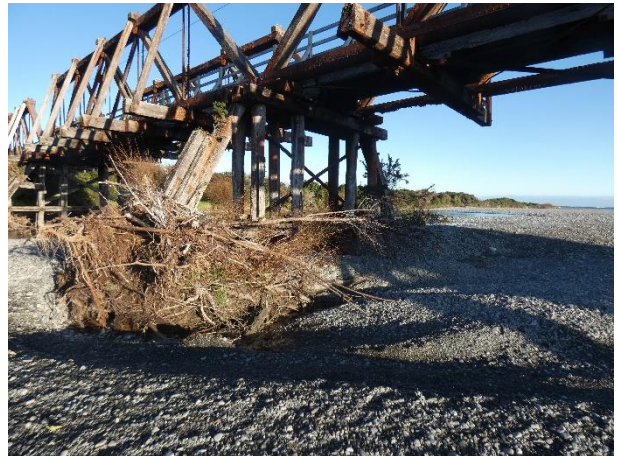
Debris Caught on Piers Causing Local Scour.

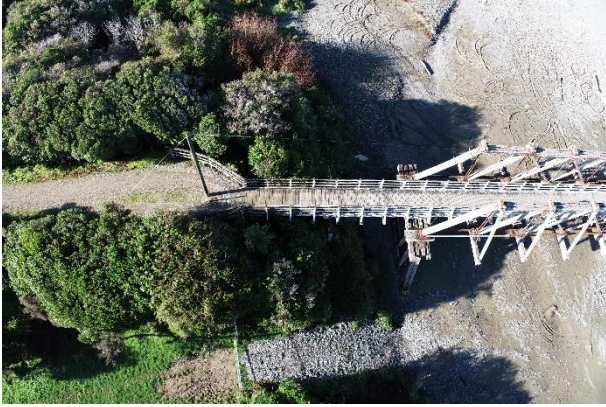
Approach Spans Shrouded in Dense Vegetation. Northern Approach.

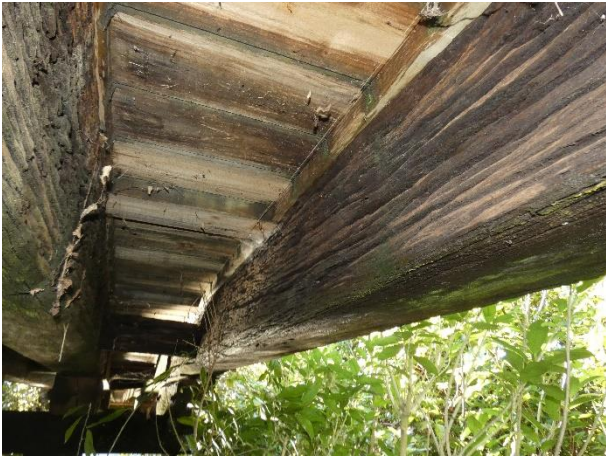
Moisture in Timber Components. Reduced Air Flow for Drying due to Vegetation.

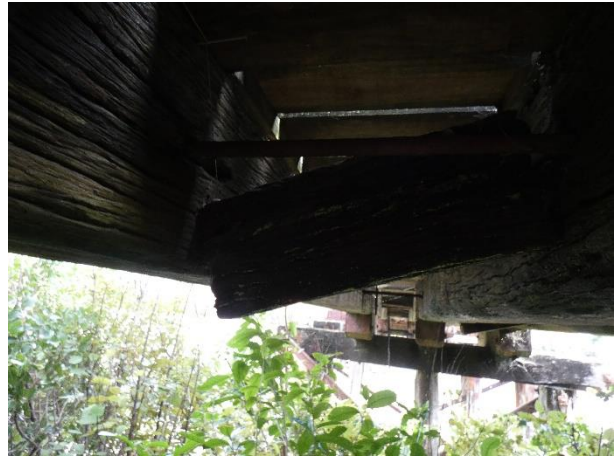
Dislodged and Missing Timber Bracing Blocks Typical.

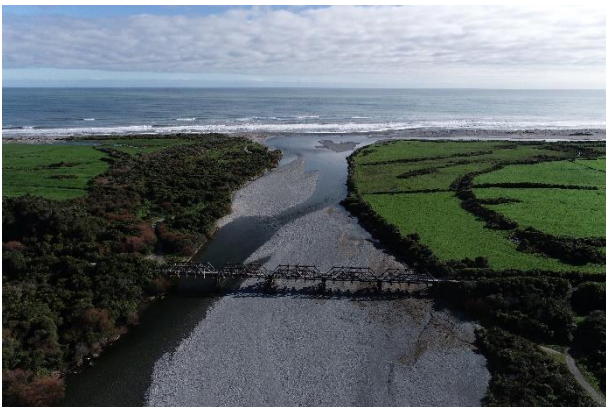
Observation – Flow Favours True Left of River as this is the Outside of the Curved Alignment. Significant Gravel Deposition.

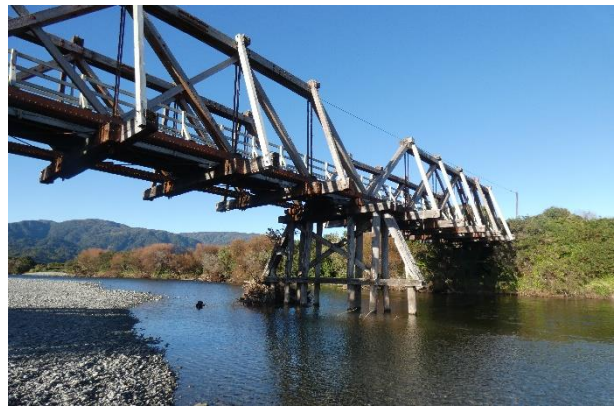
Pier G and Underside of Span G-H not inspected due to Channel Location. Main Channel is Deep. Pile Embedment Depth Unknown.
