Water Supply Activity Management Plan

Westland District Council

2025 - 2034

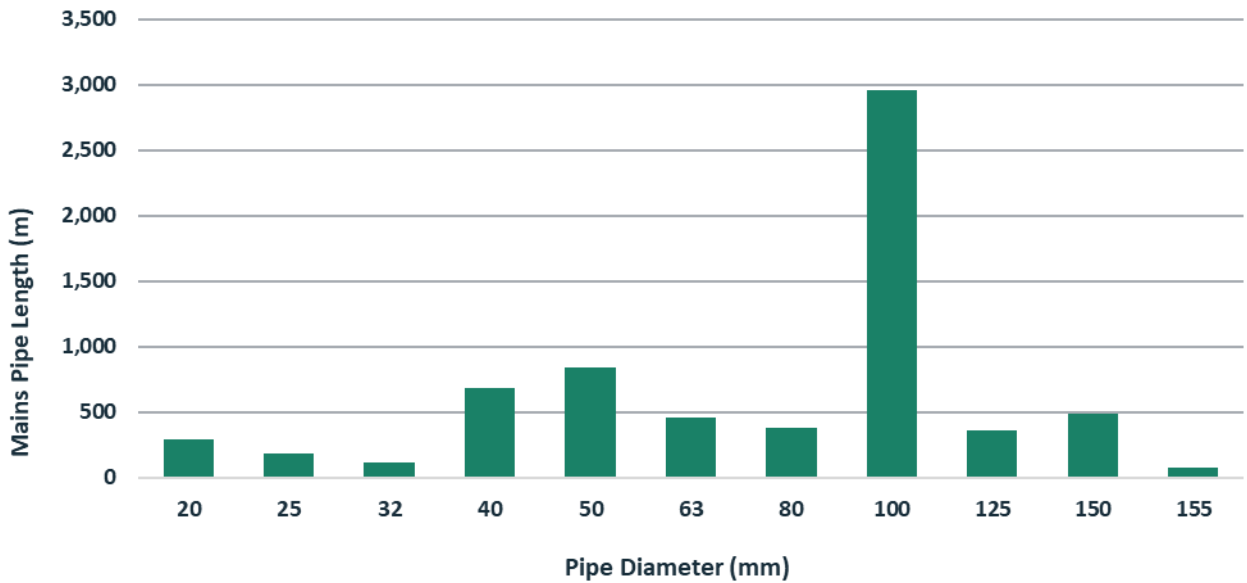
Figure 1-3: Kumara Supply Mains Pipe Diameter.

A summary of the material, diameters and ages of mains pipes within the Kumara Supply are shown below in Figure 1-2, Figure 1-3 and Figure 1-4.

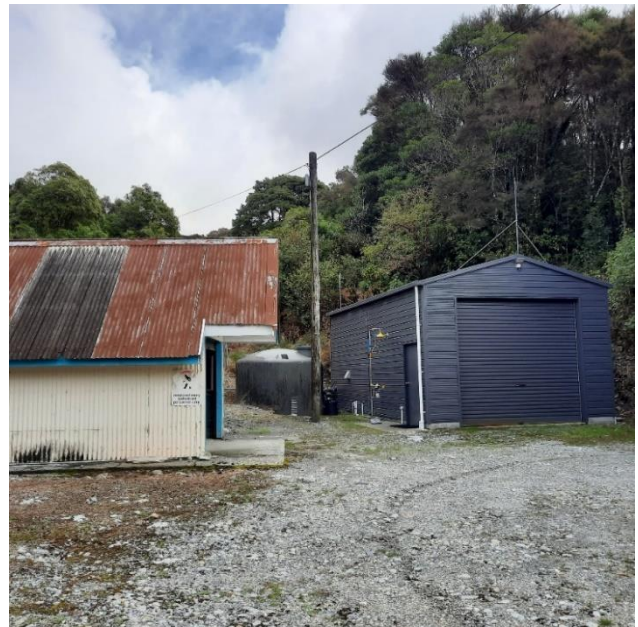
Figure 1-6: Treatment Plant.

The new treatment plant was commissioned in late 2019 and includes granular media filtration, cartridge filtration and UV disinfection. Chlorination was added to the supply in 2023 to ensure compliance with DW standards.

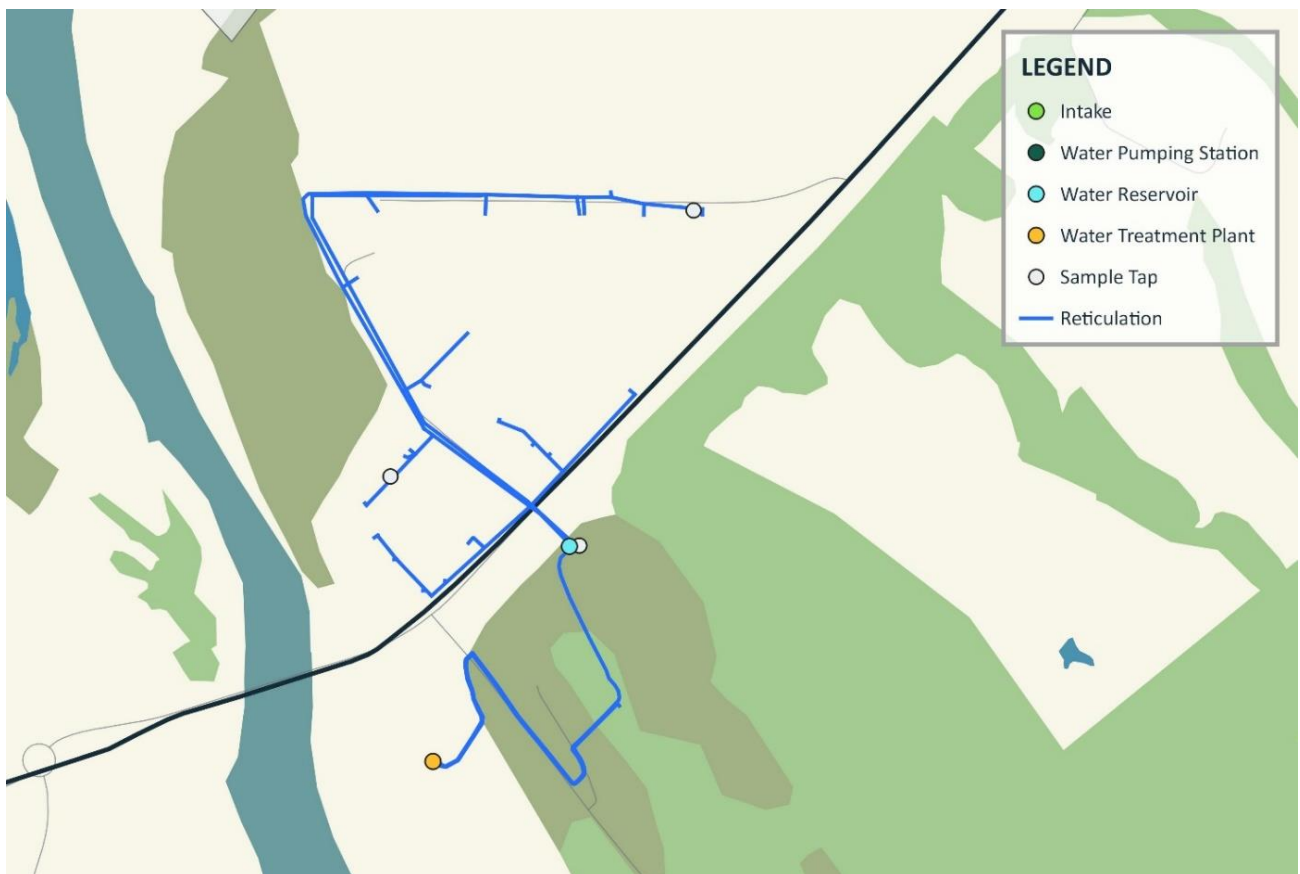
Figure 2-1: Arahura Water Supply Map.

Treated water from the water treatment plant is pumped up to the treated water reservoirs and is gravity fed to the reticulation system. There is a dedicated treated water reservoir for the Arahura Marae which, when required, water can be pumped from to the Marae's own reservoir via a pumped service lateral.

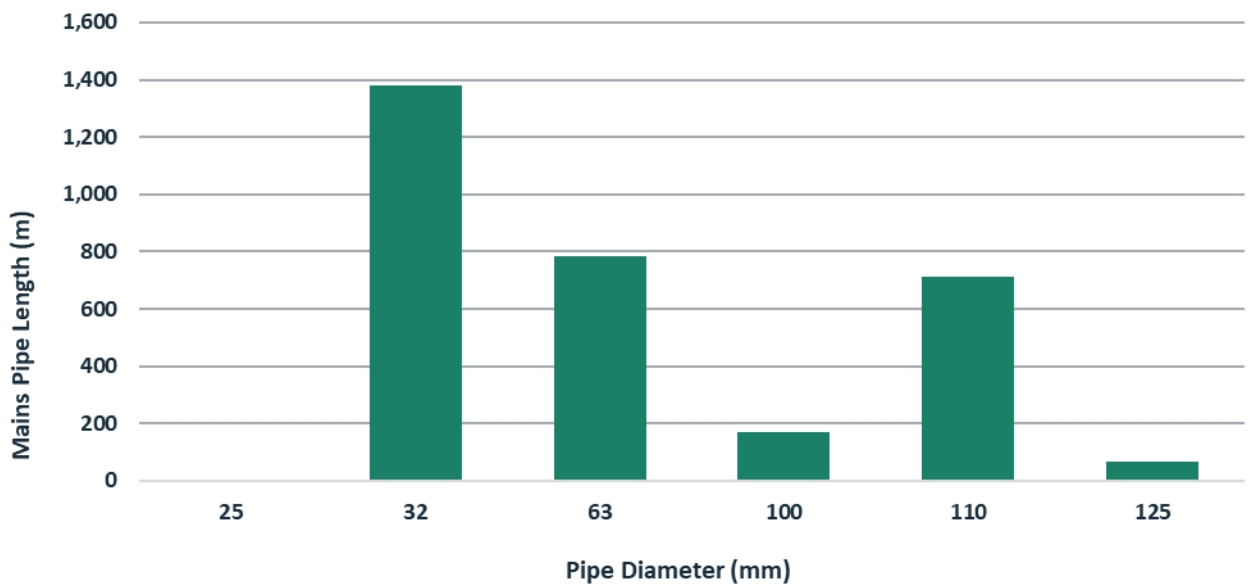
Figure 2-3: Arahura Supply Mains Pipe Diameter.

A summary of the material, diameters and ages of mains pipes within the Arahura Supply are shown below in Figure 2-2, Figure 2-3 and Figure 2-4.

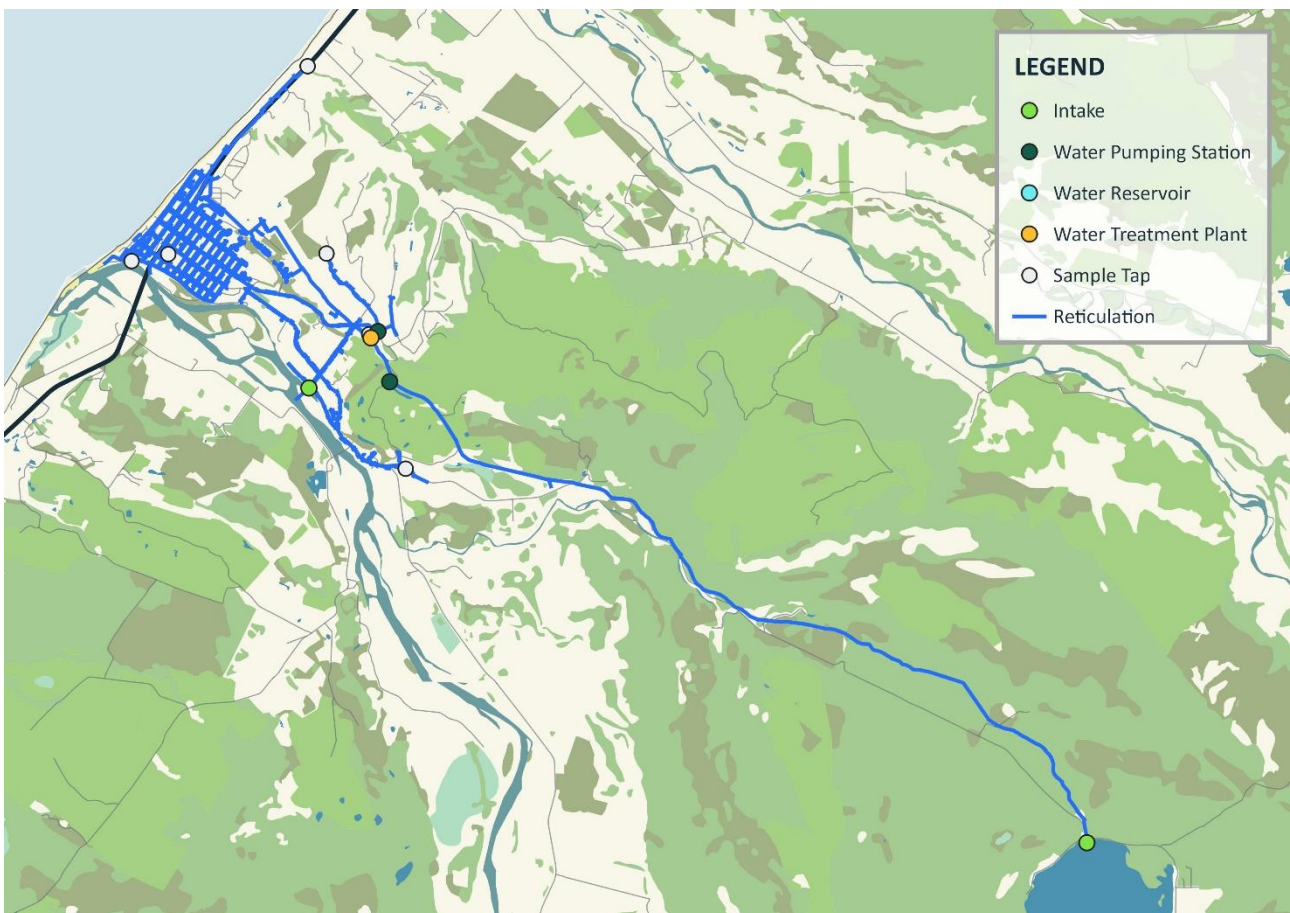
Figure 3-1: Hokitika Drinking Water Supply Map.

Water is treated at the Blue Spur Water Treatment Plant which consists of Membrane Filtration and Chlorine Disinfection alongside Flocculation. Treated water is both gravity and pressure fed to the reticulation supply. Westland Milk Products have a dedicated supply line with their own on-site storage facilities.

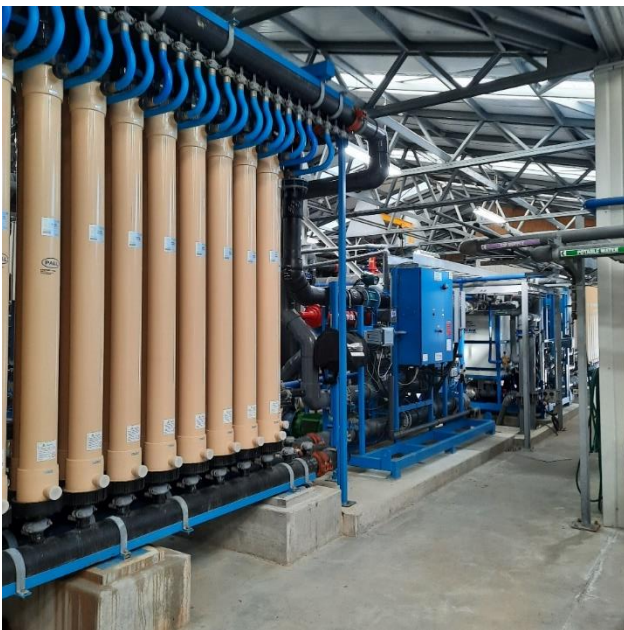
Figure 3-7: Membrane Skid.

Replacement of Membranes	Replacement of membrane units (Skid A & B).	High	Renewal		\$1,400,000		\$0	\$1,400,000
	Replacement of membrane units (Skid C & D).	High	Renewal			\$1,080,000	\$0	\$1,080,000
Treated Water Reservoirs	Replacement of four concrete reservoirs at Blue Spur.	Medium	Renewal				\$1,200,000	\$1,200,000
Replacement WTP Components	Replacement of chlorination and UV units (Depolox Units -5C & pH).	High	Renewal	\$55,000			\$0	\$55,000
Water Meter Replacement	Replacement of 94 meters.	Medium	Renewal				\$170,000	\$170,000
Whitcombe Terrace Booster	Options report for low pressure issues.	Low	LOS				\$130,000	\$130,000

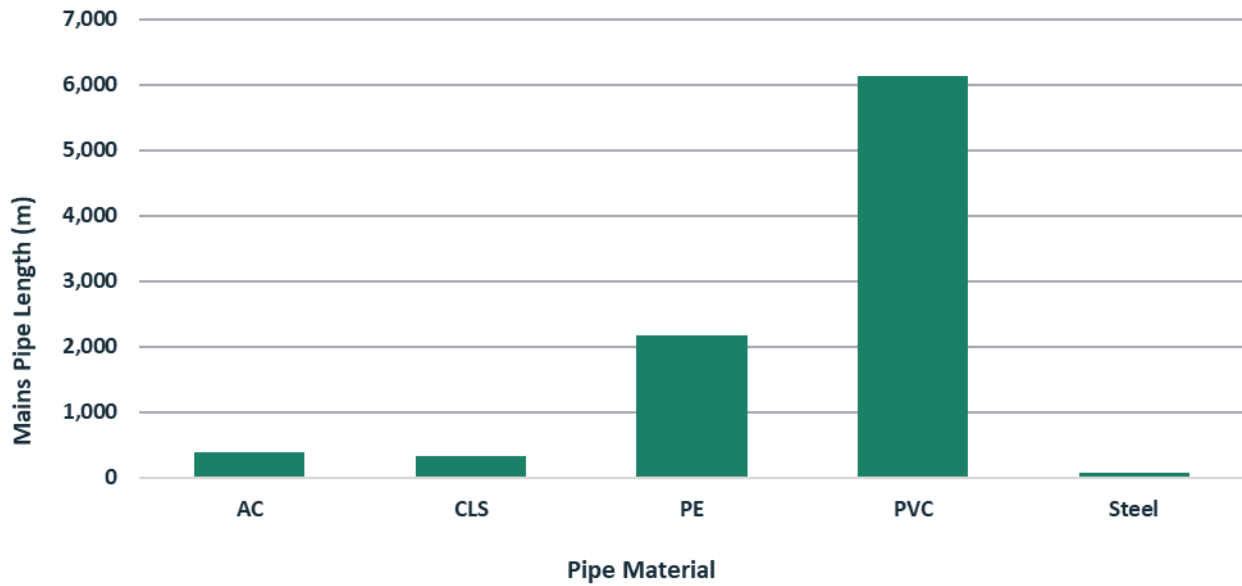
Figure 4-2: Ross Supply Mains Pipe Material.

A summary of the material, diameters and ages of mains pipes within the Ross Supply are shown below in Figure 4-2, Figure 4-3 and Figure 4-4.

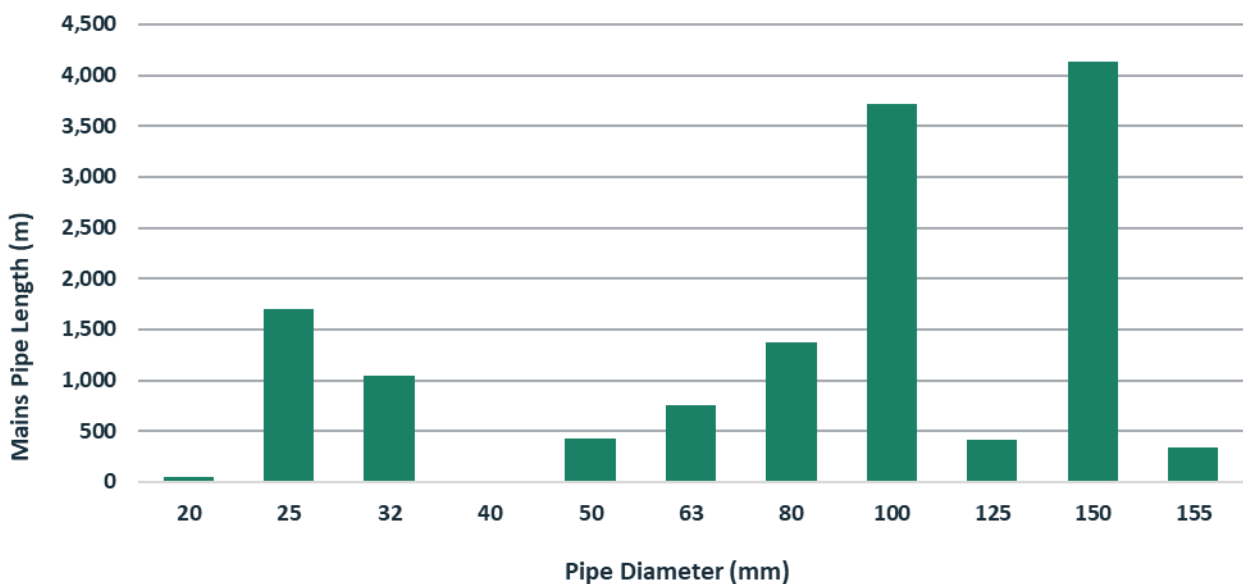
Figure 5-3: Harihari Supply Mains Pipe Diameter.

A summary of the material, diameters and ages of mains pipes within the Harihari Supply are shown below in Figure 5-2, Figure 5-3 and Figure 5-4.

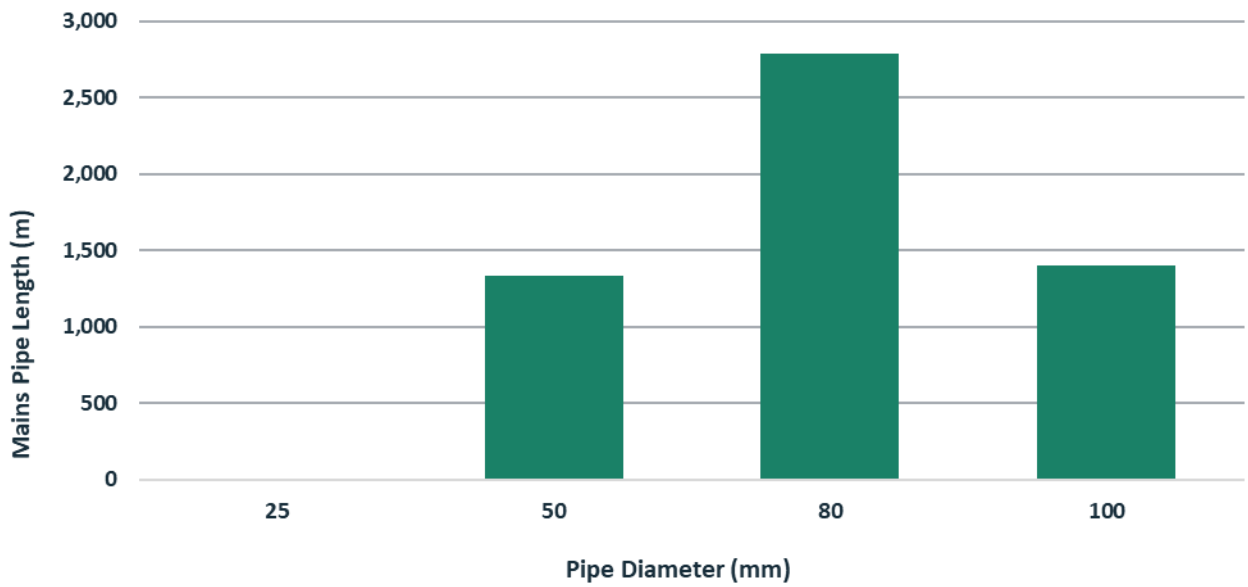
Figure 6-3: Whataroa Supply Mains Pipe Diameter.

A summary of the material, diameters and ages of mains pipes within the Whataroa Supply are shown below in Figure 6-2, Figure 6-3 and Figure 6-4.

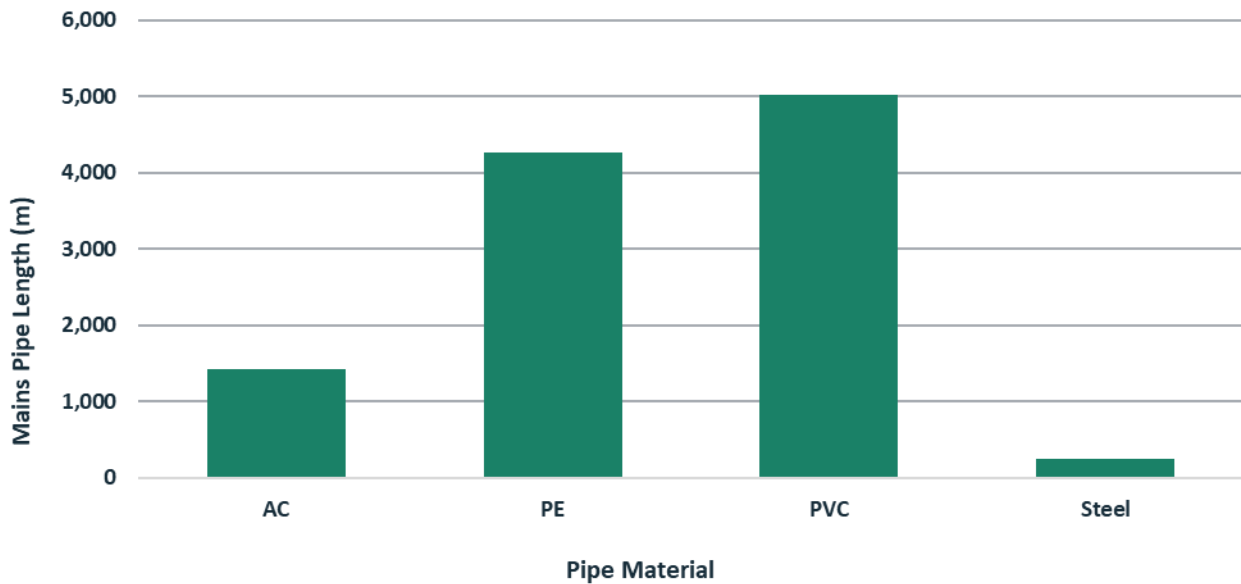
Figure 7-2: Franz Josef Supply Mains Pipe Material.

A summary of the material, diameters and ages of mains pipes within the Franz Josef Supply are shown below in Figure 7-2, Figure 7-3 and Figure 7-4.

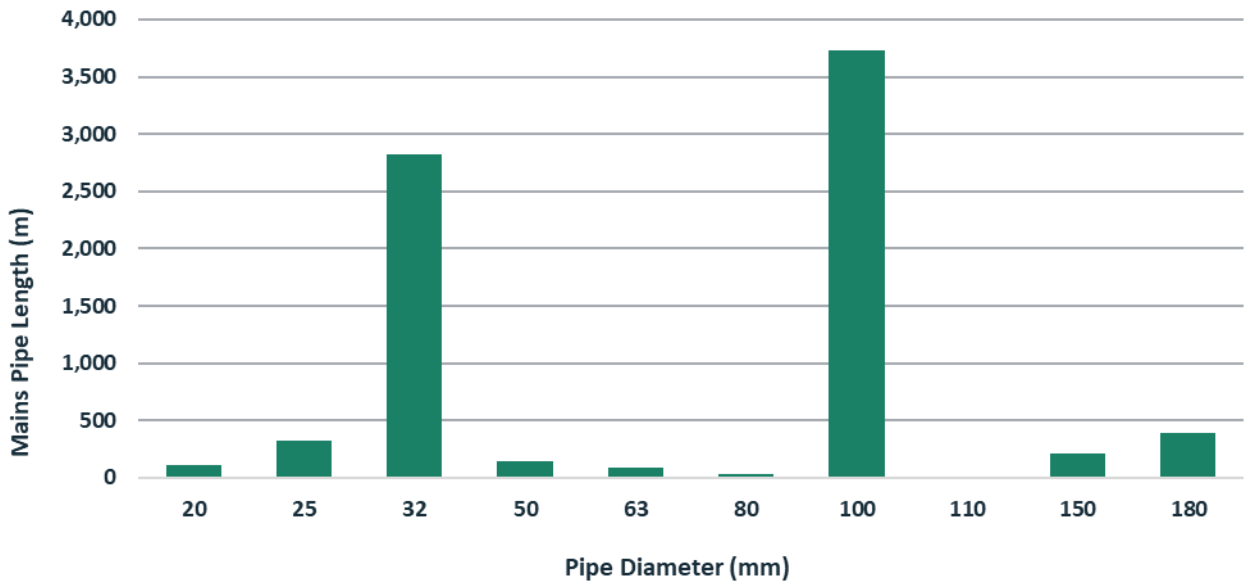
Figure 8-3: Fox Glacier Supply Mains Pipe Diameter.

A summary of the material, diameters and ages of mains pipes within the Fox Glacier Supply are shown below in Figure 8-2, Figure 8-3 and Figure 8-4.

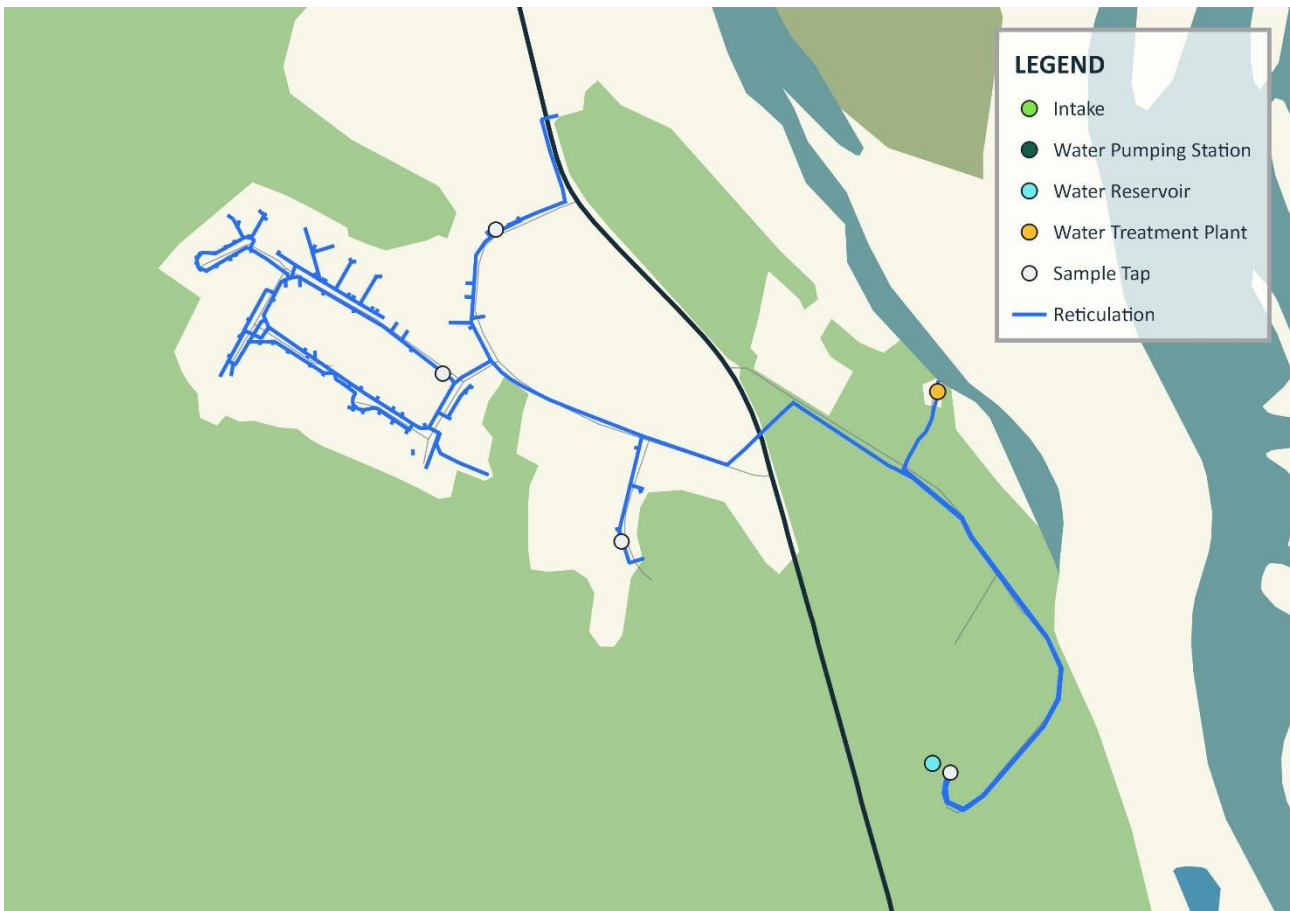
Figure 9-1: Haast Drinking Water Supply Map.

Raw water is drawn from a bore on the western bank of the Haast River. Water is pumped from the bore to the adjacent water treatment plant and is treated through multimedia filtration and UV disinfection. Chlorination was added to the supply in 2023 to ensure compliance with DW standards. Treated water is pumped up to a 400m³ reservoir and then gravity fed to the reticulation network.
