AGENDA

NOTICE OF AN ORDINARY MEETING OF

COUNCIL

to be held on **Thursday, 29 August 2024** commencing at **1 pm** in the Council Chambers,
36 Weld Street, Hokitika and via Zoom

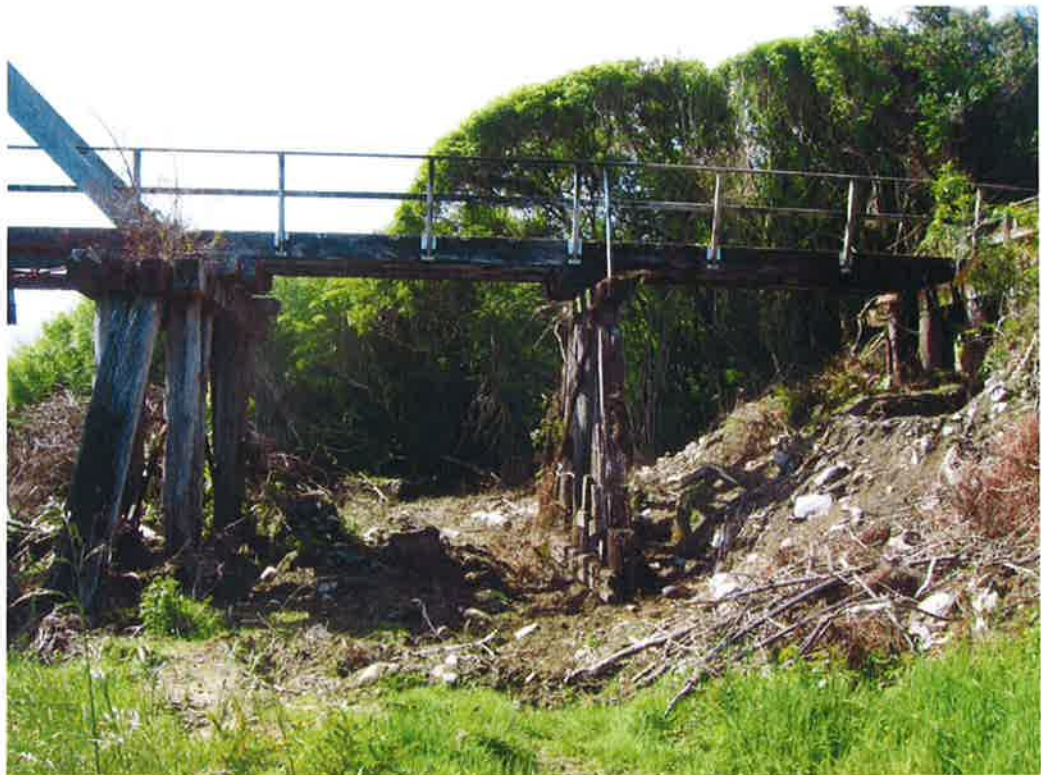
Figure 4-2 : Typical End Span (Spans 8 and 9 – Southern End)

The bridge superstructure is supported on timber piers. The timber piers supporting the longer Howe truss spans (river spans) consist of ten piles and the piers supporting the shorter simply supported spans (land spans) and forming the abutment walls consist of five and three piles respectively. Figures 4-2 and 4-3 on the following pages show typical piers supporting both river and land spans.

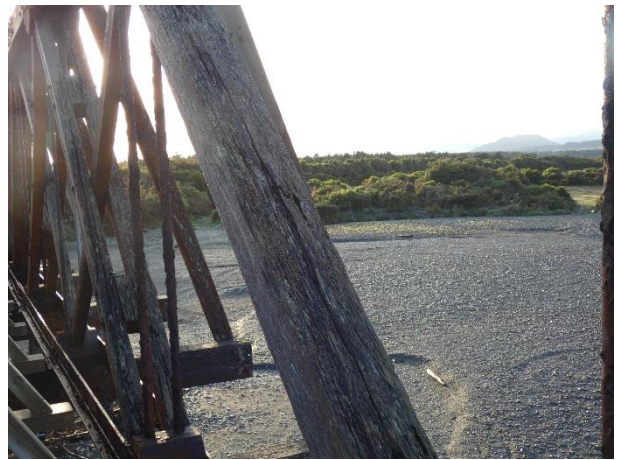
Typical Timber Splitting – King Strut Shown.

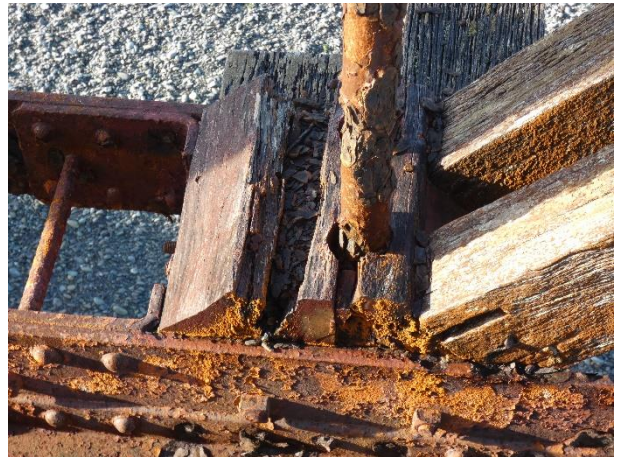
Typical Splitting and Section Loss of Thrust Blocks.

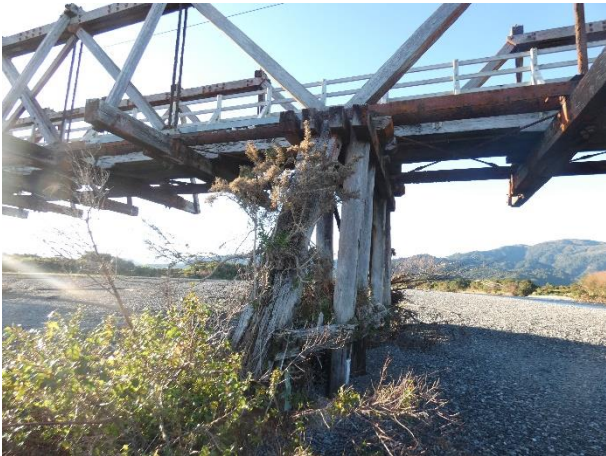
Vegetation Growth From Timber Decay Pockets
