Memorandum

To	Erle Bencich
Copy	Mark Smith, Kathie Ragg
From	Rem Markland
Office	Greymouth
Date	19 June 2024
File/Ref	6-WWES5.02
Subject	Totara Rail Bridge - Summary Assessment 2024

Project Number: 6-WWES3.98

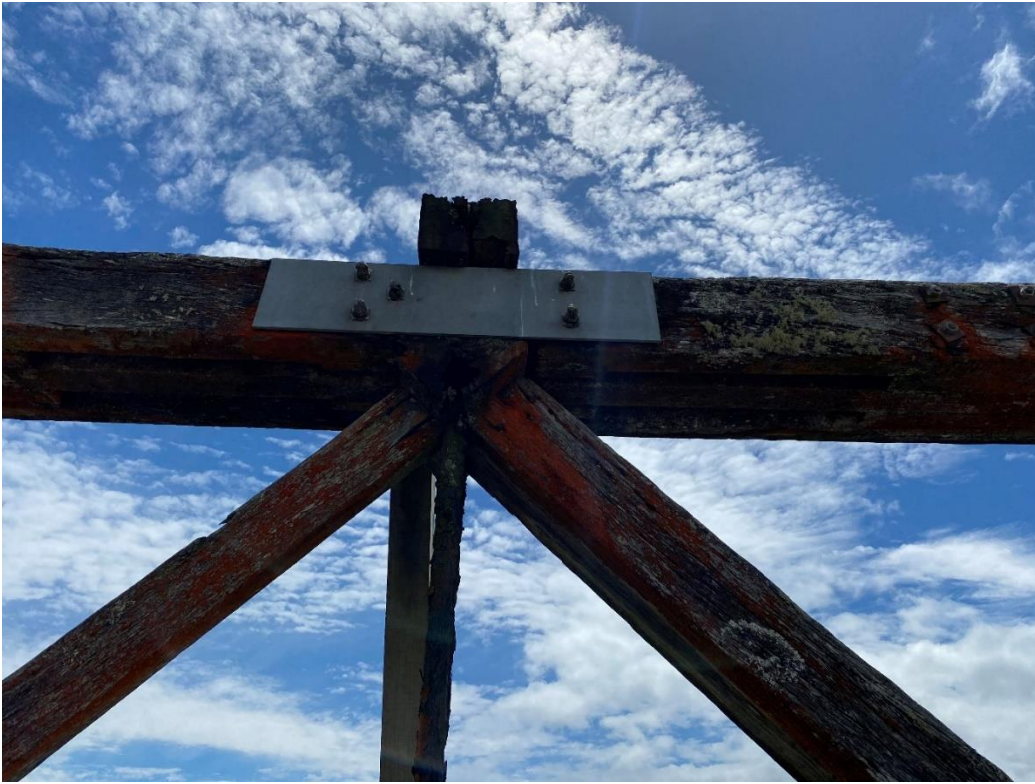
Saddle block split

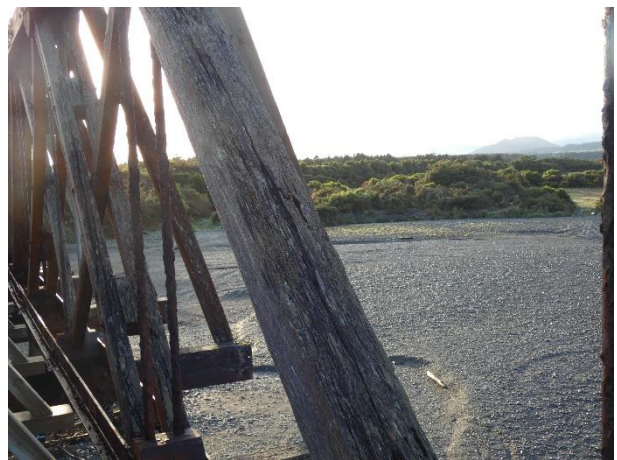
Typical Timber Splitting – King Strut Shown.

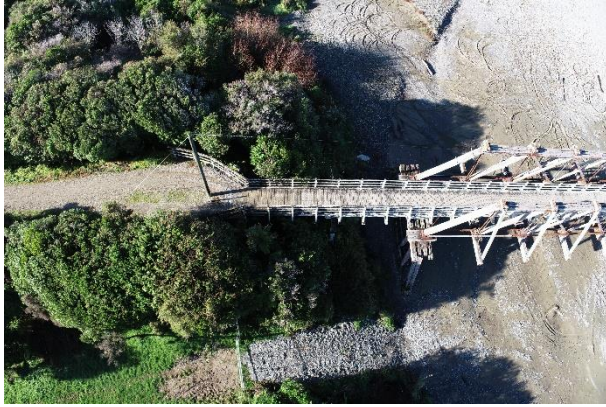
Approach Spans Shrouded in Dense Vegetation. Northern Approach.

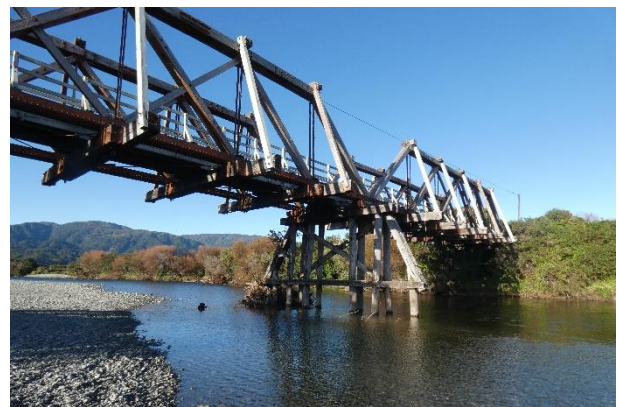
Pier G and Underside of Span G-H not inspected due to Channel Location. Main Channel is Deep. Pile Embedment Depth Unknown.
